FOUR POINT INSPECTION

Doc #: 1611-000

Date: 11/07/2016

Dwelling Address: 1234 Sample Road, Naples, FL 34120

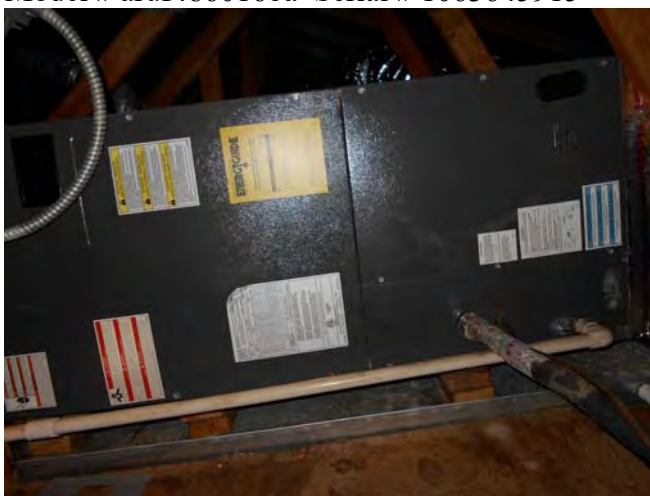
Step #	Component	Comments
201	Heating	Electric; split system; forced air. Electrical disconnect provided near this unit. Unit is located at attic.
202	Heating Conditions	Estimated age of the Heating System is 04 years old. (2010) Estimated approximate life remaining of 06-10 years.
203	Heater Manufacturer	Goodman. Model # aruf486016ba Serial # 1063645915

204	Heating Comments	Functional. The heating system was tested using normal operating controls and appeared to function properly at time of inspection. Due to inaccessibility of many of the components of this unit, the review is limited. Holes or cracks in the heat exchanger are not within the scope of this inspection as heat exchangers are not visible or accessible to the inspector. Unit was operated by the thermostat. As with all mechanical equipment the unit can fail at anytime without warning. Inspectors cannot determine future failures. If a detailed inspection is desired, a licensed heating contractor should be consulted prior to closing to ensure proper and safe operation of this unit
-----	------------------	---

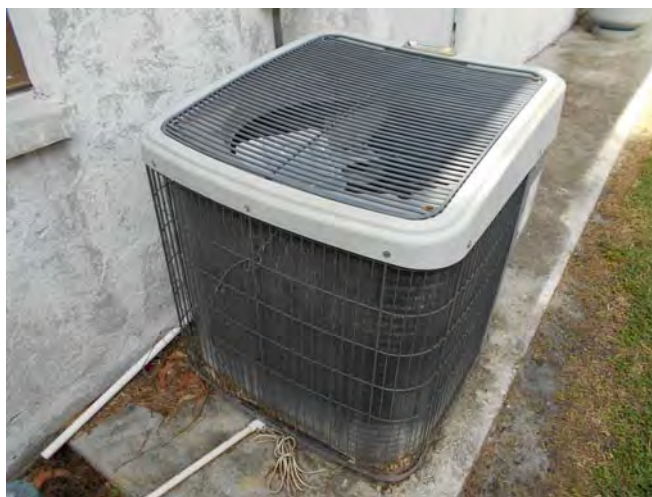
- 205 Cooling Functional. The cooling system was tested using normal operating controls
Electric; split system; forced air. Electrical disconnect provided near this unit.
Unit is located atside of house
- 206 Cooling Estimated age of the Cooling System is 09 years old. (2005)
Conditions Estimated approximate life remaining of 3-5 years.
- 207 Cooling Mfr. International Comfort.
Model: tca248akc4 Serial: e053312378

- 208 Cooling Functional. The cooling system was tested using normal operating controls
Comments and appeared to function properly at time of inspection. Due to inaccessibility
of many of the components of this unit, the review is limited. Unit was
operated by the thermostat. As with all mechanical equipment the unit can fail
at anytime without warning. Inspectors cannot determine future failures. If a
detailed inspection is desired, a licensed heating contractor should be consulted
prior to closing to ensure proper and safe operation of this unit.

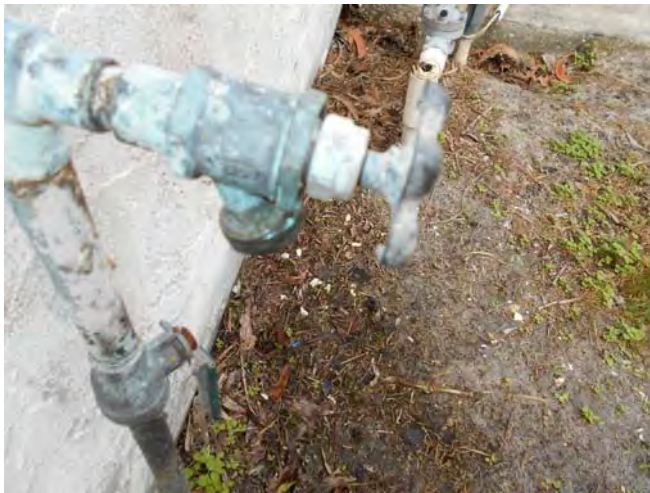
Step #	Component	Comments
301	Plumbing Supply System	Property has a public water supply. Water pressure at time of inspection was 60 psi. Main water shut off is located at left side of building.

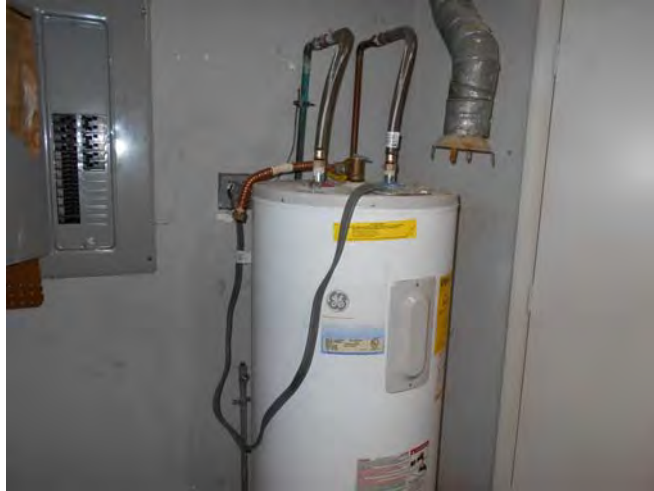
305 Water Heater
Manufacturer

Whirlpool.
Model # e1f50rdo45v Serial # 0328135470

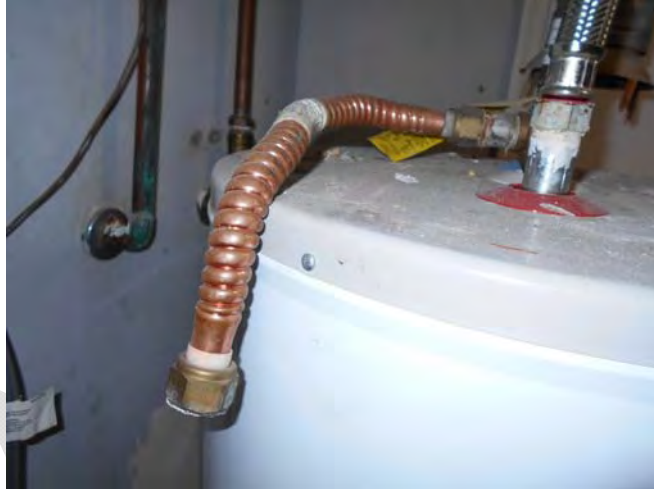
Temperature pressure relief valve installed as a safety feature.

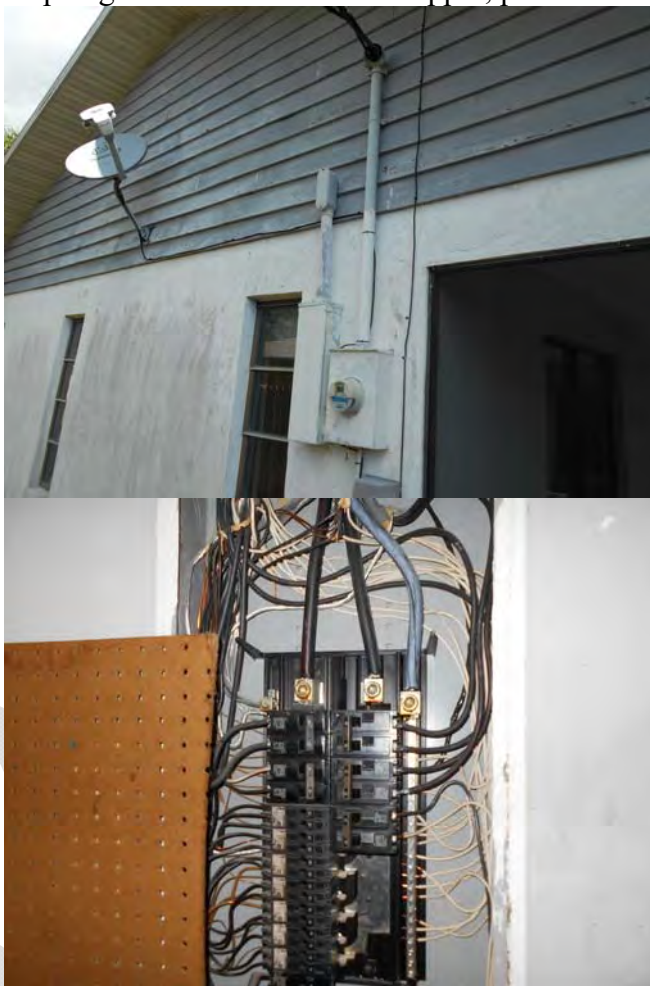
Step #	Component	Comments
401	Electrical Main Box	120 volts; 240 volts; 200 amps. Service entrance is overhead. The main panel is located at the garage. Main disconnect noted main meter. Breakers present to provide overload protection. Main conductor is aluminum, 4/0. Low amperage branch conductor is copper, preferred for safety

Estimated age of the Electrical System is 28 years old. (1987)
 Estimated approximate life remaining of 25-35 years.

402	Electrical Main Box Comments	Functional. ITE Panel
-----	------------------------------	--------------------------
