HAZELBAKER CONSTRUCTION SERVICES
8965 QUARRY DRIVE
NAPLES, FLORIDA
(239)213-8046

Doc #: 1412-000

Dwelling Address: 123 Sunshine Way # 204, Estero, Florida 33928

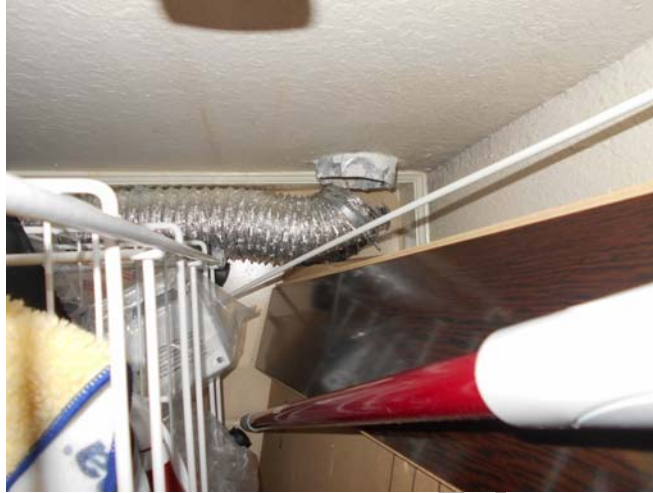
1612. Dryer & Hook-ups

Review: Dryer vent was disconnected at the time of inspection.

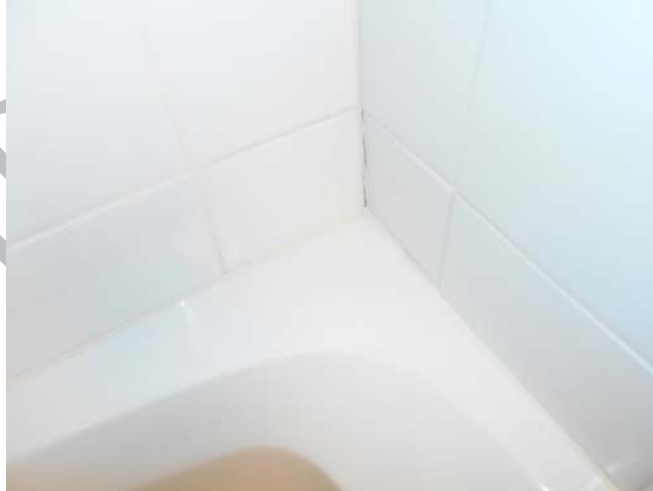
2811. Tub & Surround

Review: Tile. Open grout joints noted. Suggest replacing grout or caulking to prevent future/further moisture penetration and damage/deterioration to interior walls. This damage is not always visible or accessible to the inspector at the time of inspection.
