**HAZELBAKER CONSTRUCTION SERVICES**  
**8965 QUARRY DRIVE**  
**NAPLES, FLORIDA**  
**(239)213-8046**

Doc #: 1404-000

Dwelling Address: 123 Sunshine Way, Bonita Springs, Florida 34134

Inspector: Joel Hazelbaker, **Licensed Florida State Home Inspector: License No. HI874**

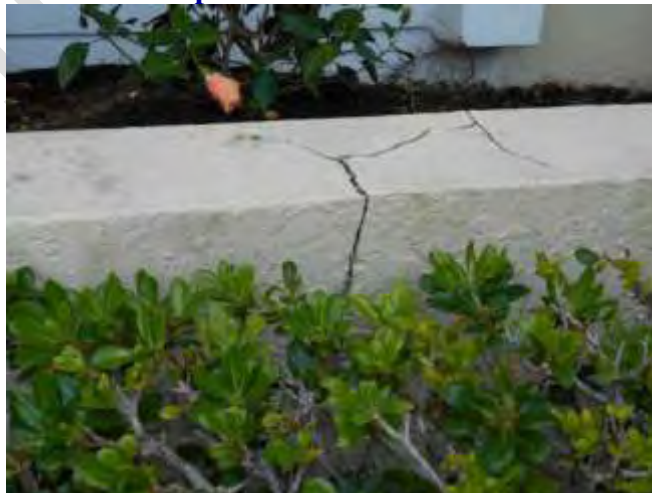
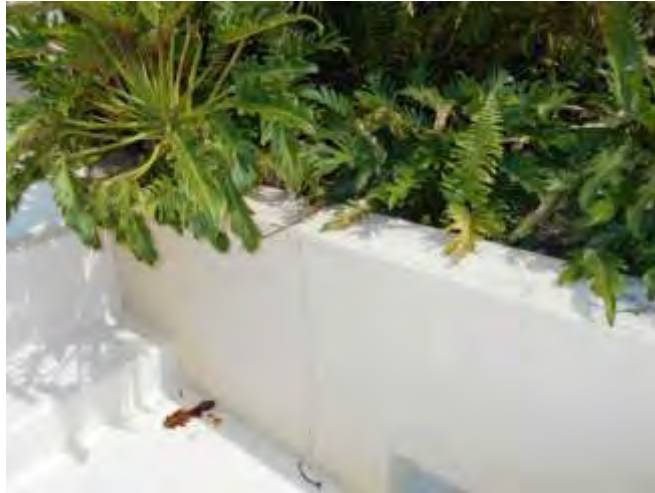
1103. Fences/Gates **Review: Cracks noted, suggest installing weeps to release water pressure behind walls.**

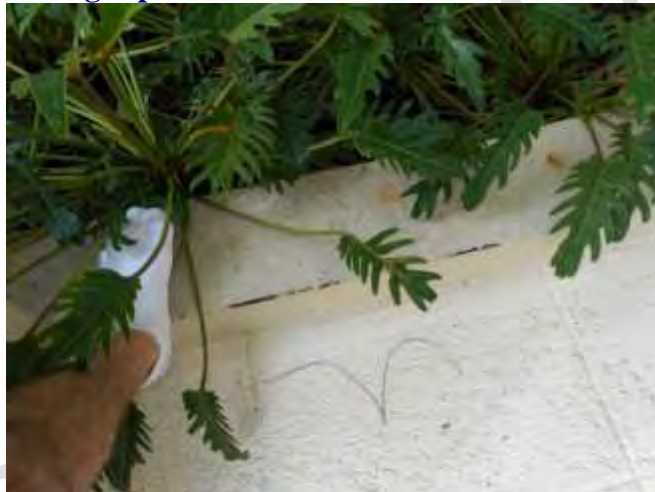
1104. Siding

**Review: Cracks/ rust noted at some locations, suggest sealing/repair.**

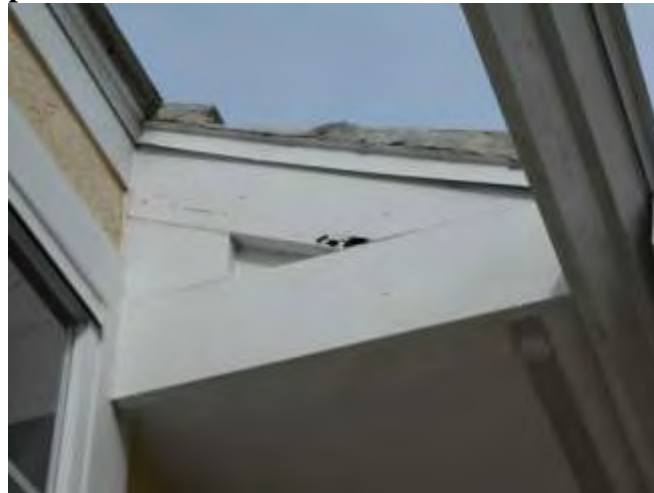
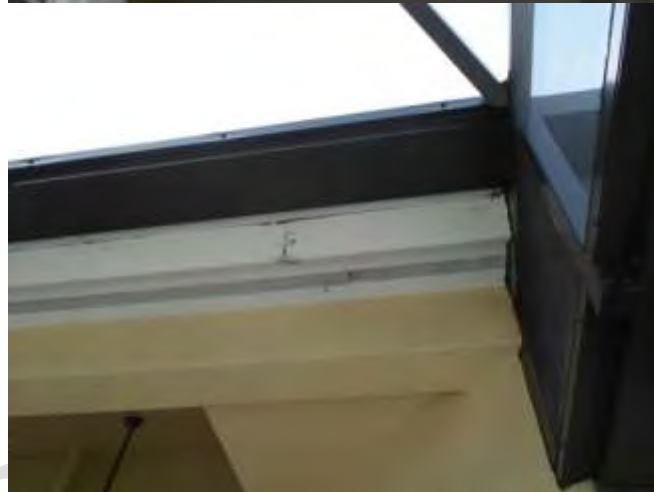
1105. Trim

**Review: Wood decay noted at fascia over garage and at pool area.**

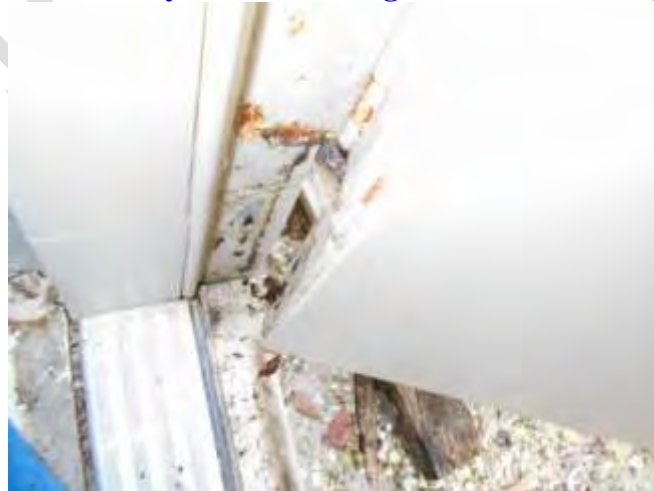
**Minor decay noted at Storage room doors on right side.**

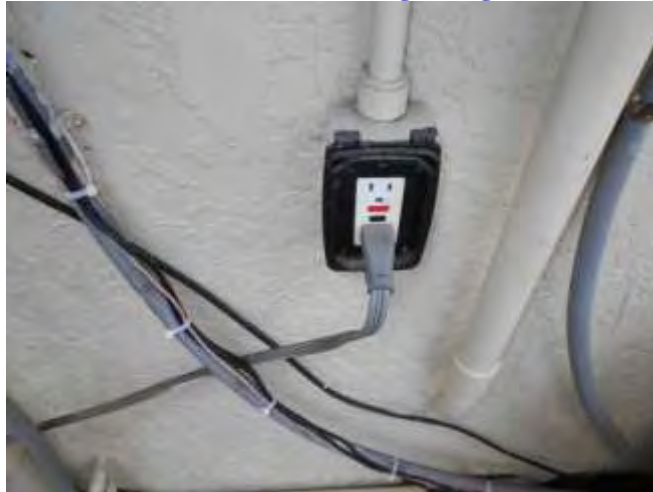
1107. Electrical

**Review: Outlet cover missing at right side.**

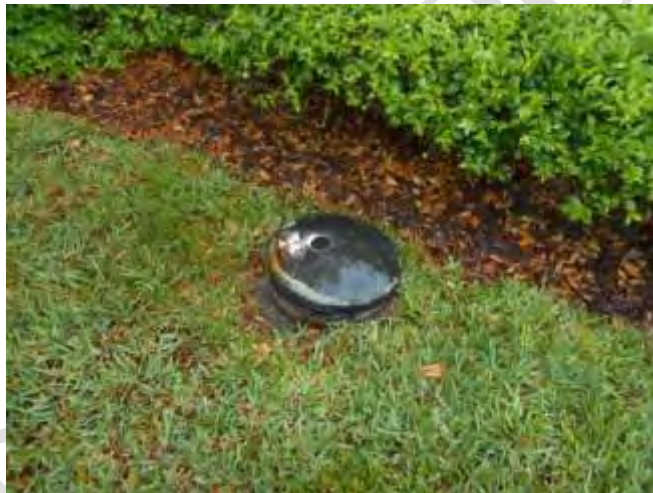
1114. Propane  
Tank/Gas  
Meter

**Review: Cover is broken.**

**Buyer would like to have Tank pressure tested and certified.**

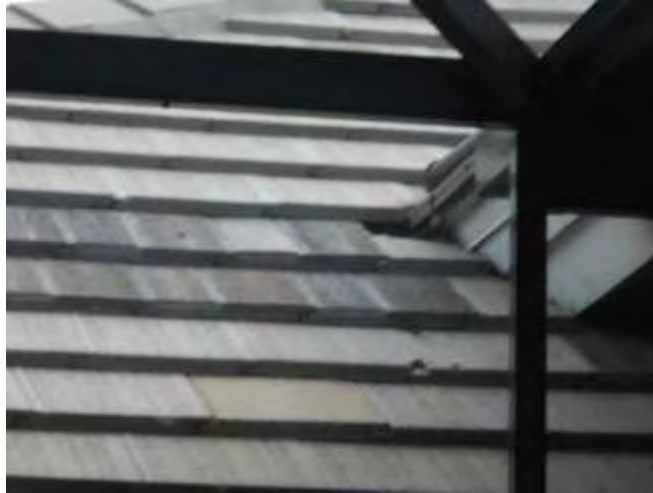
1304. Conditions

**Review: Broken loose tile noted at rear.**

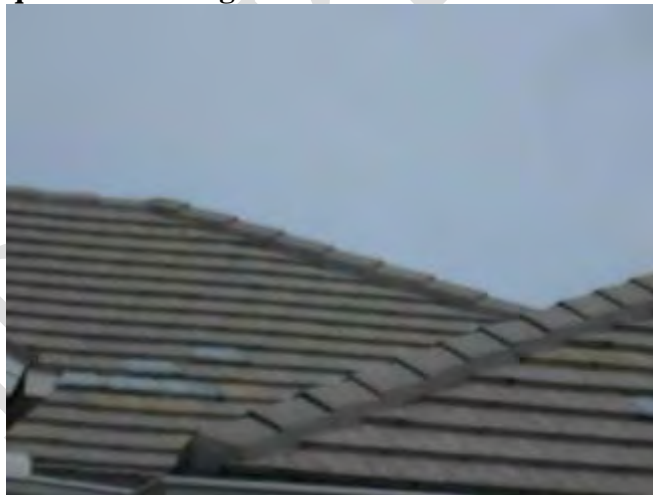
**Cracked masonry noted at ridges.****Numerous replaced tiles noted, leaks noted in attic above lanai area. Suggest further review/ repair by a qualified roofing contractor.**

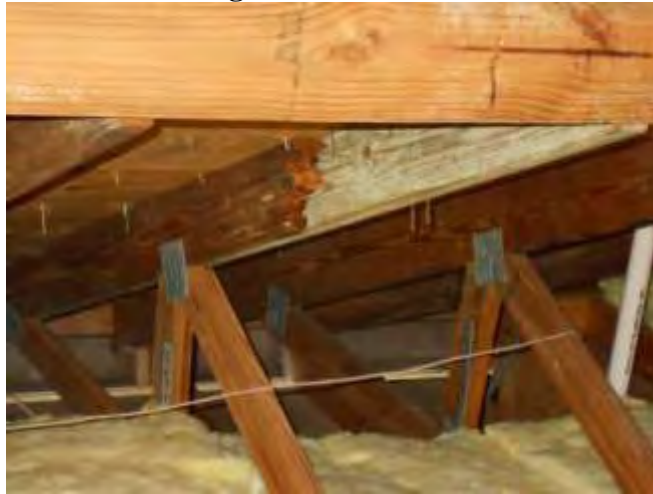
1402. Framing

**Review: Damaged truss noted that has been repaired. If concerned suggest further review by a qualified contractor or engineer.**

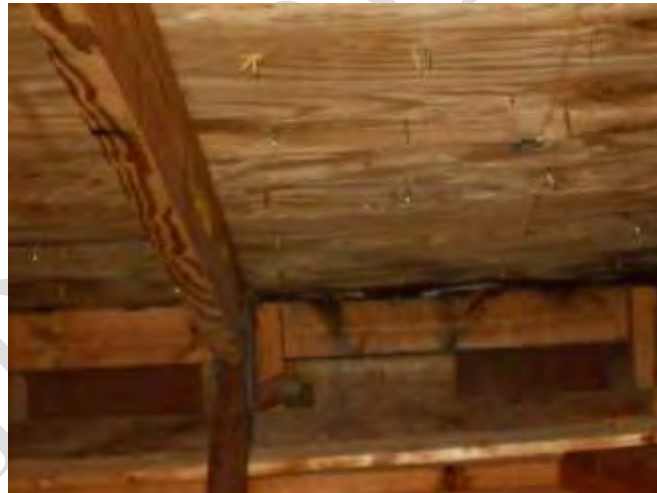
1404. Evidence of Leaking

**Review: Stains noted at rear over lanai.**

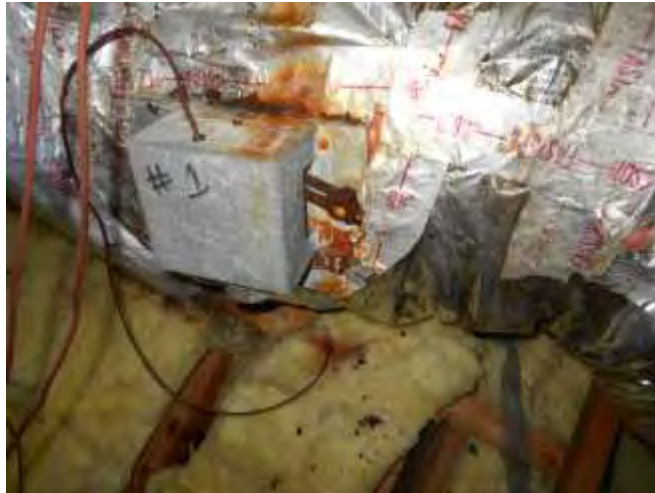
1410. HVAC Ducts **Review: Leaks in ducts noted at motorized dampers, condensation causing rust. Suggest properly sealing ducts.**

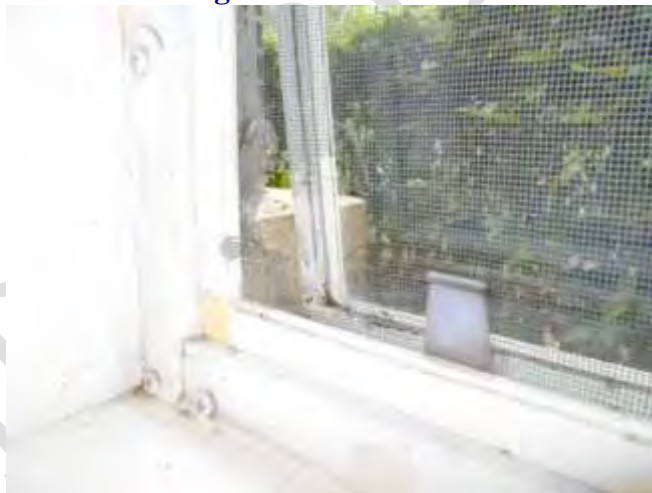
1507. Windows / Screens **Review: Damaged screens noted.**

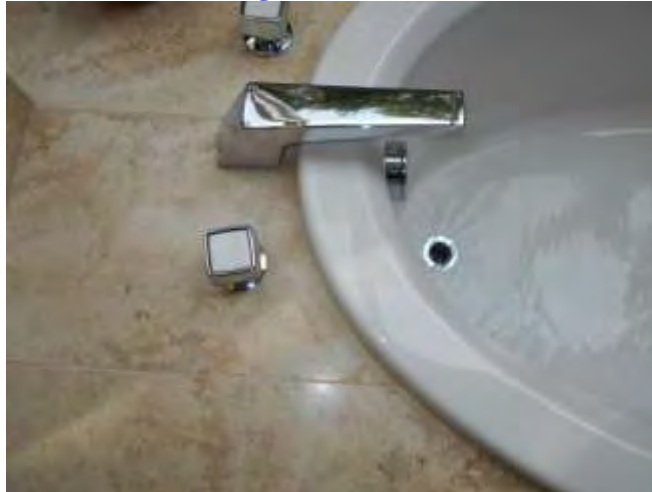
2711. Tub &  
Surround      **Review: Stopper inoperable. How water knob could not be turned using normal force.**

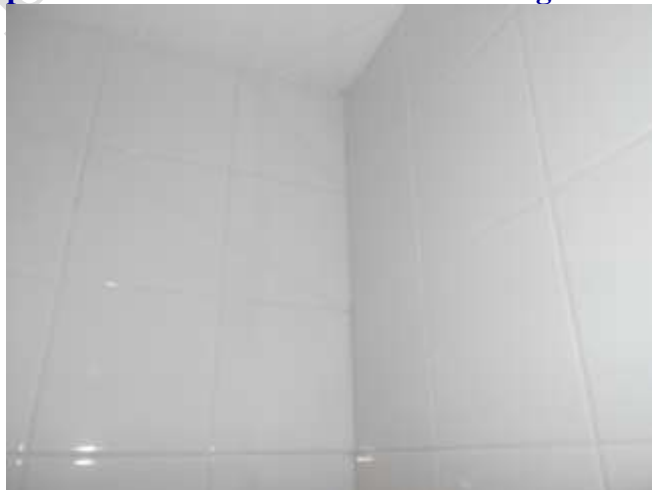
2811. Tub &  
Surround      **Review: Open grout joints noted; suggest caulking to prevent moisture intrusion into framing.**

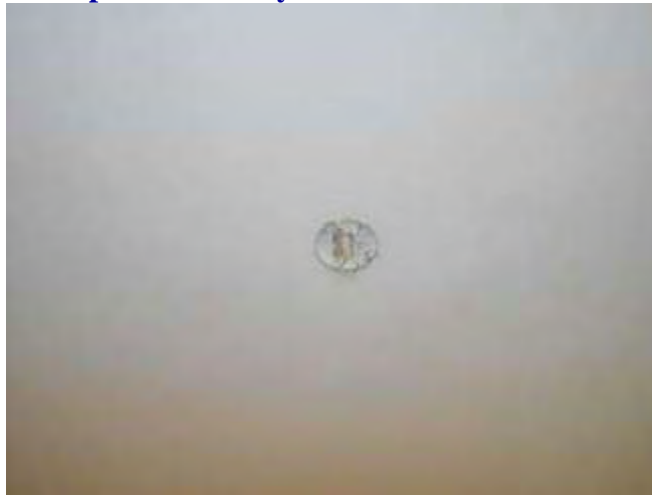
2907.3. Electrical

**Open junction box noted at ceiling; suggest installing cover plate for safety.**

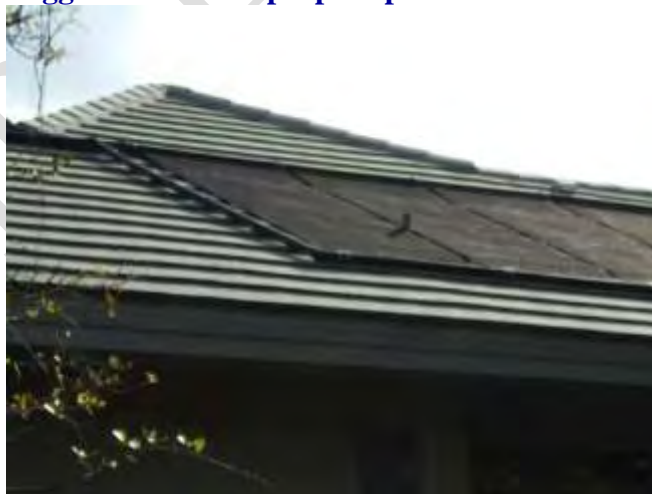
3010. Heater

**Review: Review: Solar heating system present, valves closed and system not tested. Suggest review for proper operation.**

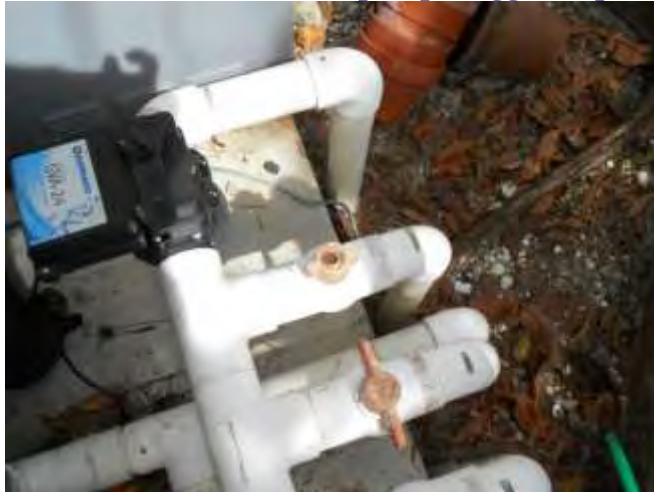
**Review: Valve broken at pump. Suggest replacement.**

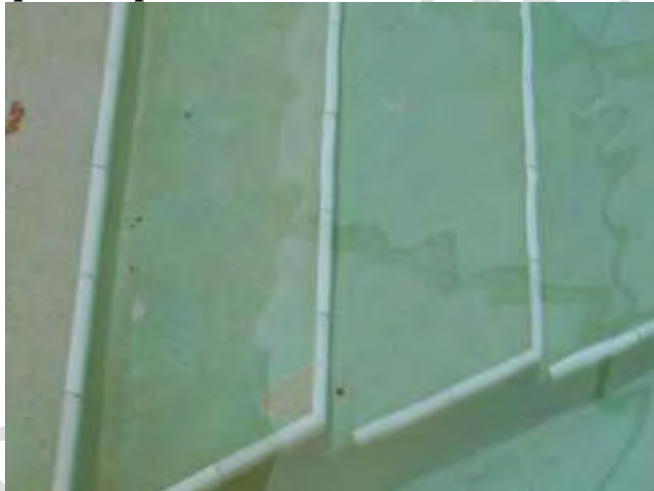
**Blemishes noted in pool surface, suggest review by a qualified pool contractor.**
