HAZELBAKER CONSTRUCTION SERVICES
14501 MARSALA WAY
NAPLES, FLORIDA 34109
(239) 213-8015

Doc #: 2112-030 Inspector: John "Jack" Defossez

Date: 12/22/2021

Dwelling Address: 123 Sunshine Way, Bonita Springs, Florida 34134

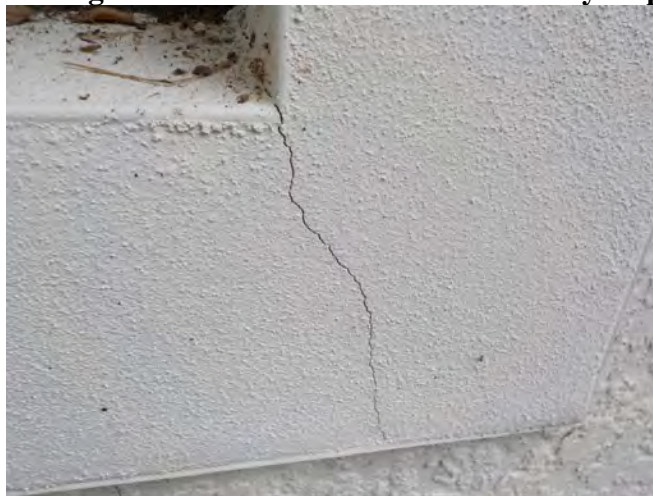
1104.	Siding	Review; Stucco. Cracks present at several locations. Cracks should be properly sealed to prevent insect and moisture intrusion. Damage/deterioration to interior walls may be present.
-------	--------	---

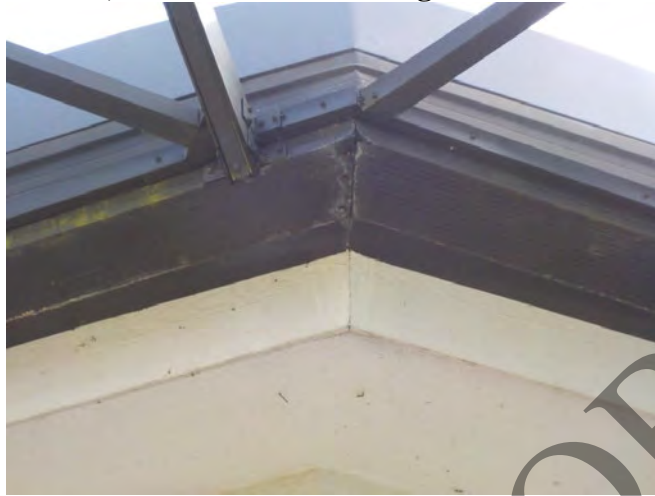
Review; Metal. Leak noted at gutter on rear side of home.

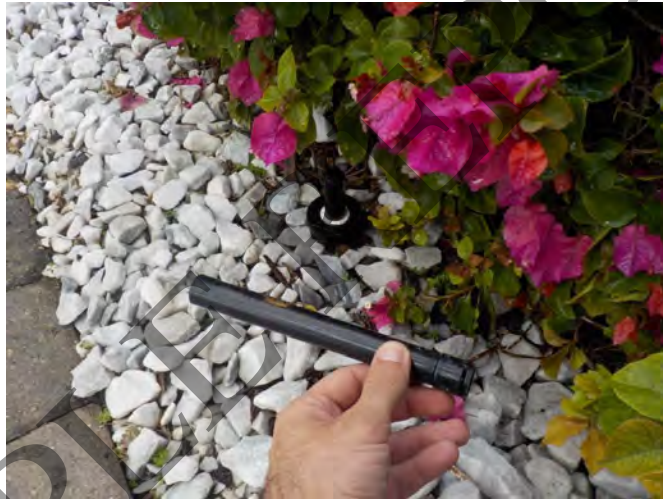
Review; Broken head noted at front side of home.

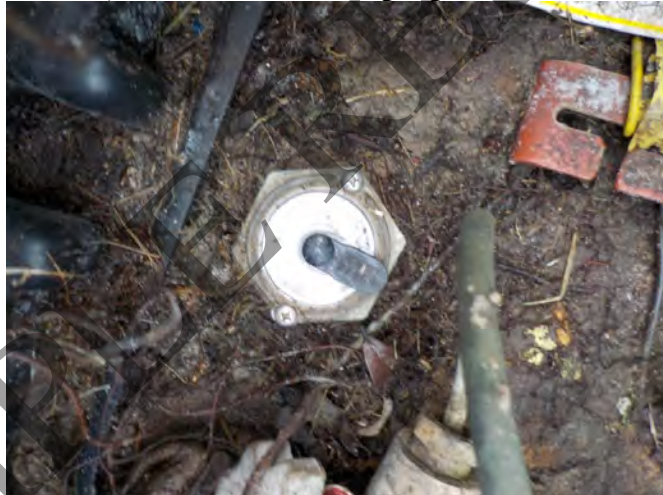
Review; Low level noted at propane tank.

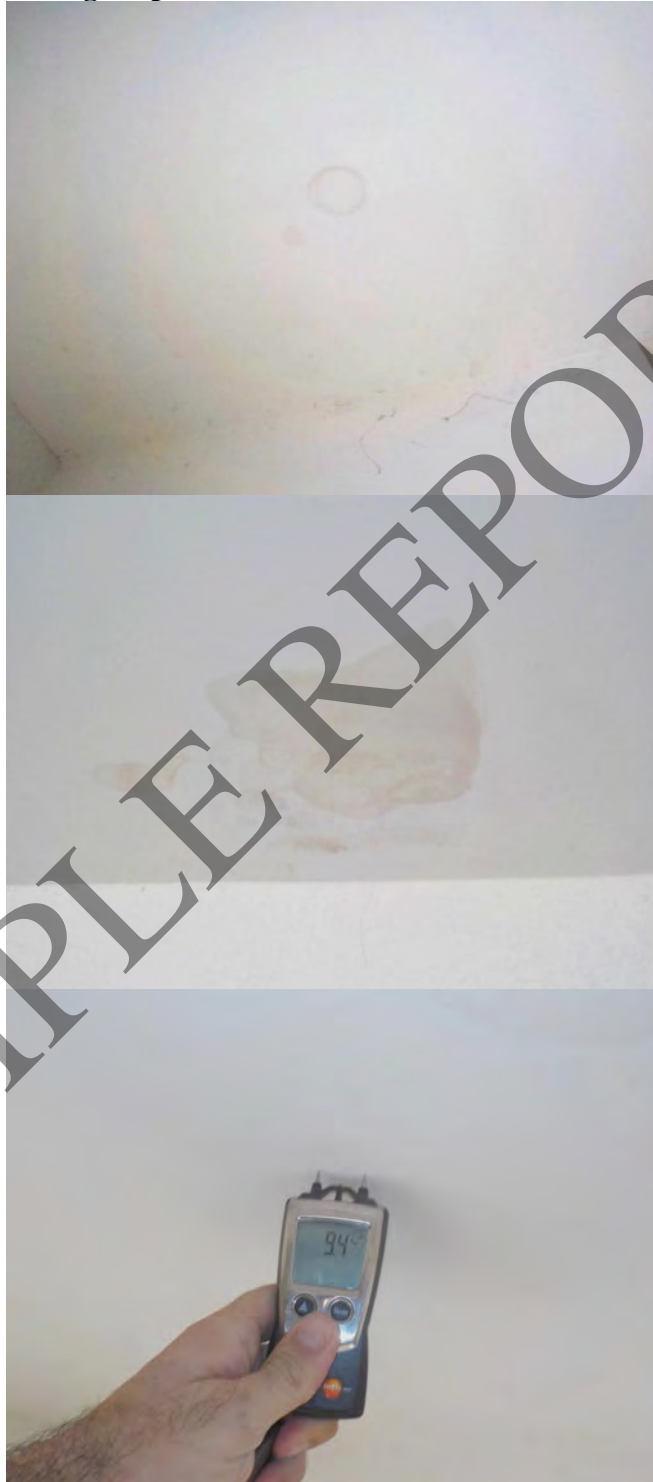
Review; Staining noted on ceiling in two areas on right-side garage. Areas were dry at time of inspection. Suggest review by a water damage expert.

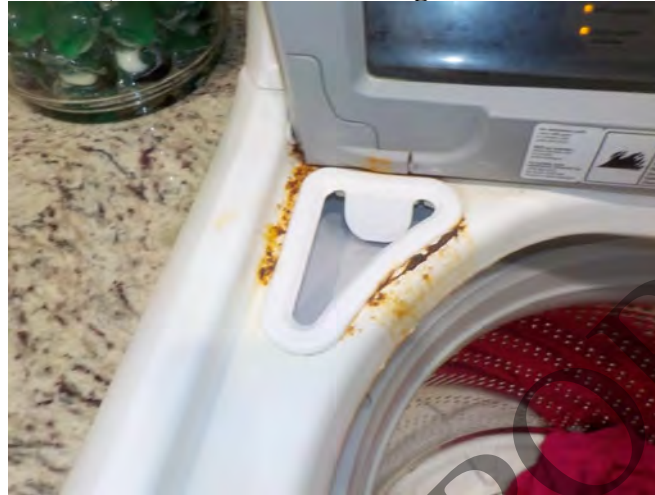
Review; Rust noted at washing machine.

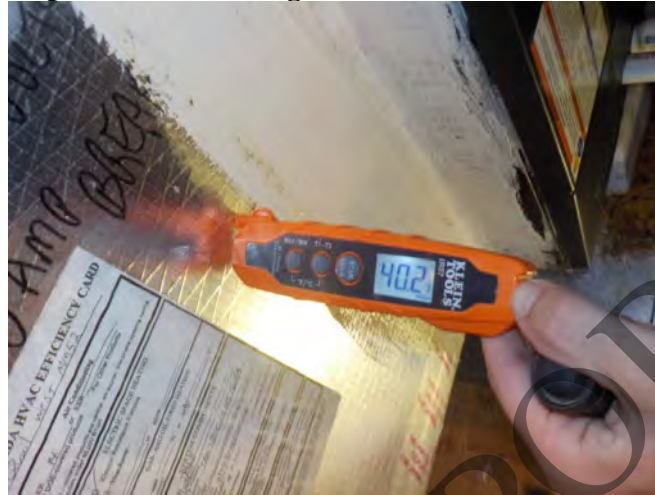
Review; Return air temperature at register was 72 degrees. Supply air temperature was 40 degrees. Difference in air temperature at time of inspection was 32 degrees.

Temperature difference was not within the 16 to 22 degrees normal operating range at time of inspection. Suggest review by a qualified HVAC contractor.

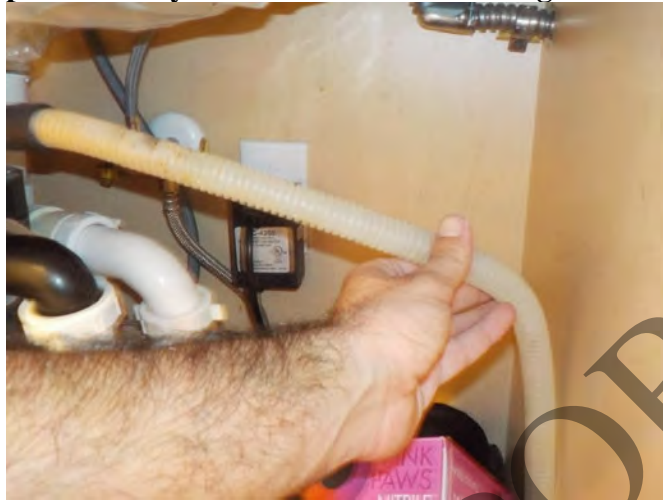
Review; No loop in drain line. A loop in drain line is required to prevent dirty drain water from entering the dishwasher.

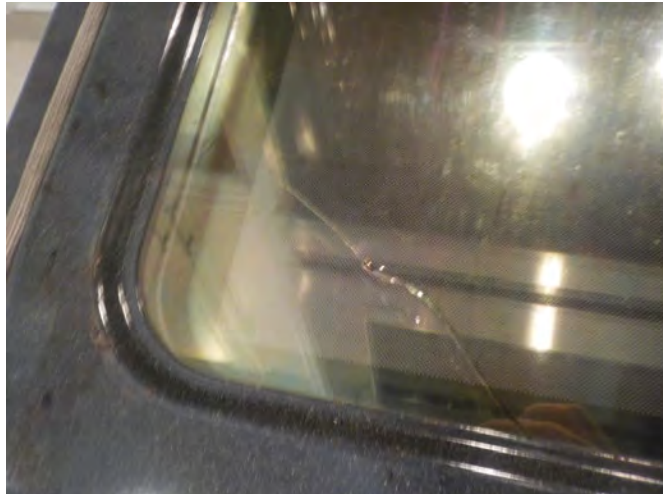
Review; Loose handle noted at lower oven door. Cracked glazing noted at window.

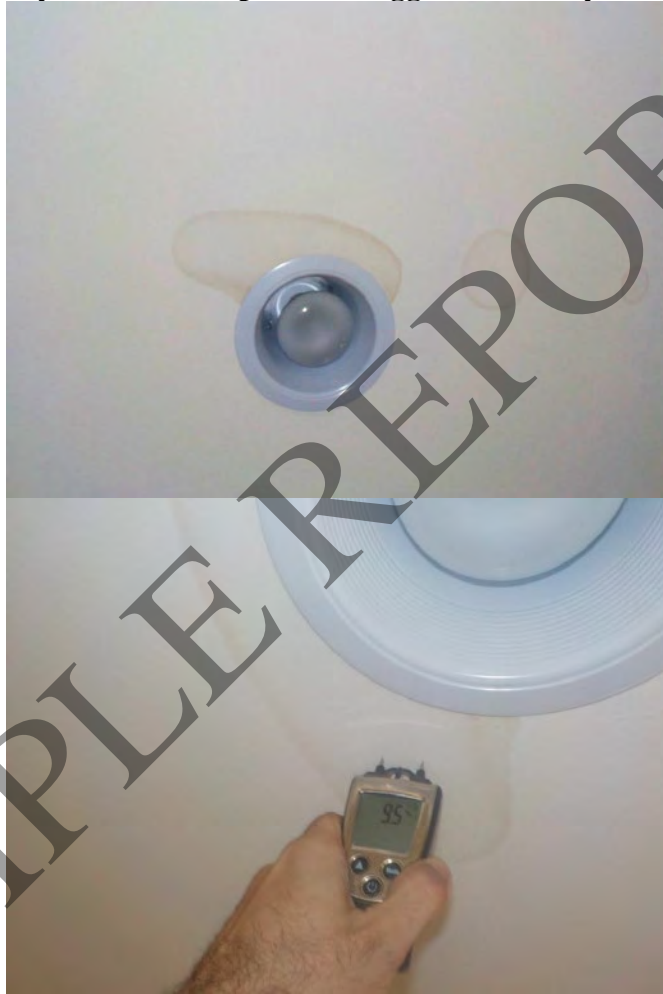
Step #	Component	Comment
2601.	Location	Entry/Bedrooms.
2602.	Floor	Tile.
2603.	Walls	Functional.
2604.	Ceiling	Review; Staining noted at ceiling in hallway area near entry. Area was dry at time of inspection. Suggest review by a water damage expert.

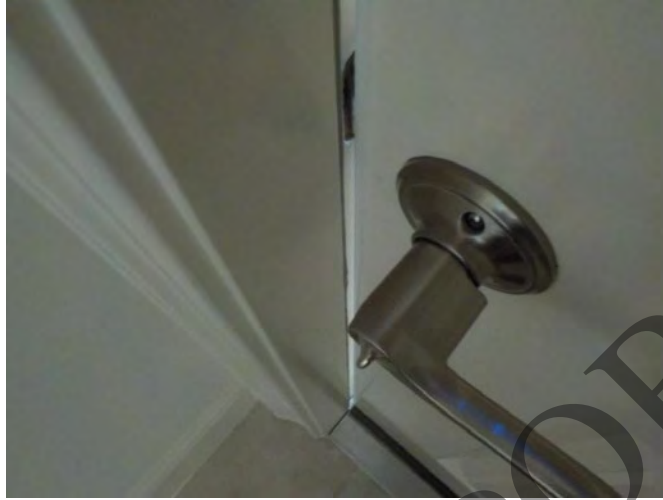
2606. Exterior Doors **Review; Wood/Metal. Gap in weather stripping noted at door leading to garage on left side of home.**

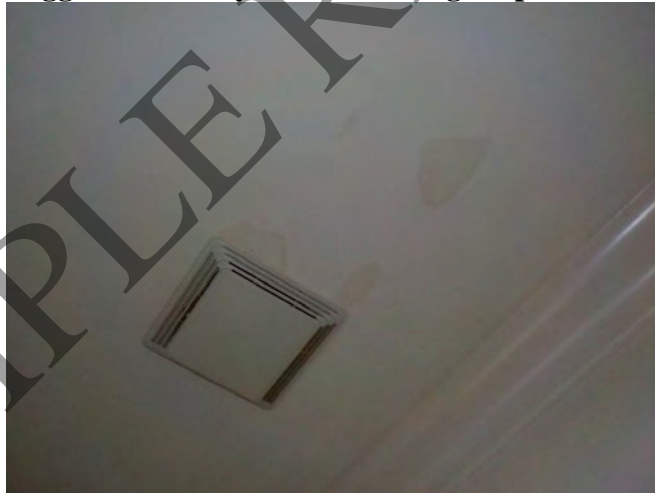
2803. 2.	Ceiling	Review; Staining noted at ceiling. Areas were dry at time of inspection. Suggest review by a water damage expert.
----------	---------	---
