**HAZELBAKER CONSTRUCTION SERVICES**  
**14501 MARSALA WAY**  
**NAPLES, FLORIDA 34109**  
**(239) 213-8015**

Doc #: 2112-030  
Dwelling Address: 123 Sunshine Way, Bonita Springs, Florida 34134  
Client Name: John Doe  
Inspector: John "Jack" Defossez, **Licensed Florida State Home Inspector: License No. HI9806**

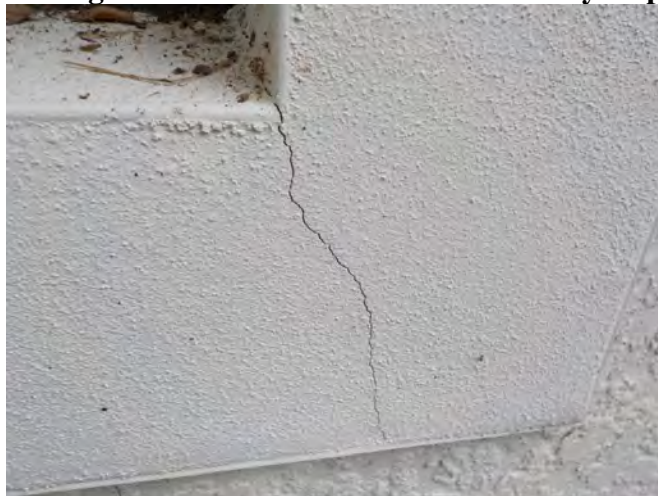
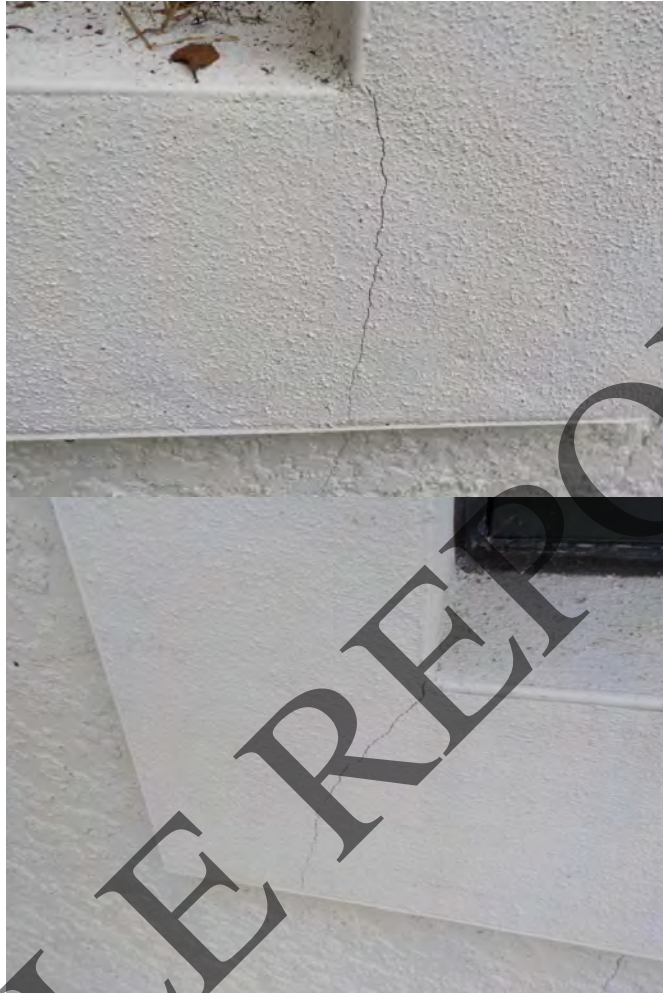
1104. Siding **Review; Stucco. Cracks present at several locations. Cracks should be properly sealed to prevent insect and moisture intrusion. Damage/deterioration to interior walls may be present.**

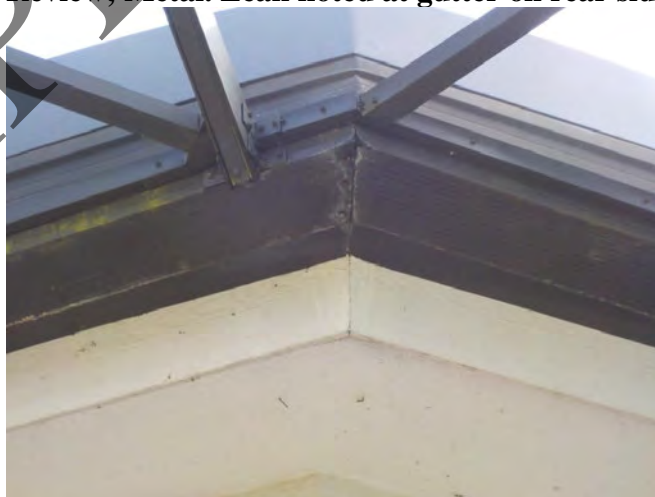
1108. Gutters & Downspouts

**Review; Metal. Leak noted at gutter on rear side of home.**

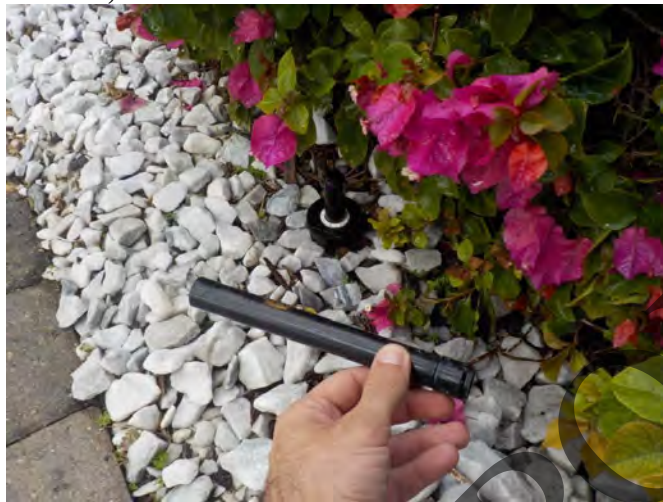
1110. Sprinkler System

**Review; Broken head noted at front side of home.**

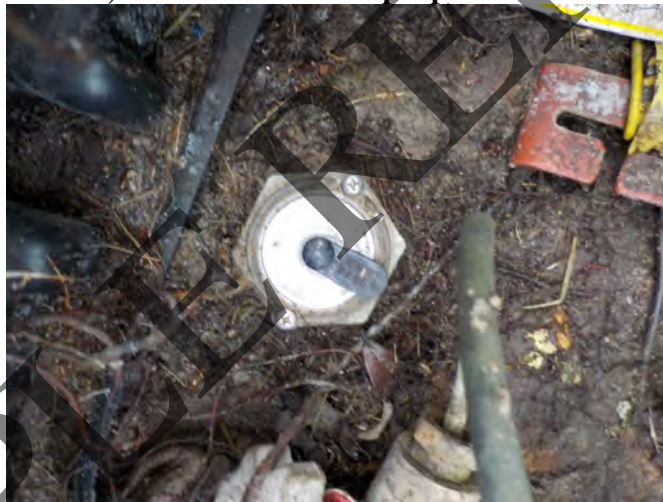
1114. Propane Tank/Gas Meter

**Review; Low level noted at propane tank.**

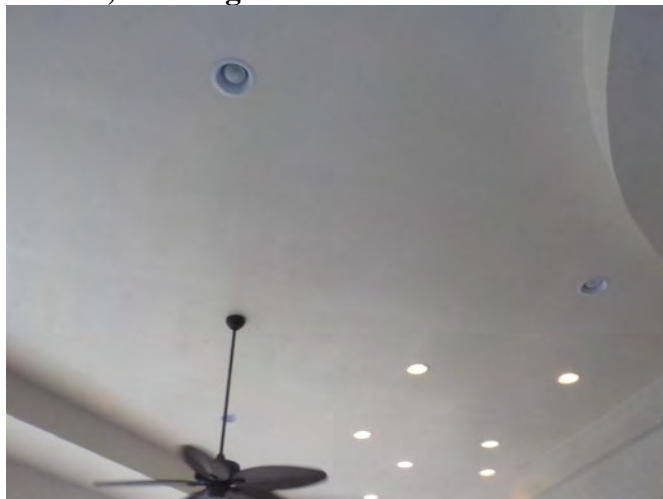
1204. Electrical

**Review; Some lights not functional. Possible bad bulbs.**

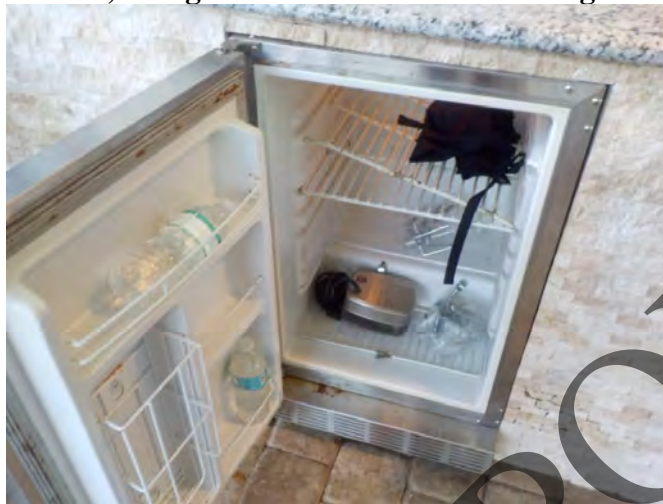
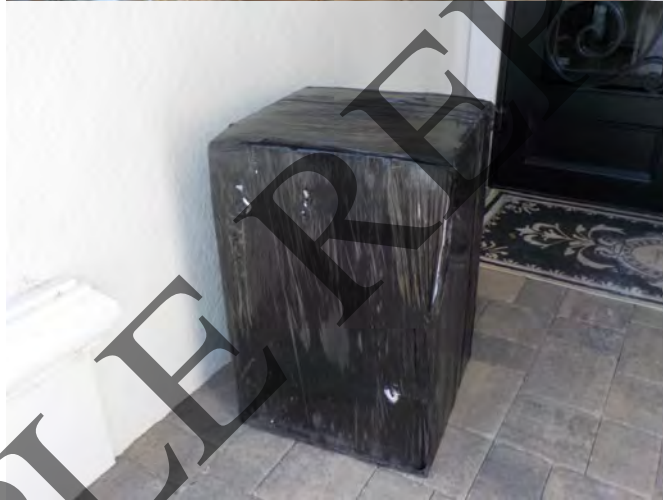
1212. Refrigerator

**Review; Fridge is not functional. New fridge to be installed.**

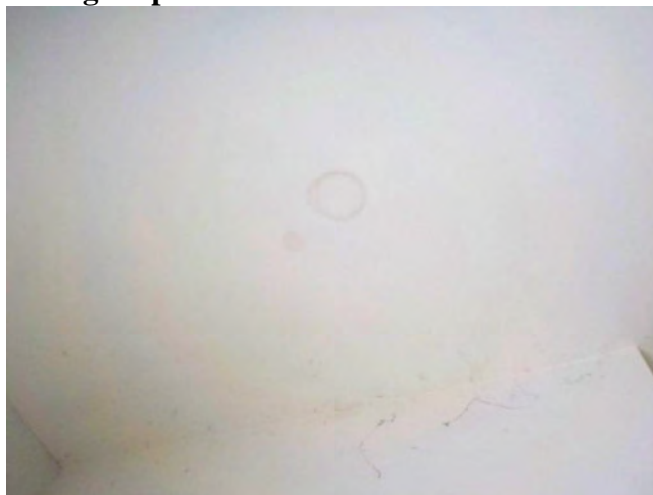
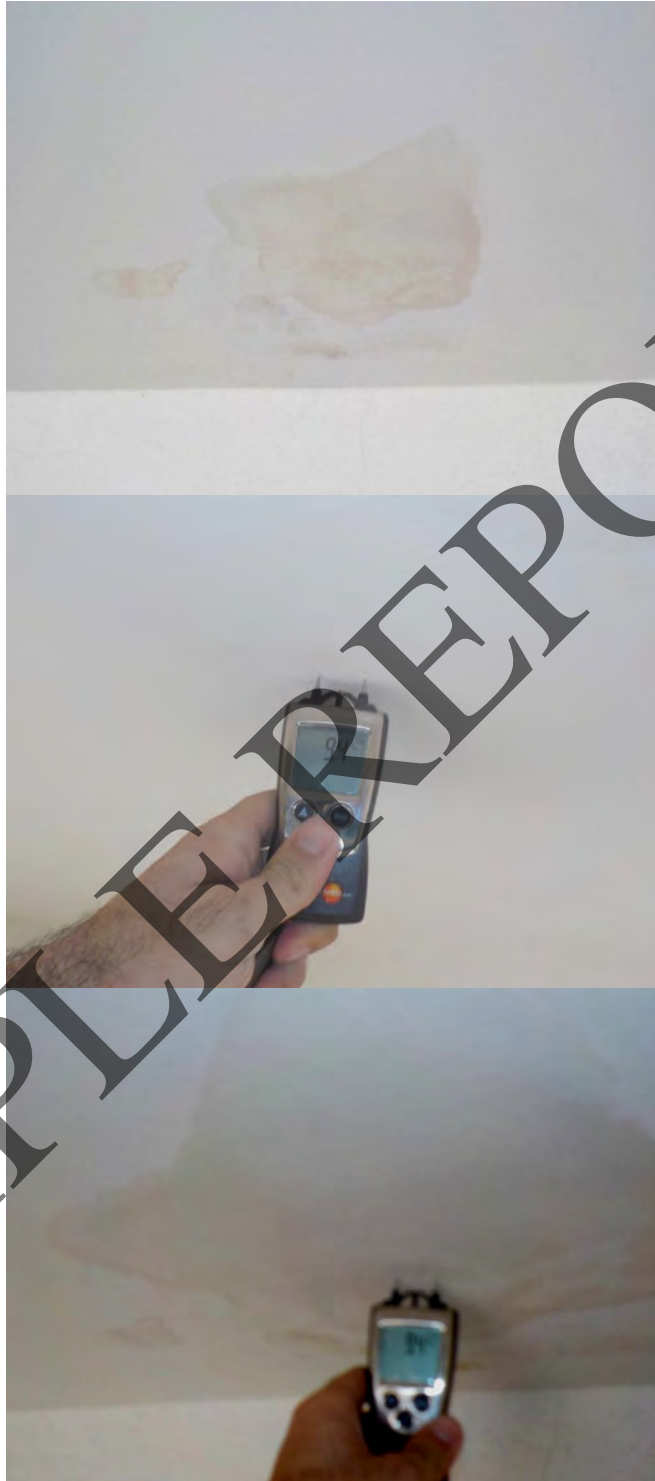
1512. Ceiling

**Review; Staining noted on ceiling in two areas on right-side garage. Areas were dry at time of inspection. Suggest review by a water damage expert.**

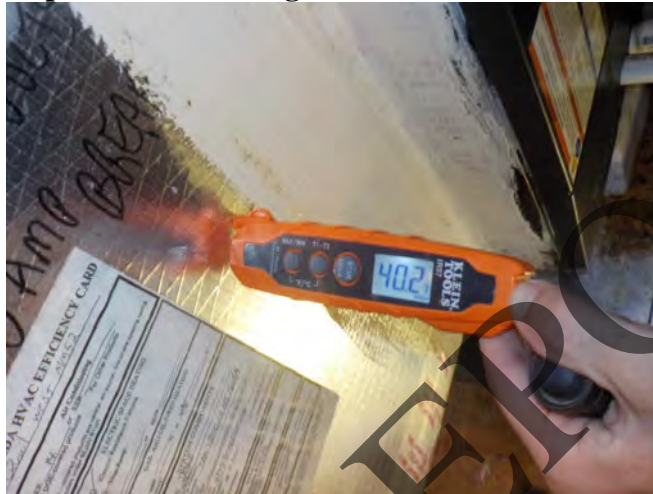
1810. A/C  
Temperature  
Differences

**Review; Return air temperature at register was 72 degrees. Supply air temperature was 40 degrees. Difference in air temperature at time of inspection was 32 degrees.**

**Temperature difference was not within the 16 to 22 degrees normal operating range at time of inspection. Suggest review by a qualified HVAC contractor.**

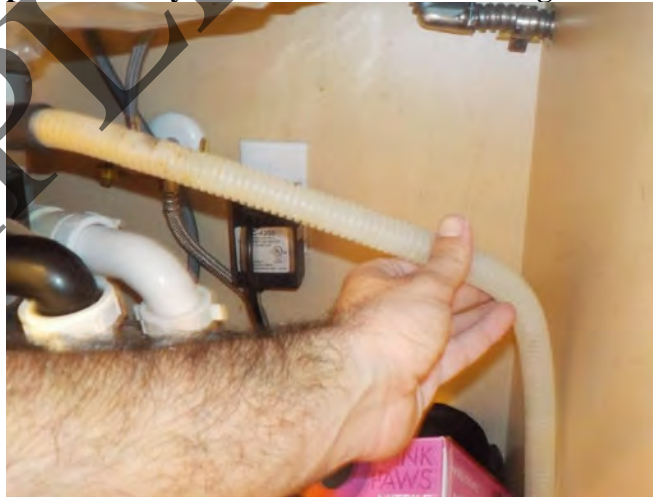
2114. Dishwasher

**Review; No loop in drain line. A loop in drain line is required to prevent dirty drain water from entering the dishwasher.**

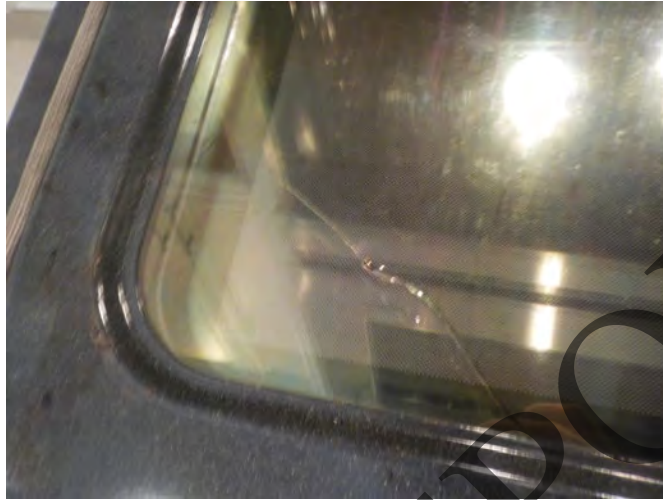
2116. Oven

**Review; Loose handle noted at lower oven door. Cracked glazing noted at window.**

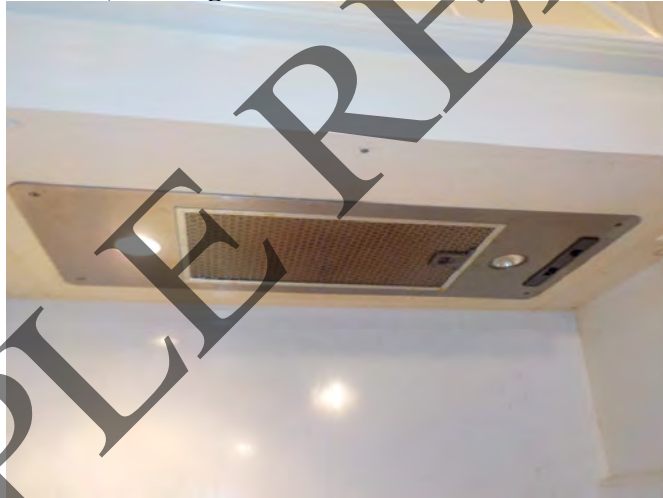
2117. Hood/Fan/Light

**Review; One light not functional at hood. Possible bad bulb.**

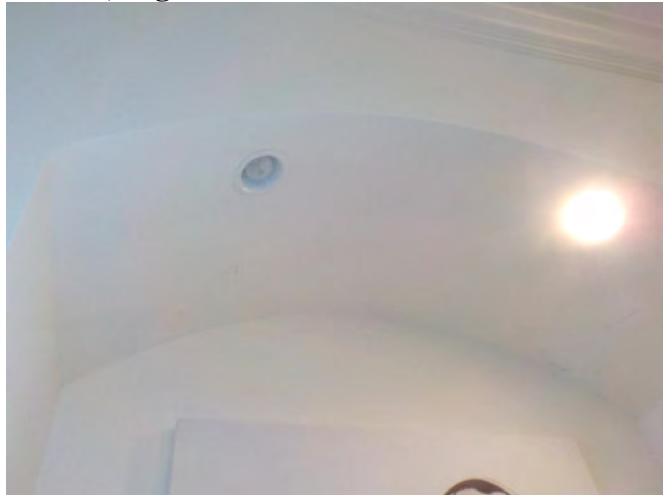
2207. Electrical

**Review; Light is not functional. Possible bad bulb.**

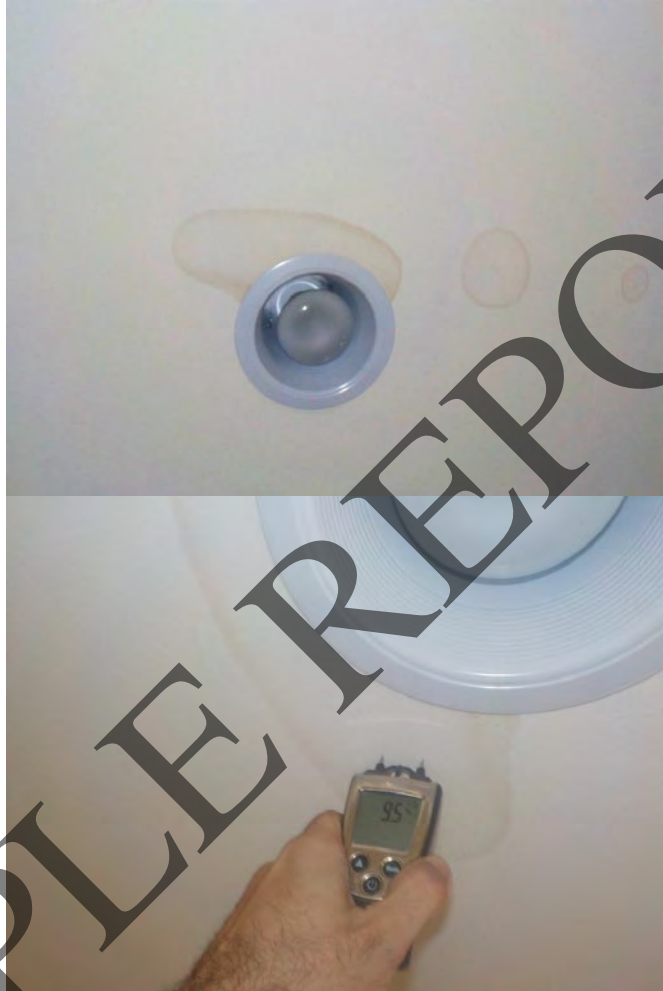
2604. Ceiling

**Review; Staining noted at ceiling in hallway area near entry. Area was dry at time of inspection. Suggest review by a water damage expert.**

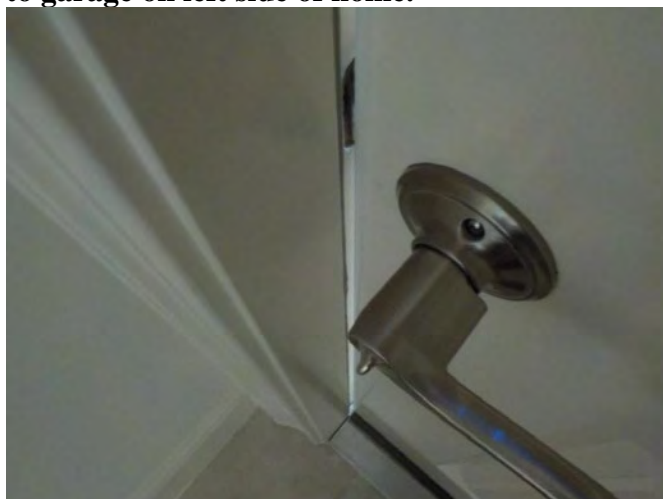
2606. Exterior Doors

**Review; Wood/Metal. Gap in weather stripping noted at door leading to garage on left side of home.**

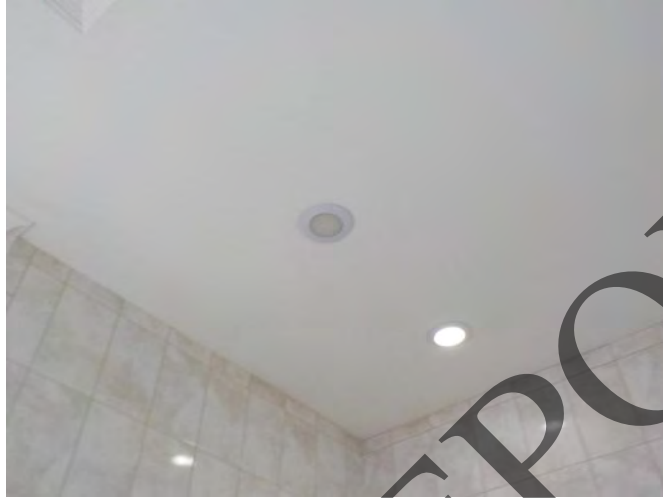
2707. Electrical

**Review; Light is over shower is not functional. Possible bad bulb.**

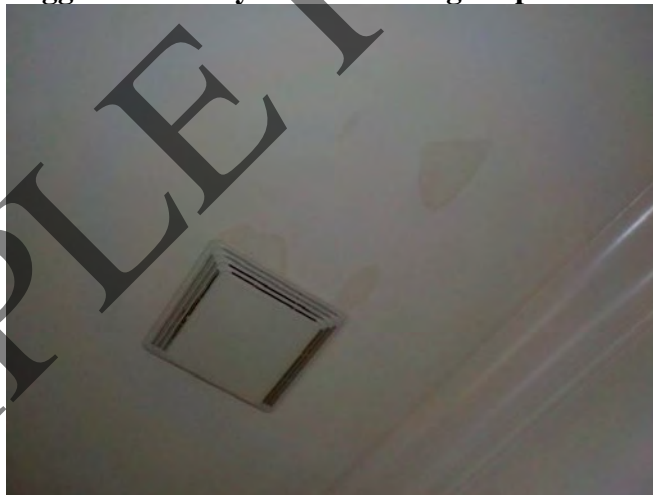
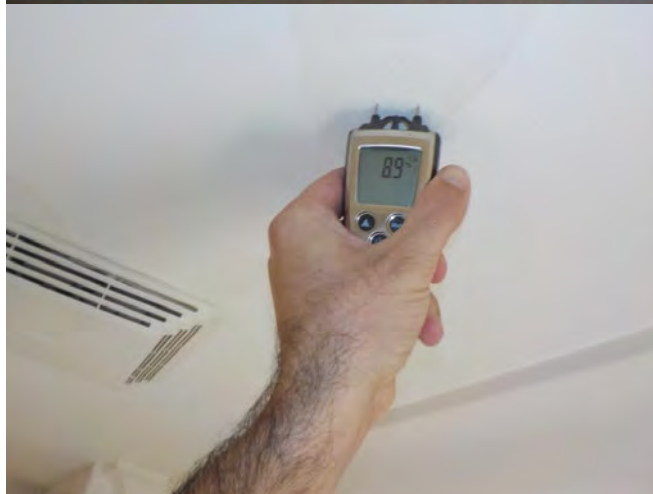
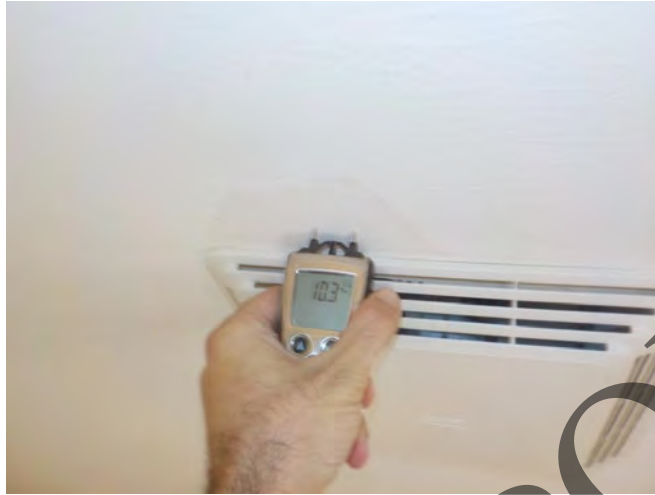
2803. 2. Ceiling

**Review; Staining noted at ceiling. Areas were dry at time of inspection. Suggest review by a water damage expert.**

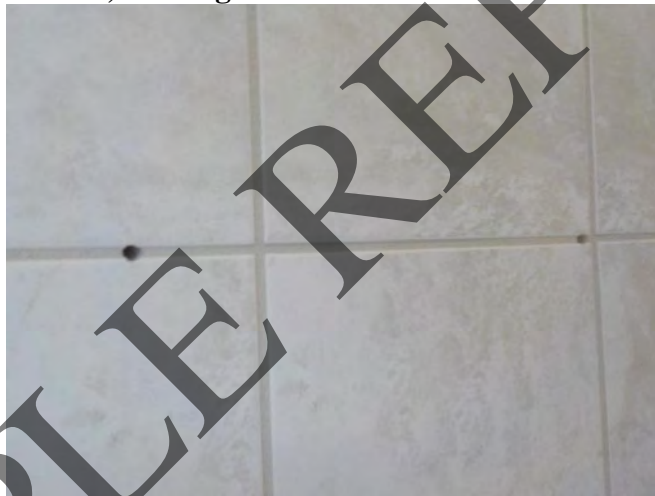
2811. 2. Tub &  
Surround

**Review; Missing towel rack noted.**

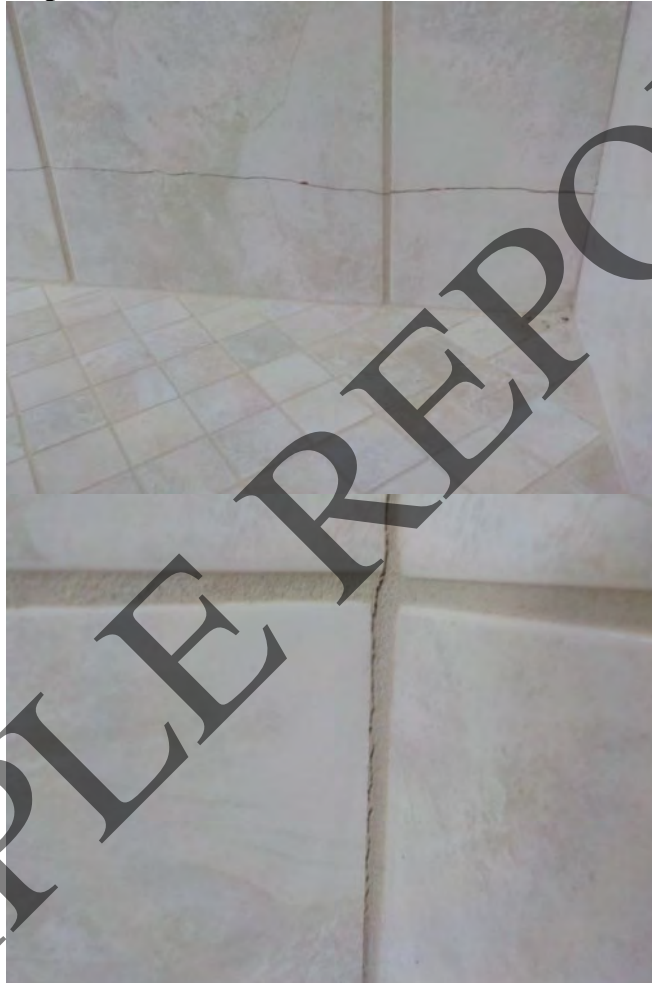
**Review; Tile. Cracked tiles & open grout joints noted. Suggest replacing grout or caulking to prevent future/further moisture penetration and damage/deterioration to interior walls. This damage is not always visible or accessible to the inspector at the time of inspection.**

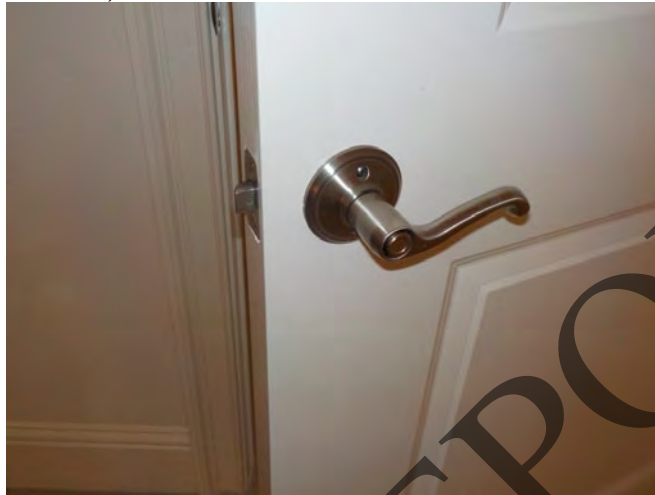
2904.4. Interior Doors **Review; Wood. Door does not latch in frame.**

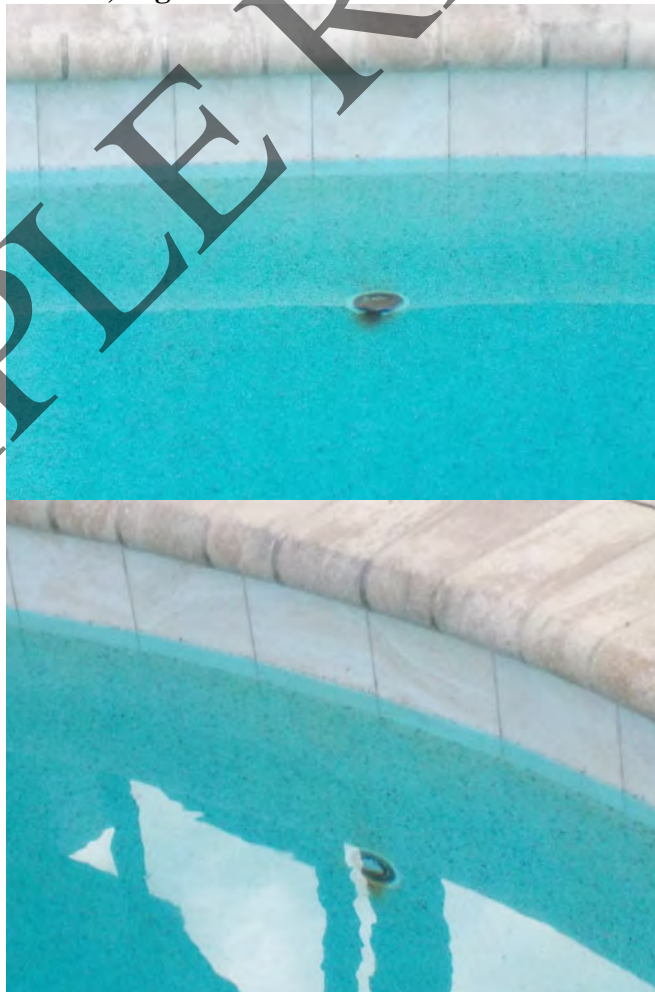
3008. Lights **Review; Lights are not functional.**

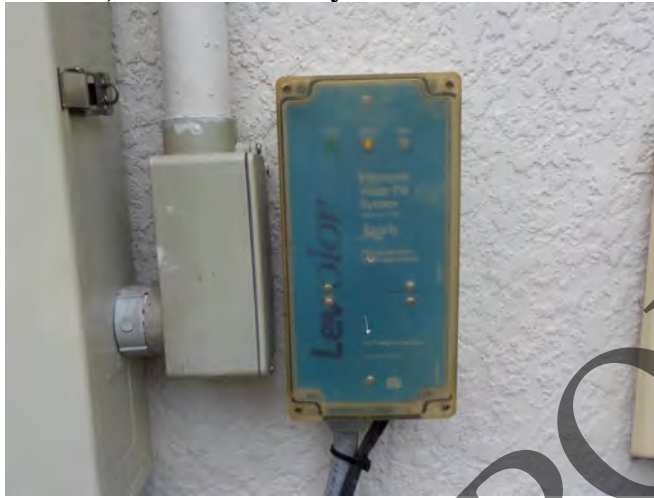
3015. Timer System **Review; Auto-level/fill system is not functional.**

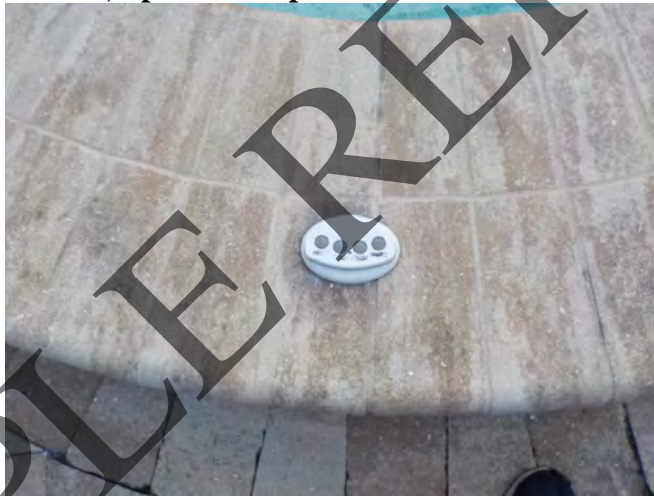
**Review; Spa control pad is not functional.**
