FOUR POINT INSPECTION

Doc #: 1611-000

Date: 11/07/2016

Dwelling Address: 1234 Sample Road, Naples, FL 34120

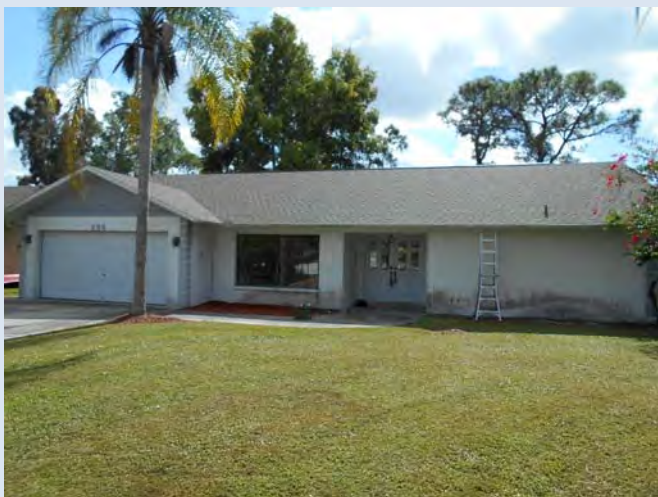
FRONT VIEW

- 01 Structure Type Single-family dwelling; concrete block construction.
- 02 Levels 1 story structure.
- 03 Lot Type Home is built on a flat lot.
- 04 Estimated Age 28 Years.

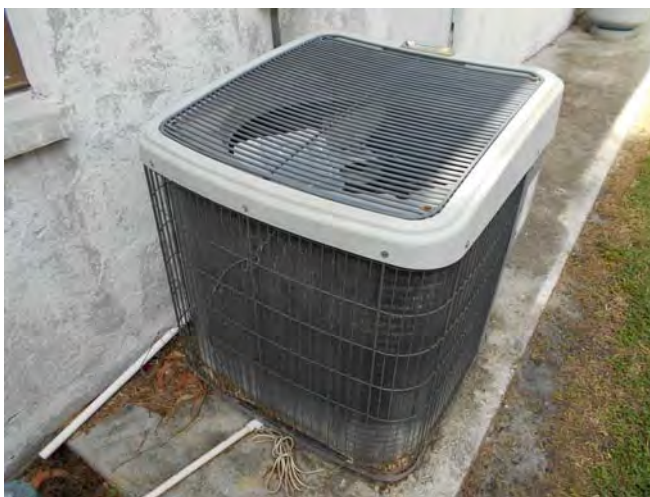
- 205 Cooling Functional. The cooling system was tested using normal operating controls
Electric; split system; forced air. Electrical disconnect provided near this unit.
Unit is located atside of house
- 206 Cooling Estimated age of the Cooling System is 09 years old. (2005)
Conditions Estimated approximate life remaining of 3-5 years.
- 207 Cooling Mfr. International Comfort.
Model: tca248akc4 Serial: e053312378

- 208 Cooling Functional. The cooling system was tested using normal operating controls
Comments and appeared to function properly at time of inspection. Due to inaccessibility
of many of the components of this unit, the review is limited. Unit was
operated by the thermostat. As with all mechanical equipment the unit can fail
at anytime without warning. Inspectors cannot determine future failures. If a
detailed inspection is desired, a licensed heating contractor should be consulted
prior to closing to ensure proper and safe operation of this unit.
-

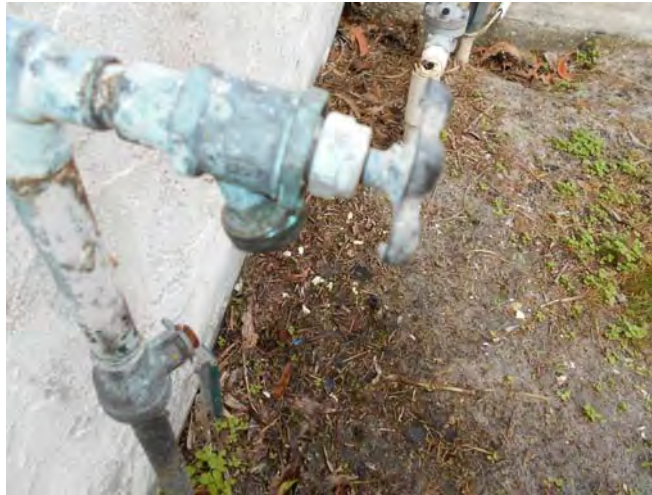
Step #	Component	Comments
301	Plumbing Supply System	Property has a public water supply. Water pressure at time of inspection was 60 psi. Main water shut off is located at left side of building.

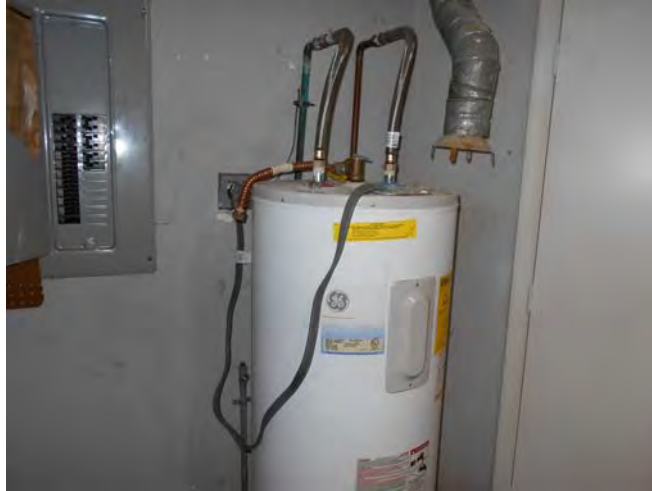
305 Water Heater
Manufacturer

Whirlpool.
Model # e1f50rdo45v Serial # 0328135470

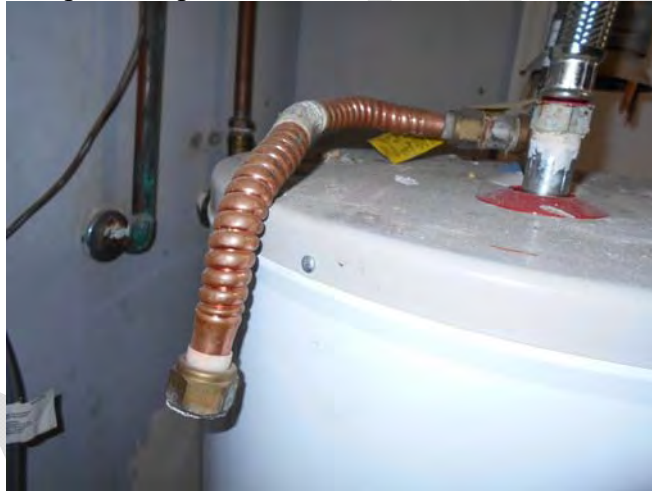
Temperature pressure relief valve installed as a safety feature.

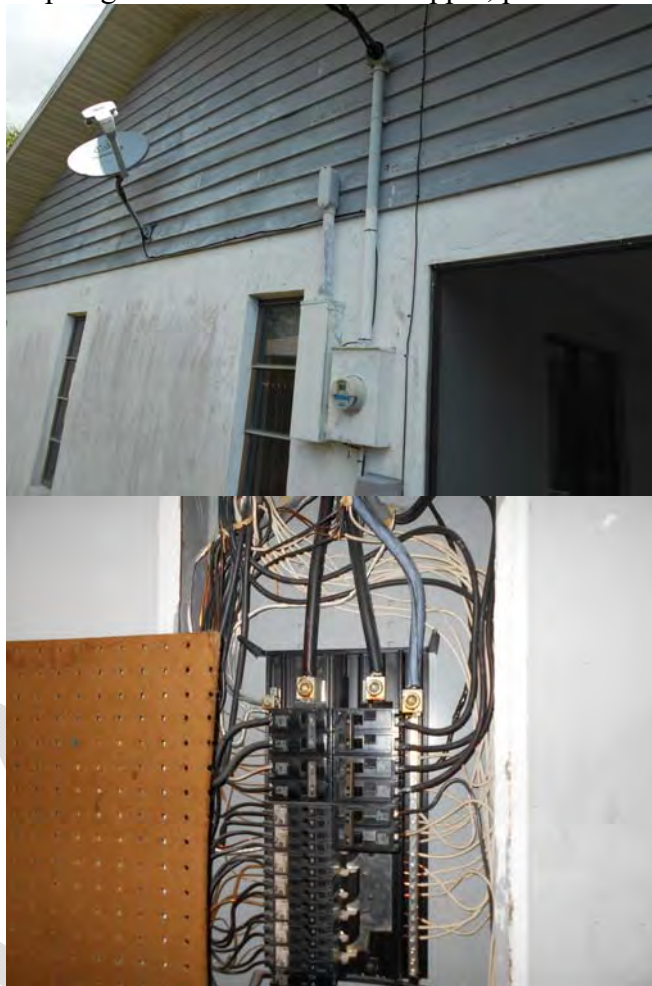
Step #	Component	Comments
401	Electrical Main Box	120 volts; 240 volts; 200 amps. Service entrance is overhead. The main panel is located at the garage. Main disconnect noted main meter. Breakers present to provide overload protection. Main conductor is aluminum, 4/0. Low amperage branch conductor is copper, preferred for safety

Estimated age of the Electrical System is 28 years old. (1987)
Estimated approximate life remaining of 25-35 years.

402	Electrical Main Box Comments	Functional. ITE Panel
-----	------------------------------	--------------------------
