**HAZELBAKER CONSTRUCTION SERVICES**  
**8965 QUARRY DRIVE**  
**NAPLES, FLORIDA**  
**(239)213-8046**

Doc #: 1412-000 Inspector: Joel Hazelbaker  
Date: 12/13/2016  
Dwelling Address: 123 Sunshine Way # 204, Estero, Florida 33928  
Client Name: John Doe

**GENERAL CONDITIONS**

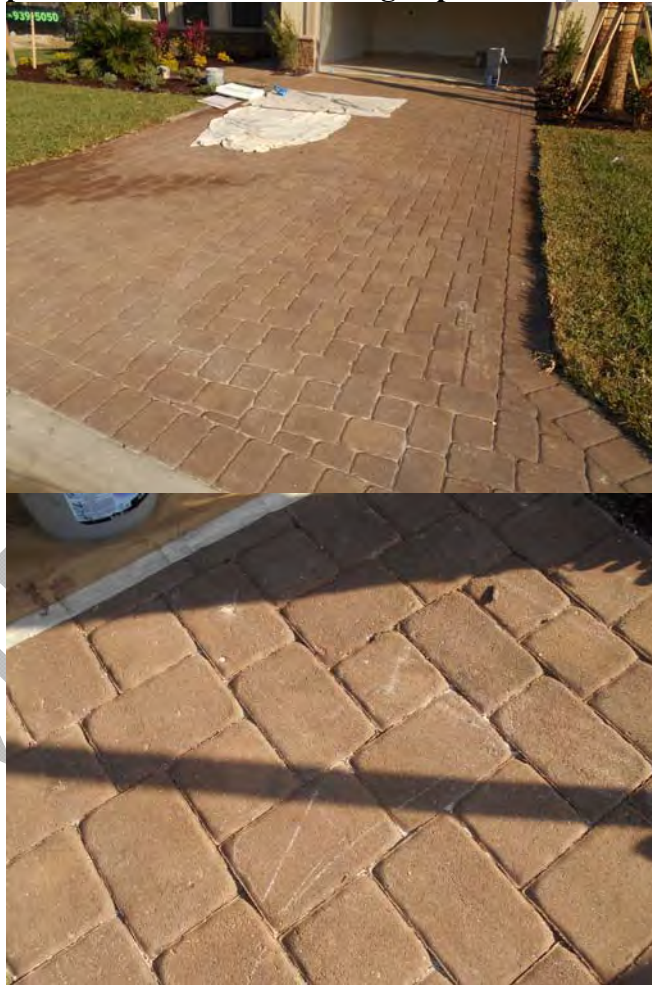
Step #	Component	Comment
1101.	Driveway	<b>Review; Brick. Brick requires cleaning of construction debris and paint at all locations. Damaged pavers should be replaced.</b>

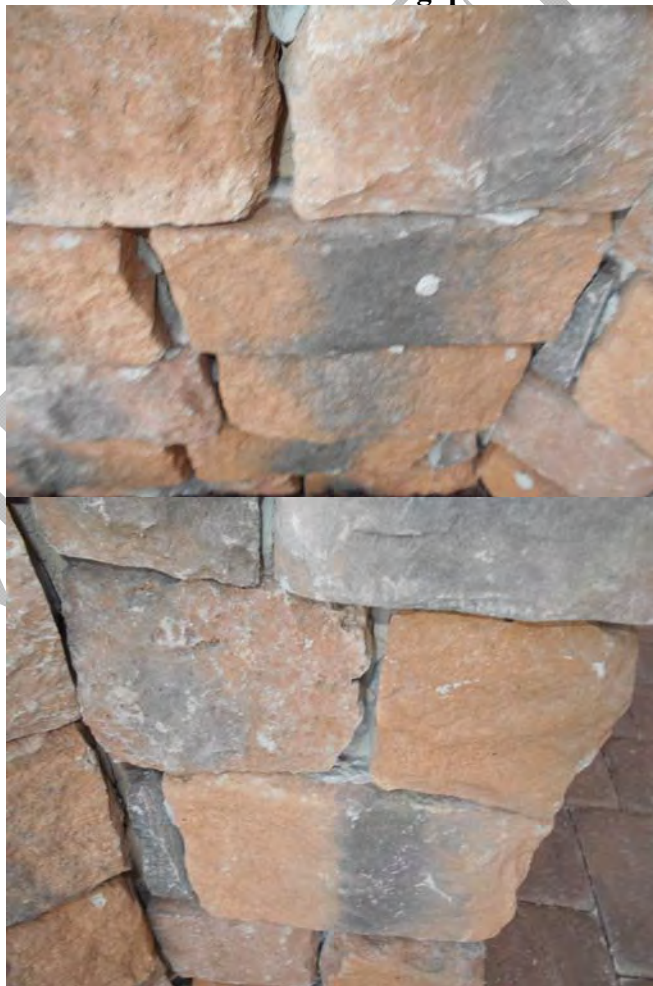
1104. Siding **Review; Stucco/Stone. Stone requires cleaning of construction debris and paint at all locations. Gaps in stone noted; suggest proper installation of stone to reduce gaps.**

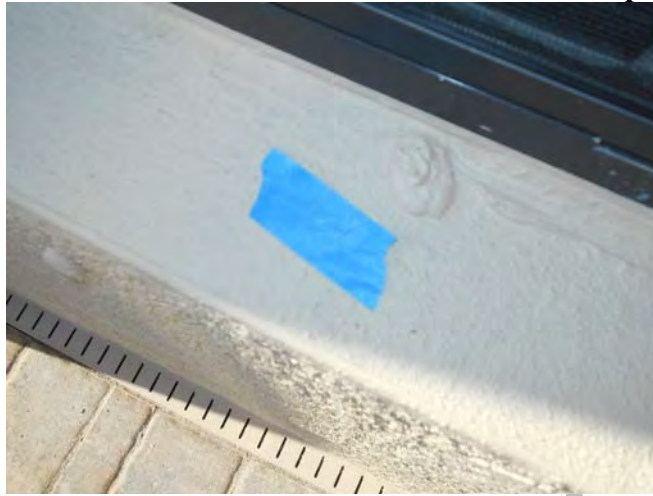
**Defects in stucco noted at some locations. Proper repairs required.**

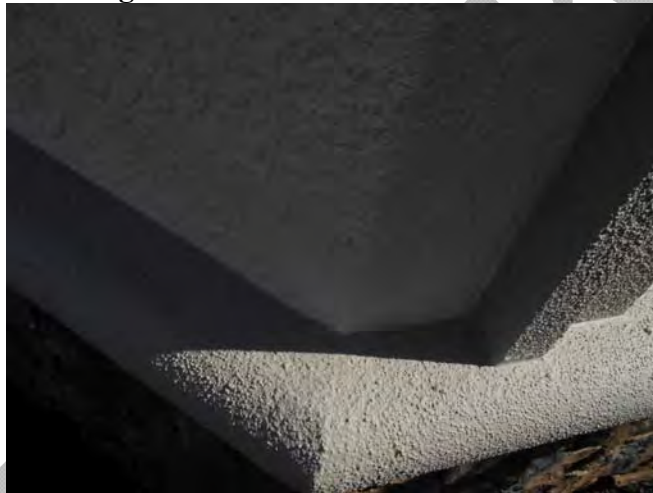
**Cracking noted.**

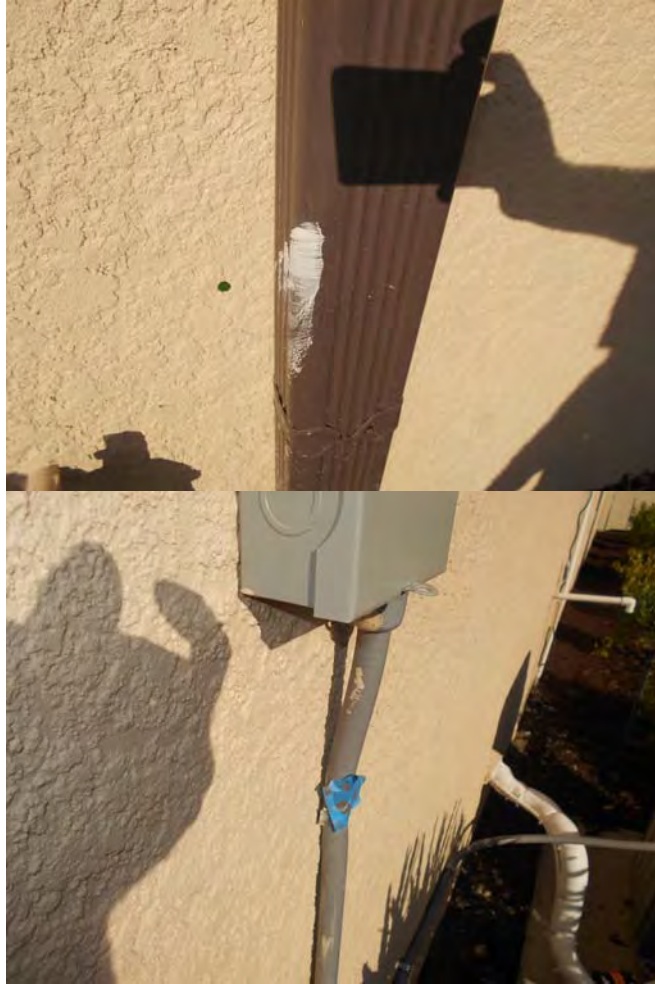
**Review; Wood/Metal. Paint overspray present. Paint and construction debris should be cleaned off exterior trim and other building components as required.**

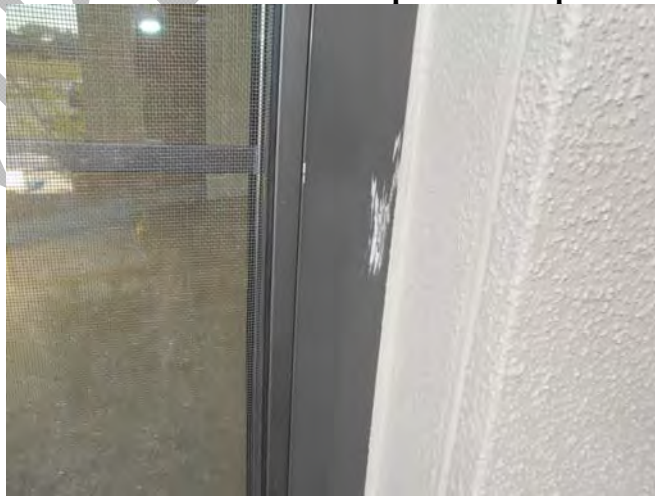
**Review; Metal. Damage to frames noted inside and out. All windows/Doors should be repaired or replaced as required.**

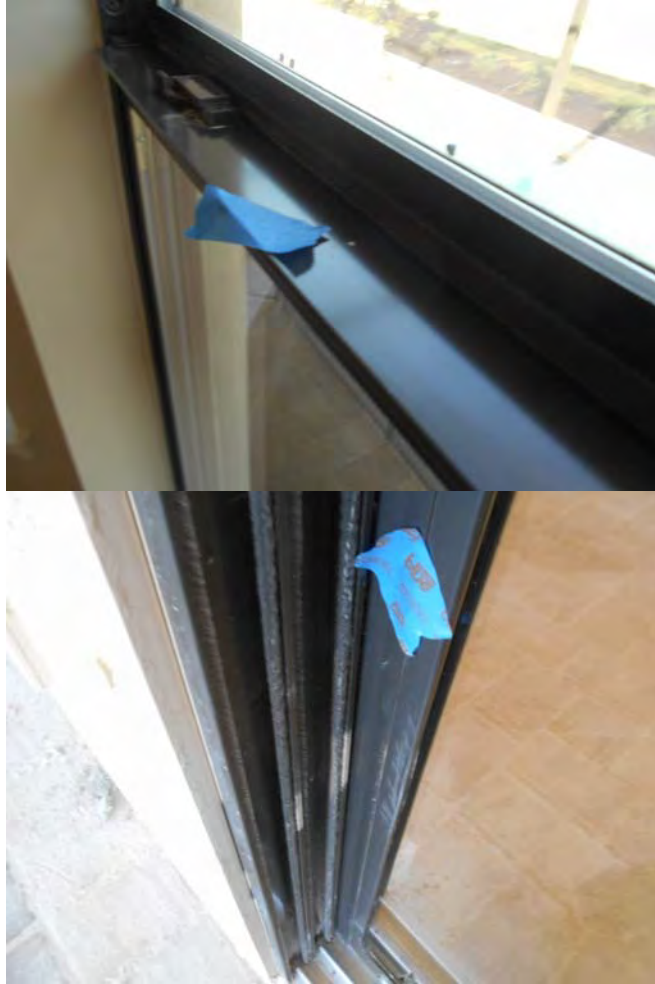
**Cleaning of glazing and frames required at all locations both inside and out.**

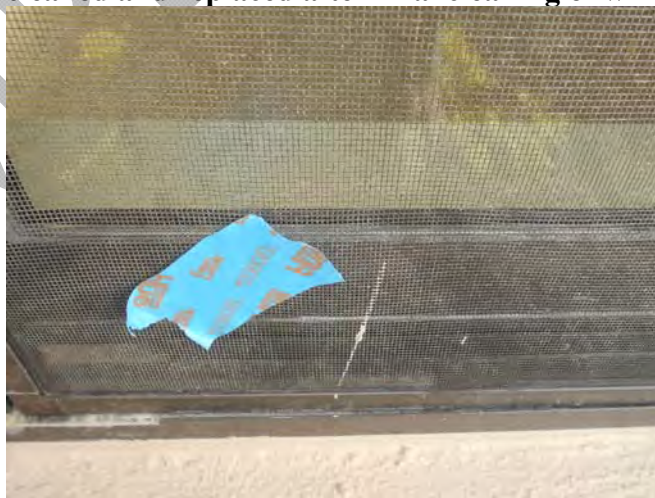
**Screens dirty and glass not cleaned; screens should be removed and cleaned and replaced after final cleaning of windows/Frames.**

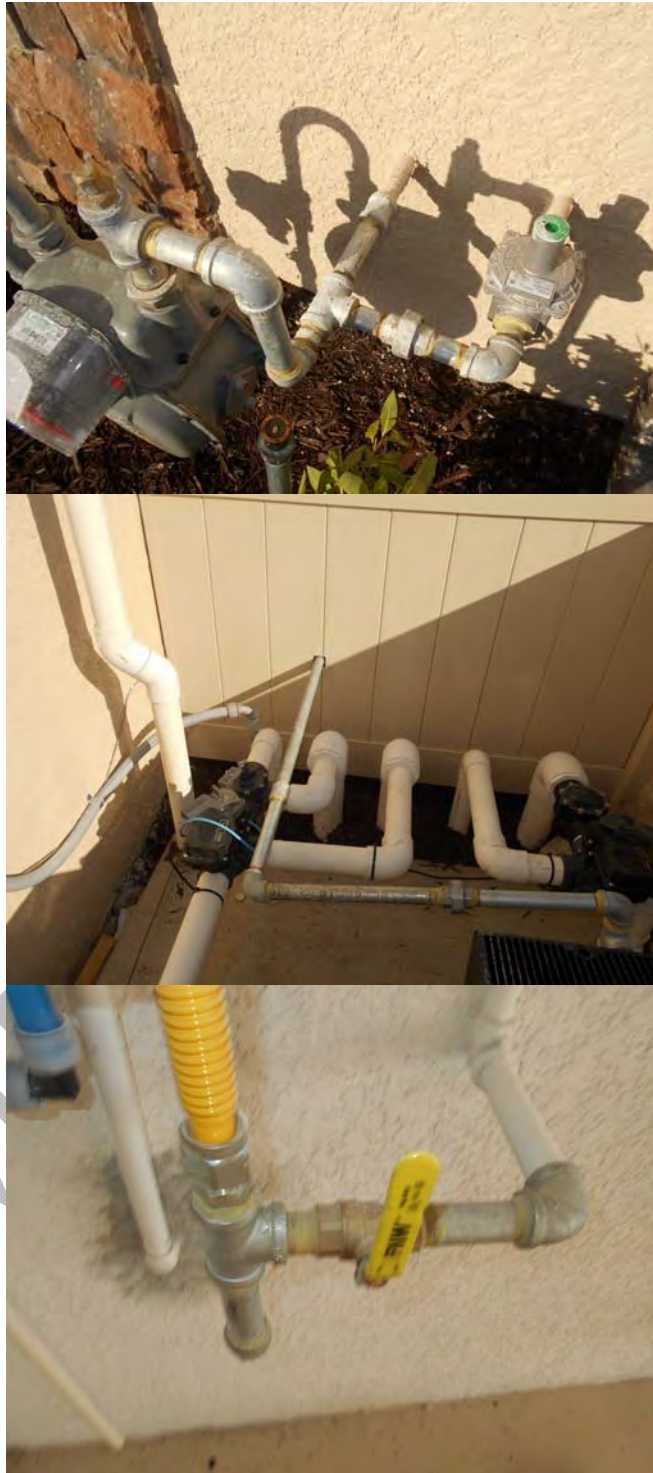
**Review; All gas piping should be properly painted to prevent corrosion.**

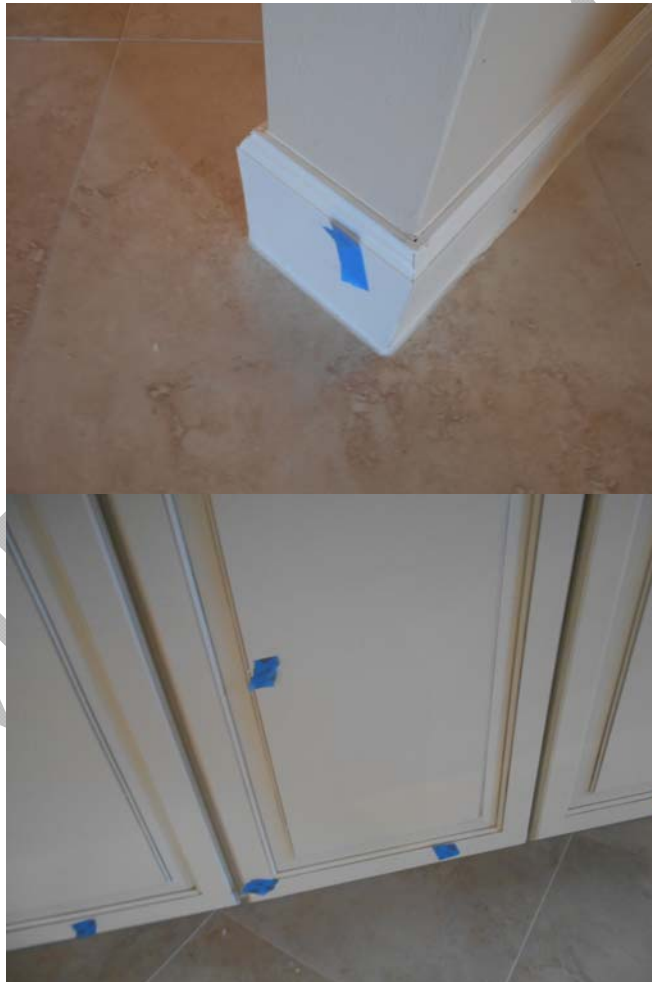
**Review; The finish quality of this home was very poor. Home was not ready for an inspection as no prior punch out was completed and no rough cleaning was done. Additionally radon testing and mold air sampling was requested and could not be completed due to violation of protocols; both the front and rear doors had been left wide open for an extended period of time.**

**Defects were too numerous to fully document in a home inspection report. The items noted in this report give an indication of the types and locations of a random sampling of the defects required to be corrected.**

**Blue tape was placed inside the home at various locations to help guide the builder as to type and extent of repairs required. See family room comments for more details.**

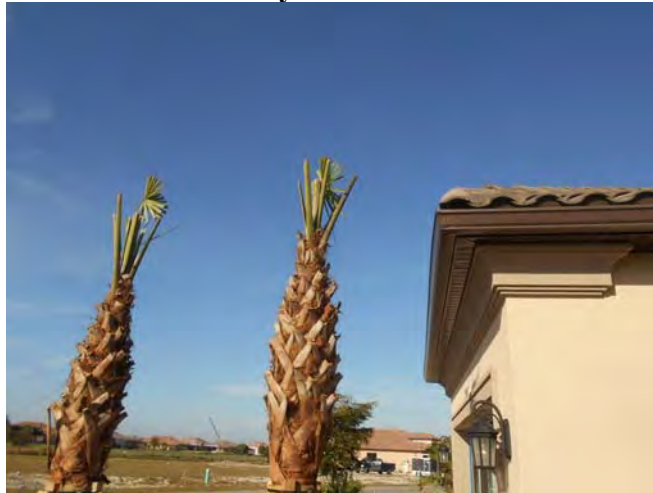
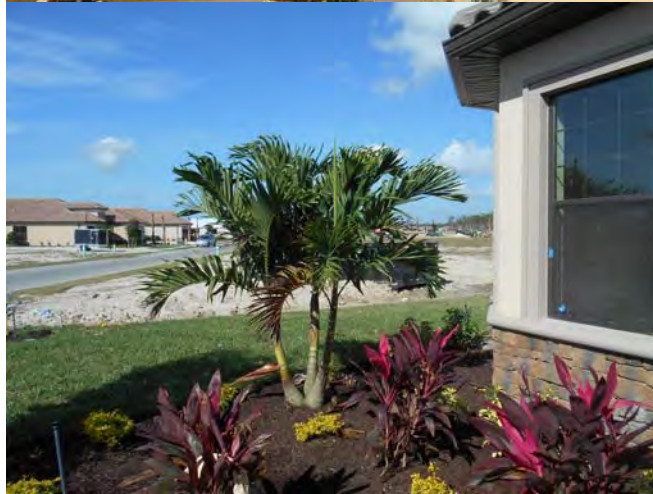
**Review; Suggest relocating vegetation that will contact or overhanging the home at maturity.**

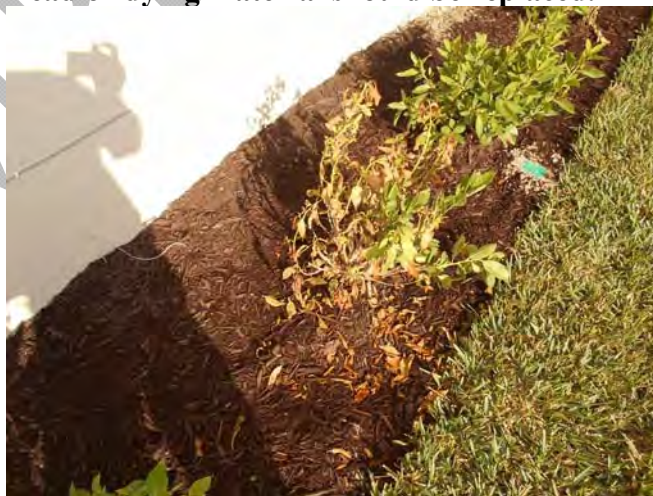
**Dead or dying material should be replaced.**

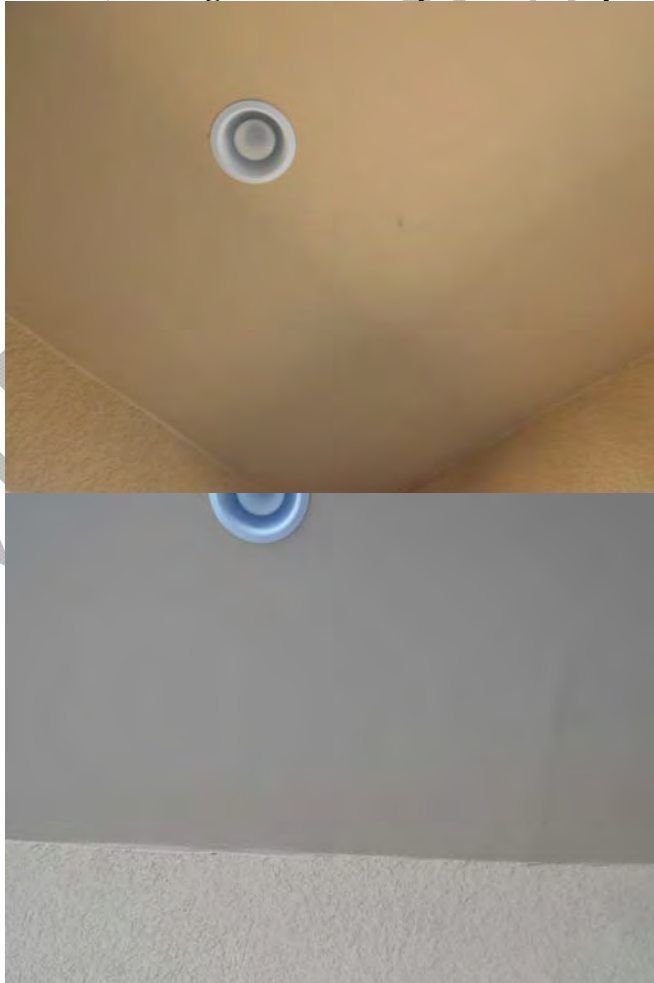
1202.	Cover	Review; Ceiling needs to be repaired and repainted.

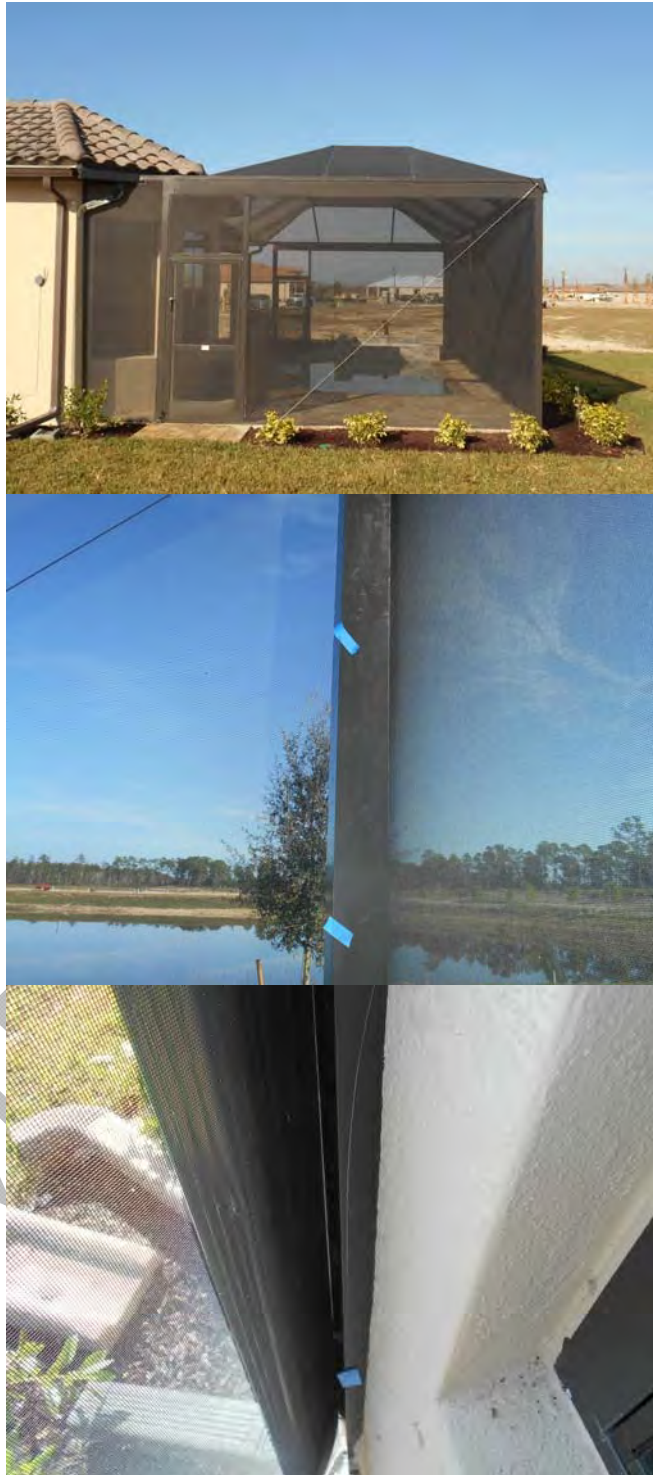
**Review; Aluminum and screen. Damage noted at frames in several locations.**

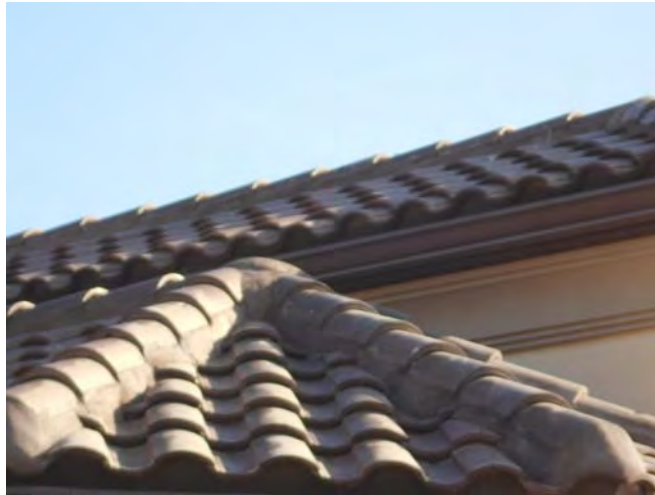
**Review;** Cleaning of all roof tile required. Paint over spray and construction debris noted.

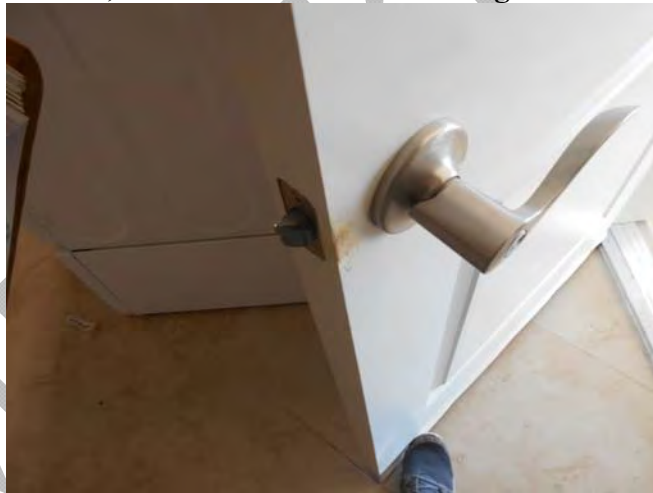
1508. Interior Door **Review; Metal/Wood. Door is damaged and sill needs cleaned.**

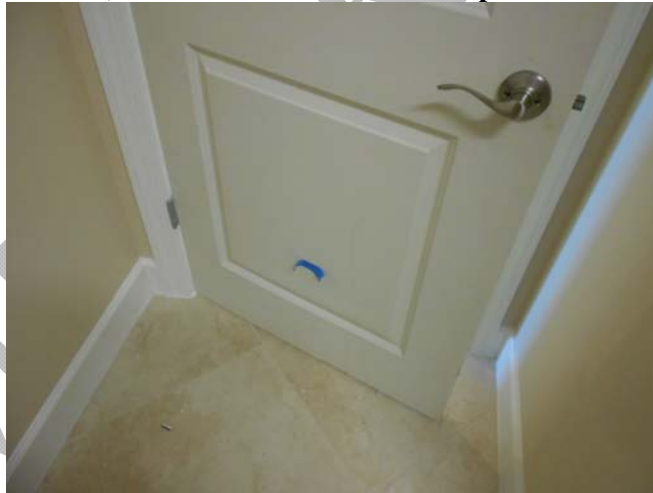
1604.	Interior Doors	<b>Review; Wood. Door has not been painted.</b>
-------	----------------	---

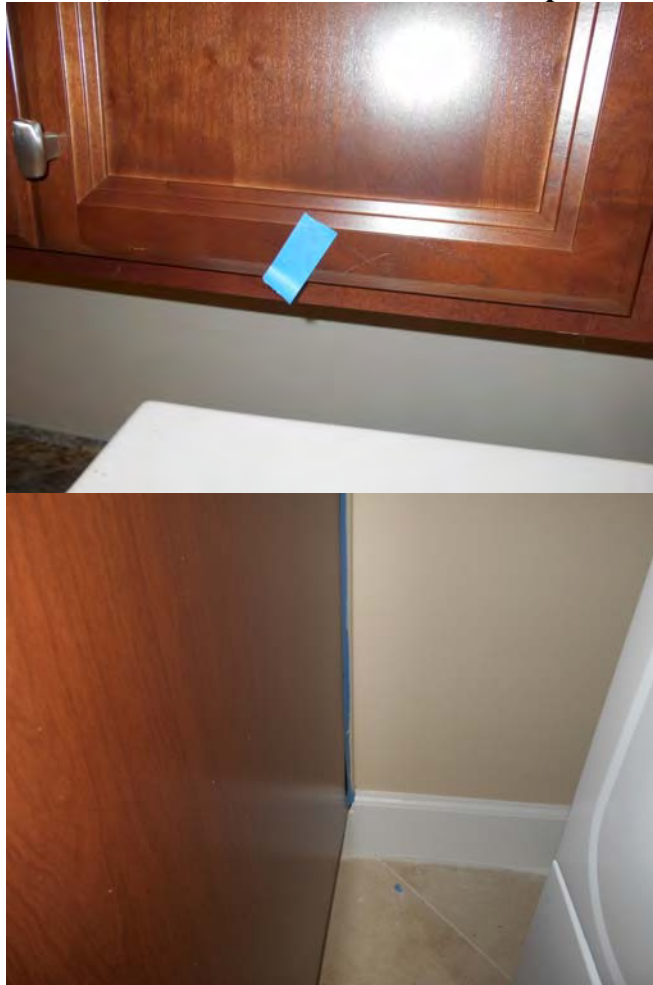
Review; Scratches noted. Trim not completed.

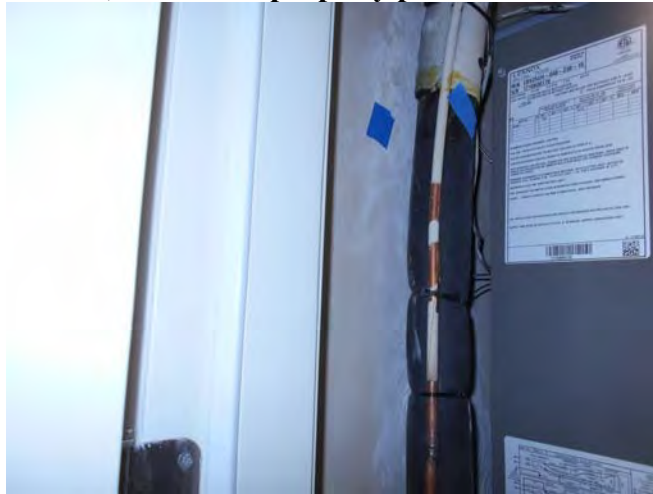
**Review; Closet not properly painted.**

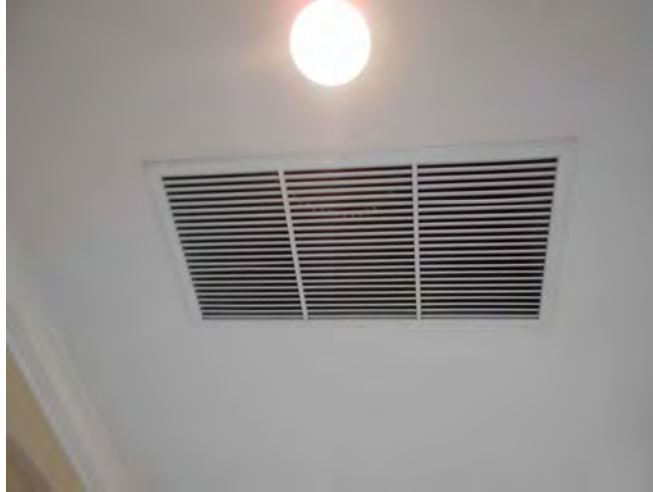
**Review; Ducts failed leak test. Suggest review with builder on proper repair.**

Section	CFM25	Leakage CFM25/ft <sup>2</sup>	Location	Pass or Fail
1	111	2.12 %	Sec. 1	Fail
2				
3				
4				
5

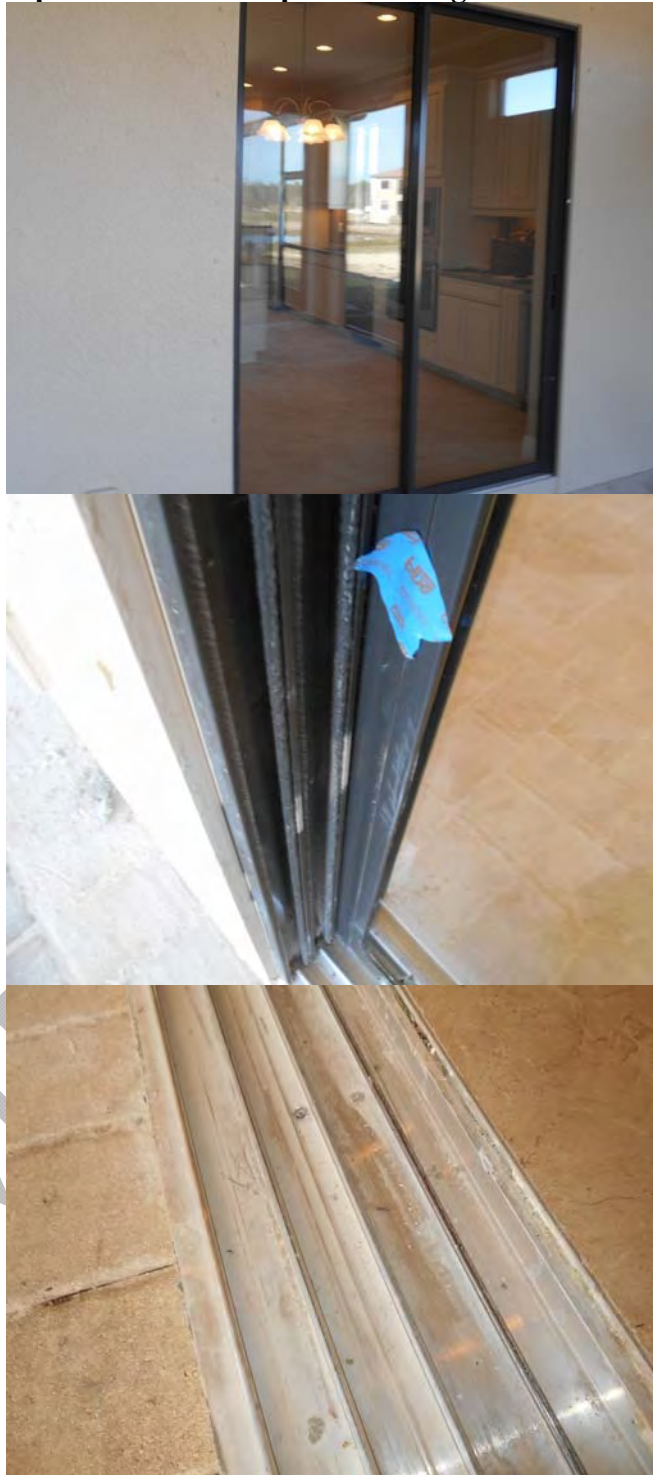
2105.      Exterior Doors      **Review; Exterior doors damaged and need properly repaired or replaced. Tracks require cleaning.**

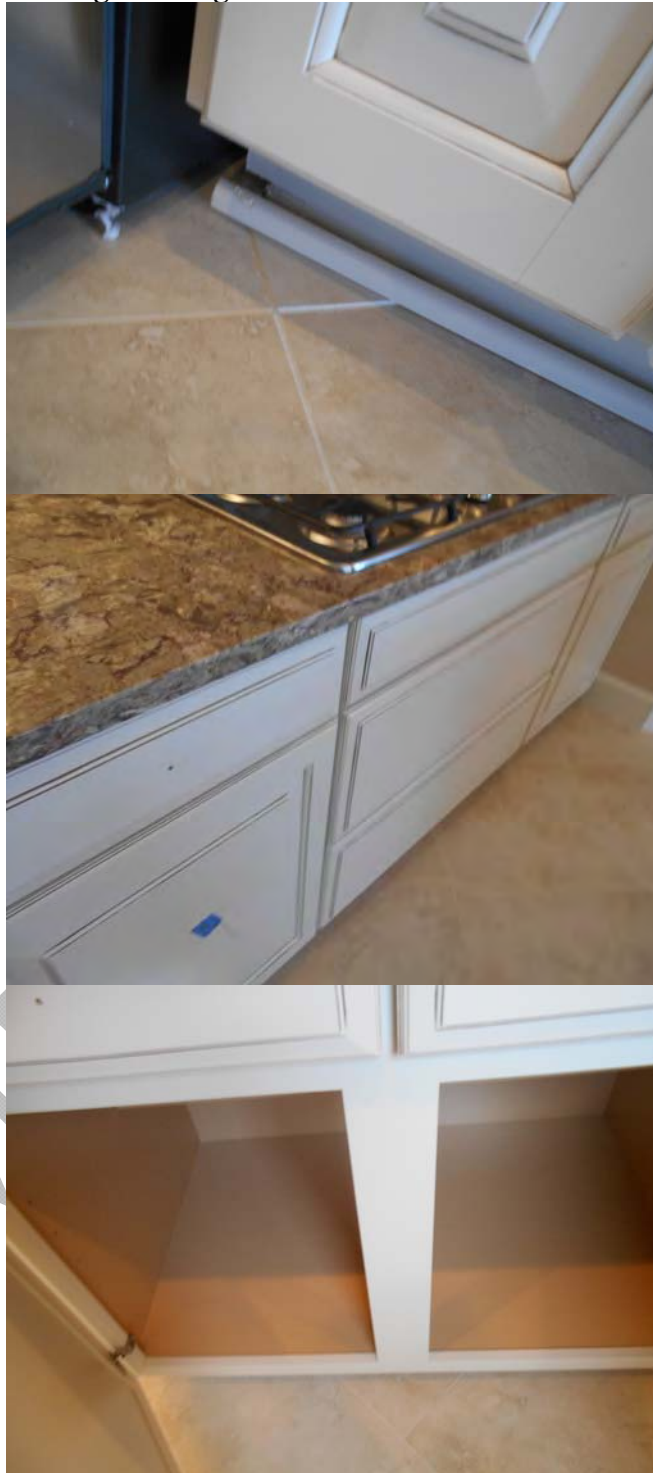
**Review; Cabinet installation incomplete. Loose trim; missing pulls; missing shelving noted.**

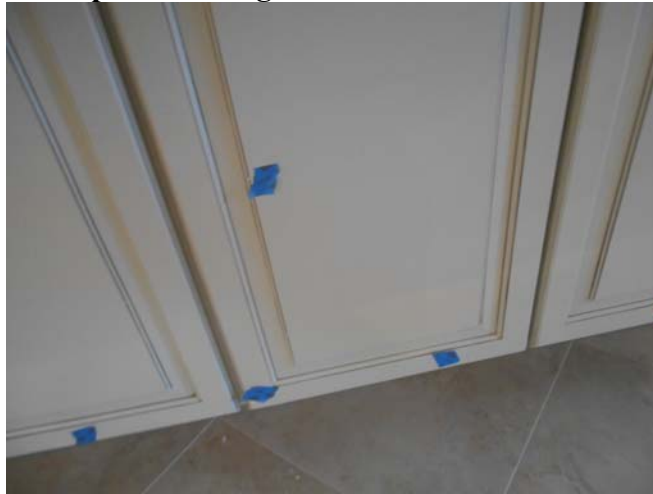
**Widespread damage noted on cabinets.**

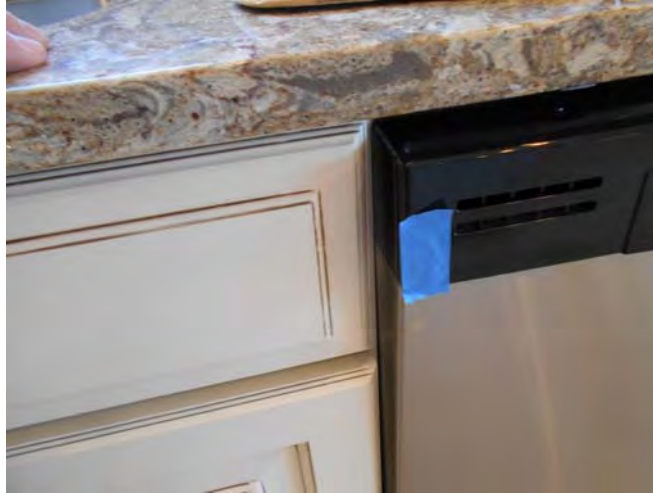
**Review; Washer door conflicts with cabinets and does not close normally.**

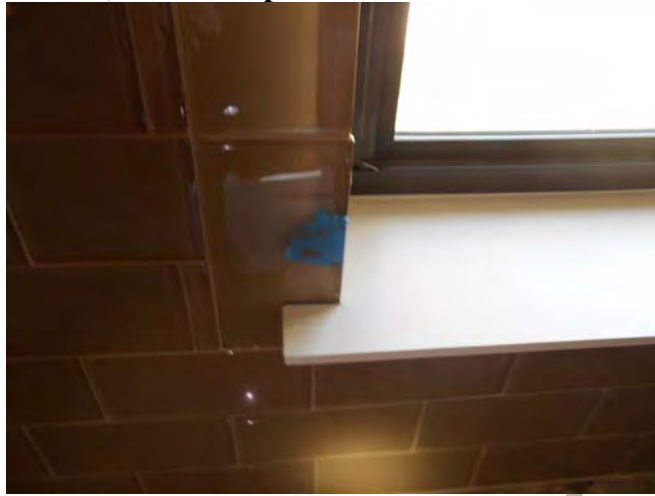
**Review; Tile backsplash uneven.**

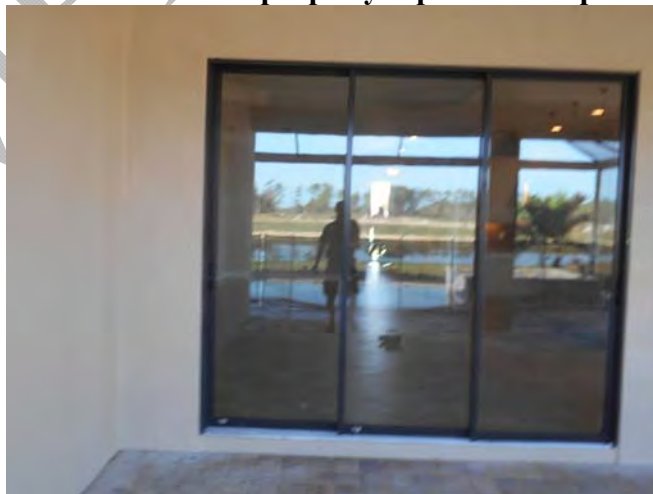
2205.	Exterior Doors	<b>Review; Aluminum sliding glass. Widespread damage noted at these doors. Doors need properly repaired or replaced. Tracks need cleaned.</b>
-------	----------------	---

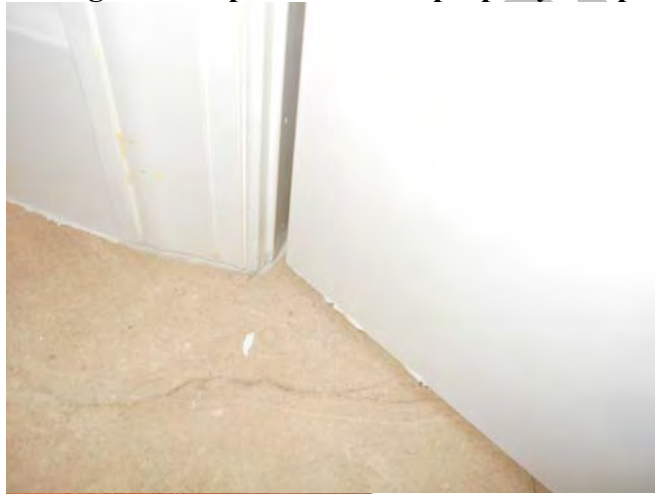
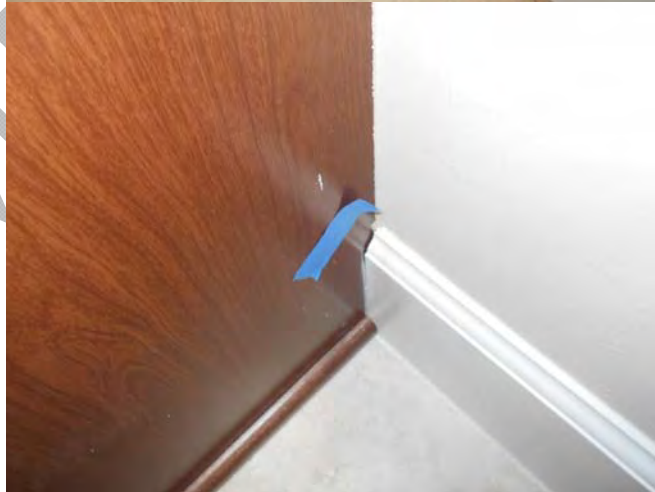
**Damaged doors present and improperly completed wood work present;**

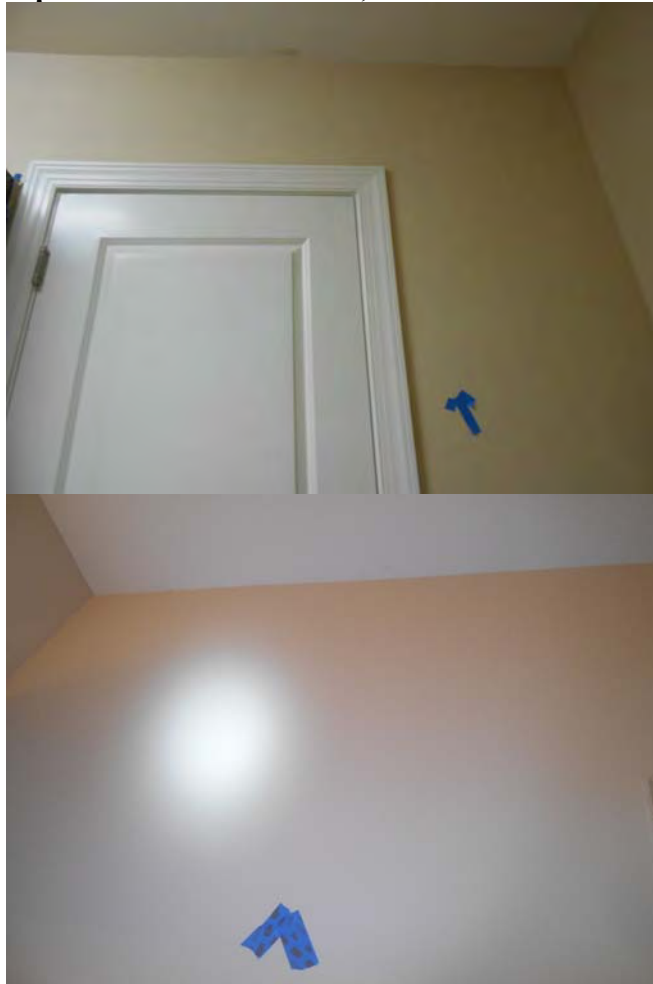
**Ceilings in most rooms have repairs requiring the entire ceiling to be repainted in each location;**

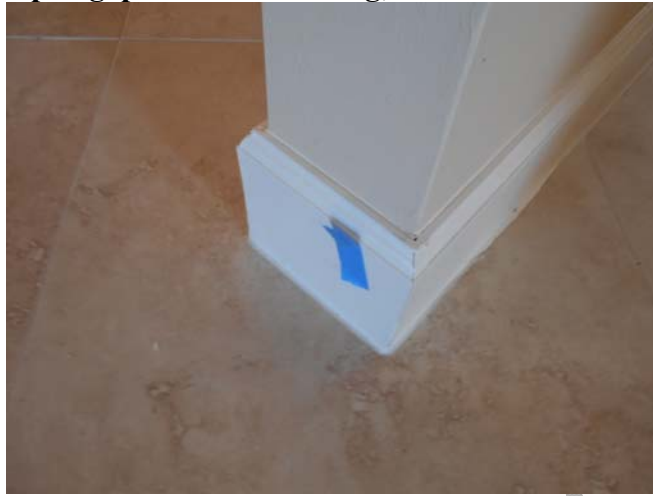
**Open gaps in woodworking;**

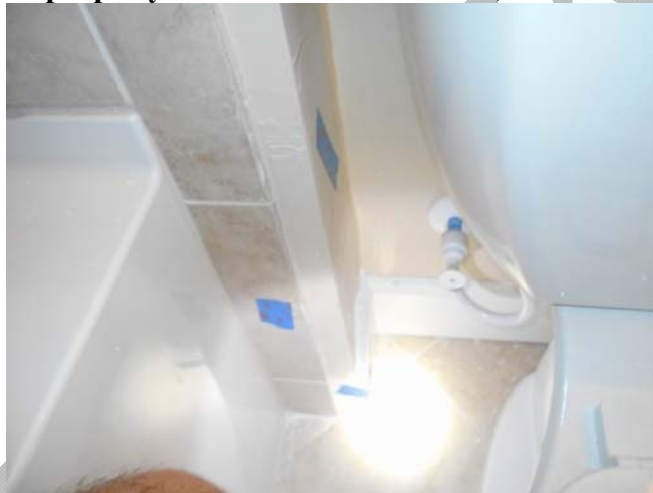
**Improperly finished doors and trim;**

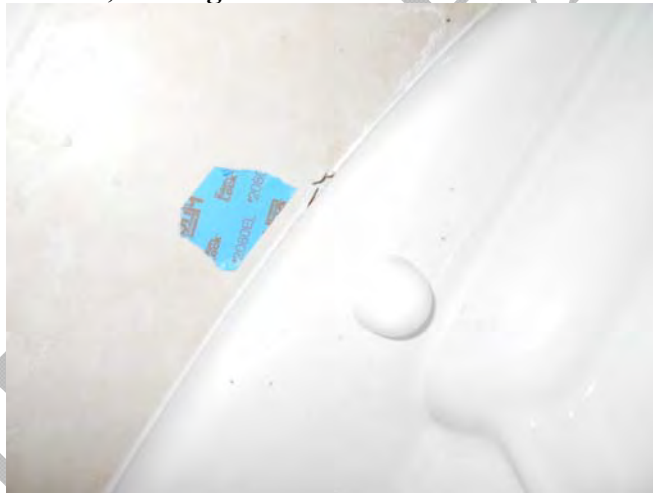
**Review; Damaged tile noted at toilet.**

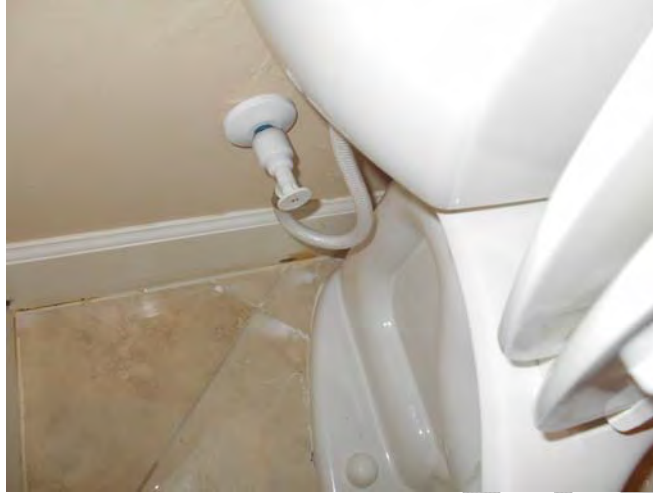
2702. Walls **Review; Water damage noted at toilet room with standing water present; proper water damage protocols should be followed which includes removal of finish materials and proper drying prior to repairs.**

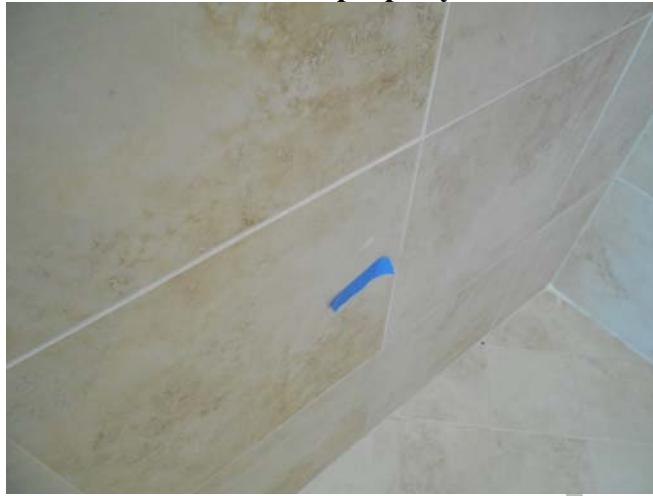
**Review. Tile. Tile needs properly cleaned.**

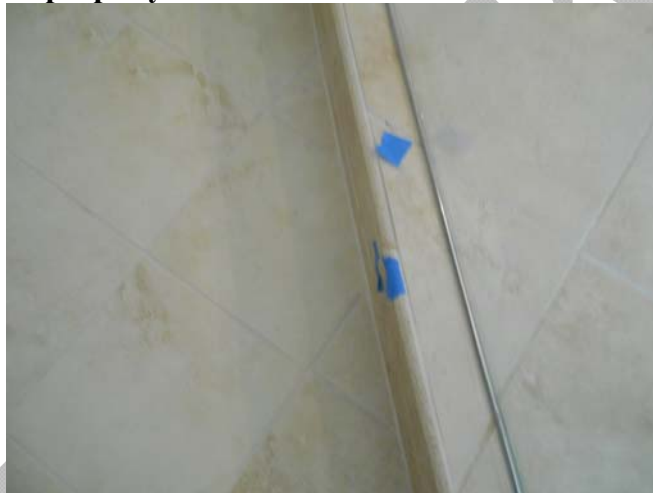
**Improperly installed tile noted.**

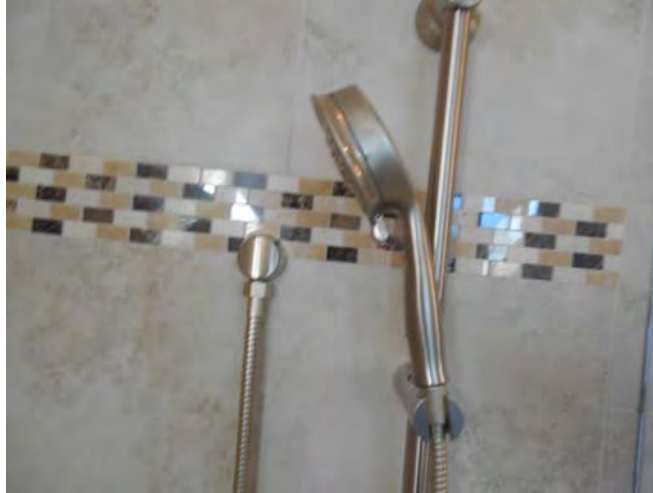
2716. Shower Faucet      **Review; No water coming out of shower heads; leaking present at toilet room wall indicating leak in wall. Immediate repairs required.**

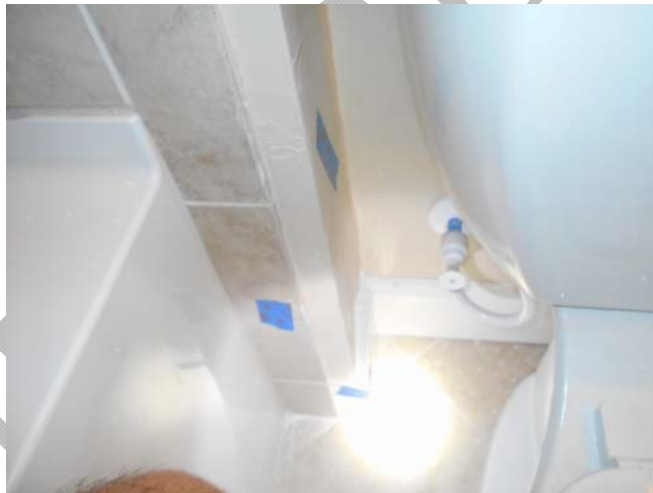
**Review; Poor finish quality and improper installation of baseboard noted.**

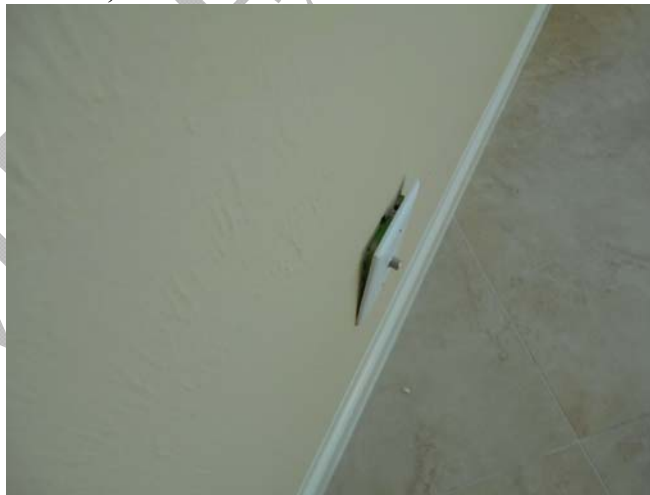
2902.2.	Walls	See family room comments.
2903.2.	Ceiling	Functional.
2904.2.	Interior Doors	Functional; Wood.
2905.2.	Exterior Doors	None.
2906.2.	Windows / Screens	Functional; Single hung.
2907.2.	Electrical	<b>Review; Loose coaxial outlet noted.</b>

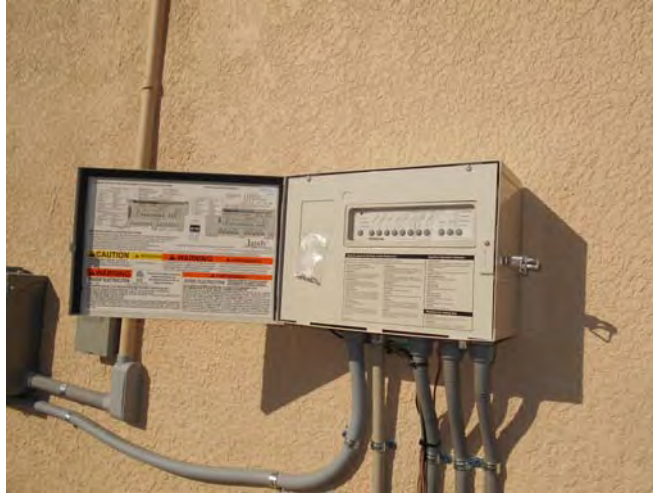
**Review; Set up for remote control but remote not present and could not be tested.**

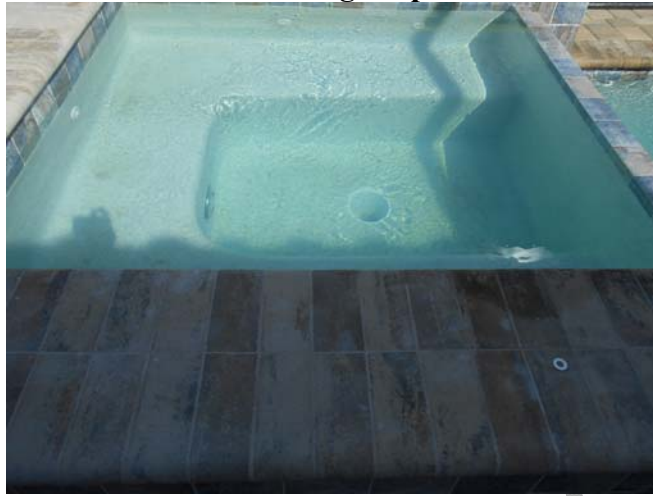
**Main drain cover missing at spa.**
