**HAZELBAKER CONSTRUCTION SERVICES**  
**8965 QUARRY DRIVE**  
**NAPLES, FLORIDA**  
**(239)213-8046**

Doc #: 1412-000

Dwelling Address: 123 Sunshine Way # 204, Estero, Florida 33928

Inspector: Joel Hazelbaker, **Licensed Florida State Home Inspector: License No. HI874**

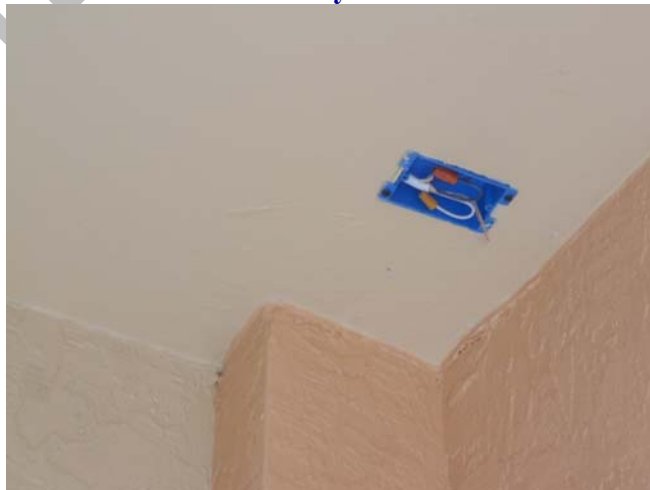
1204. Electrical **Review: Open junction box noted, suggest installing device or cover for safety.**

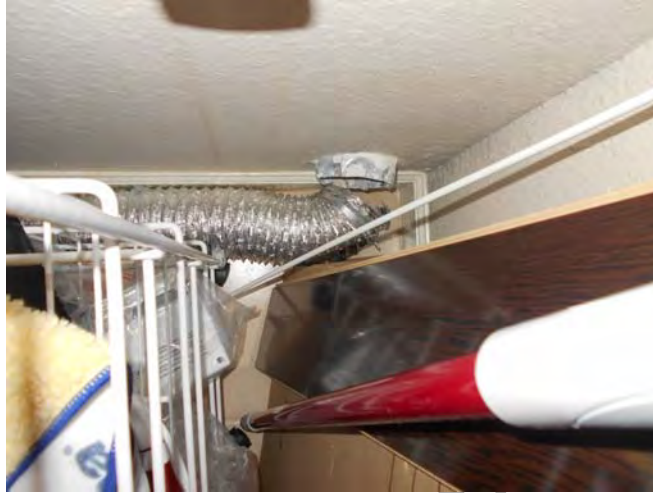
1612. Dryer & Hook-ups

**Review: Dryer vent was disconnected at the time of inspection.**

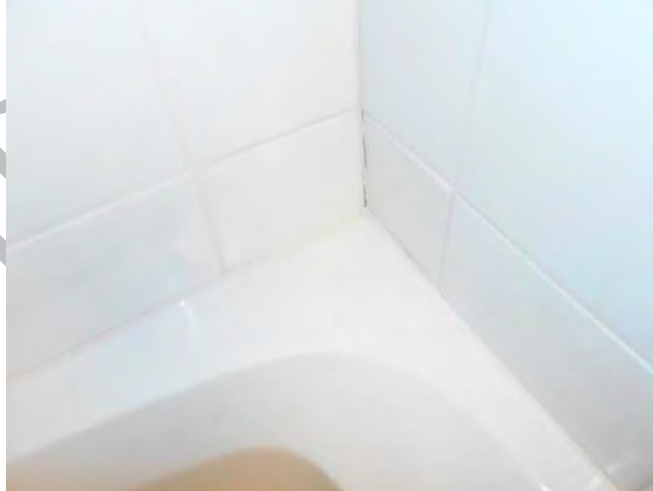
2811. Tub & Surround

**Review: Tile. Open grout joints noted. Suggest replacing grout or caulking to prevent future/further moisture penetration and damage/deterioration to interior walls. This damage is not always visible or accessible to the inspector at the time of inspection.**
