HAZELBAKER CONSTRUCTION SERVICES
8965 QUARRY DRIVE
NAPLES, FLORIDA
(239)213-8046

Doc #: 1412-000
Dwelling Address: 123 Sunshine Way # 204, Estero, Florida 33928
Client Name: John Doe
Inspector: Joel Hazelbaker, **Licensed Florida State Home Inspector: License No. HI874**

The Summary Report does not constitute our entire report and may not include all the items a client may consider important to home ownership, therefore, the client is advised to read the Inspection Report in its entirety.

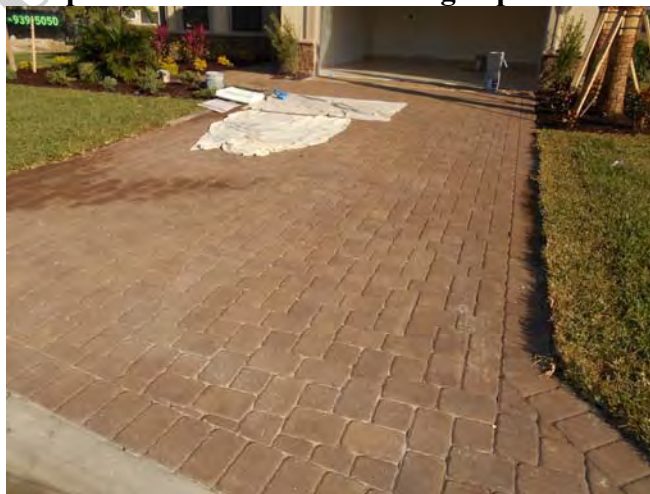
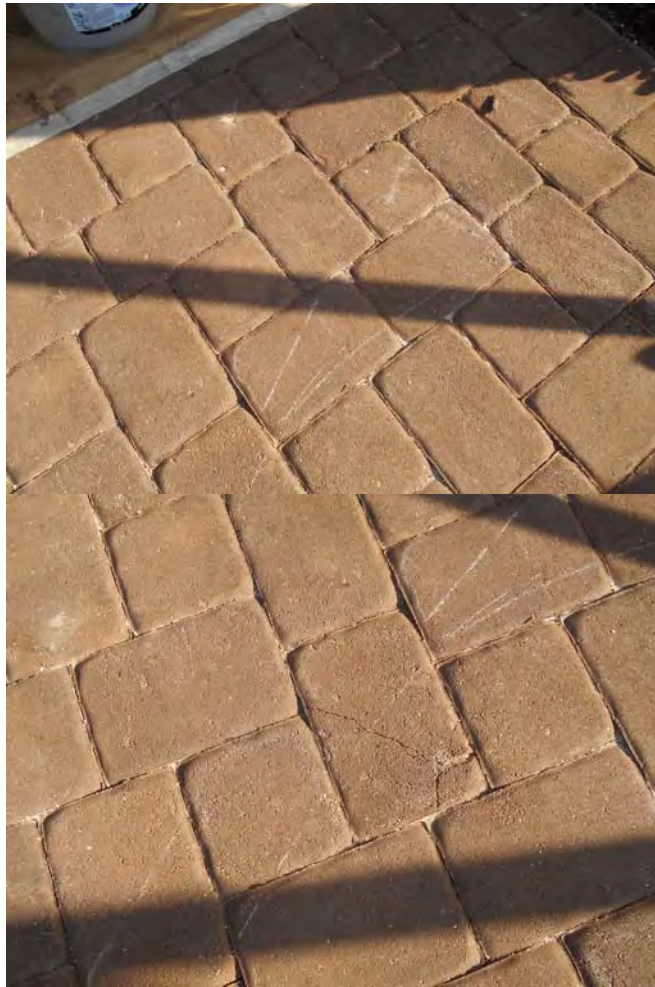
1101. Driveway **Review; Brick. Brick requires cleaning of construction debris and paint at all locations. Damaged pavers should be replaced.**

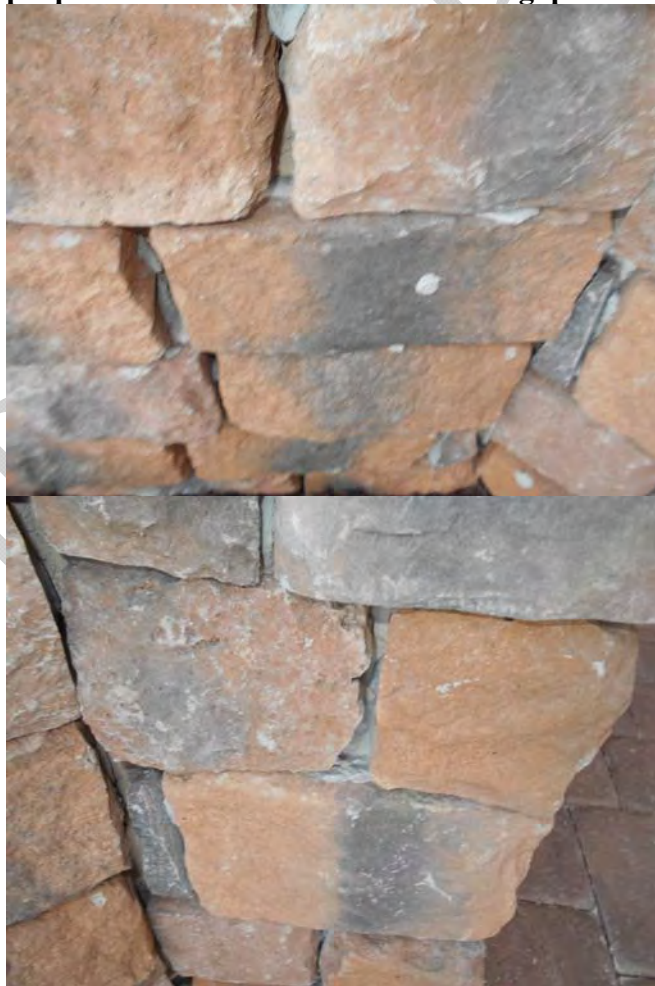
1104. Siding

Review; Stucco/Stone. Stone requires cleaning of construction debris and paint at all locations. Gaps in stone noted; suggest proper installation of stone to reduce gaps.

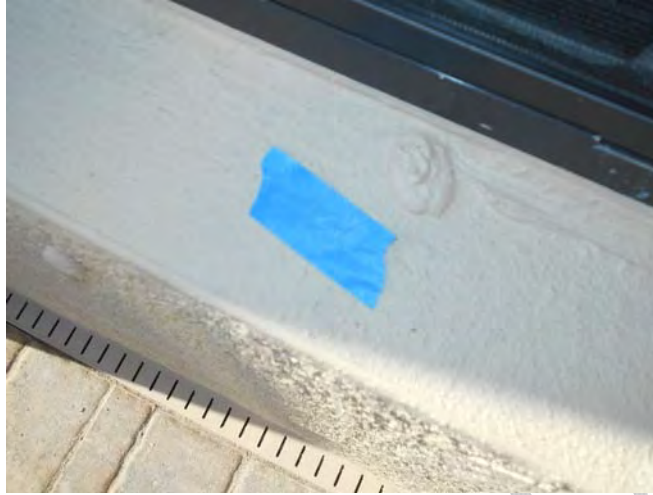
Defects in stucco noted at some locations. Proper repairs required.

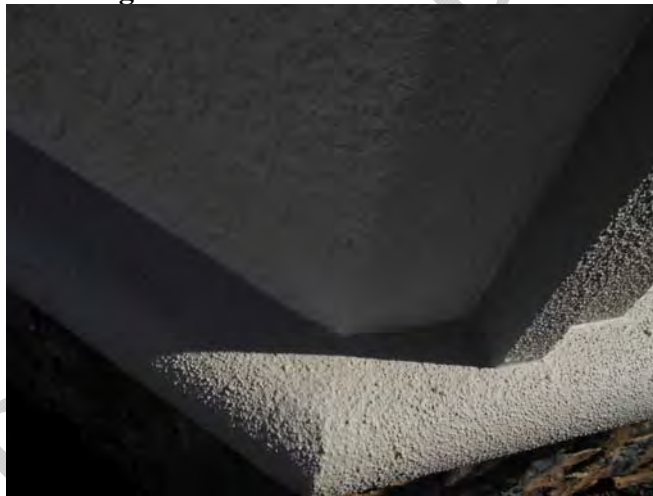
Cracking noted.

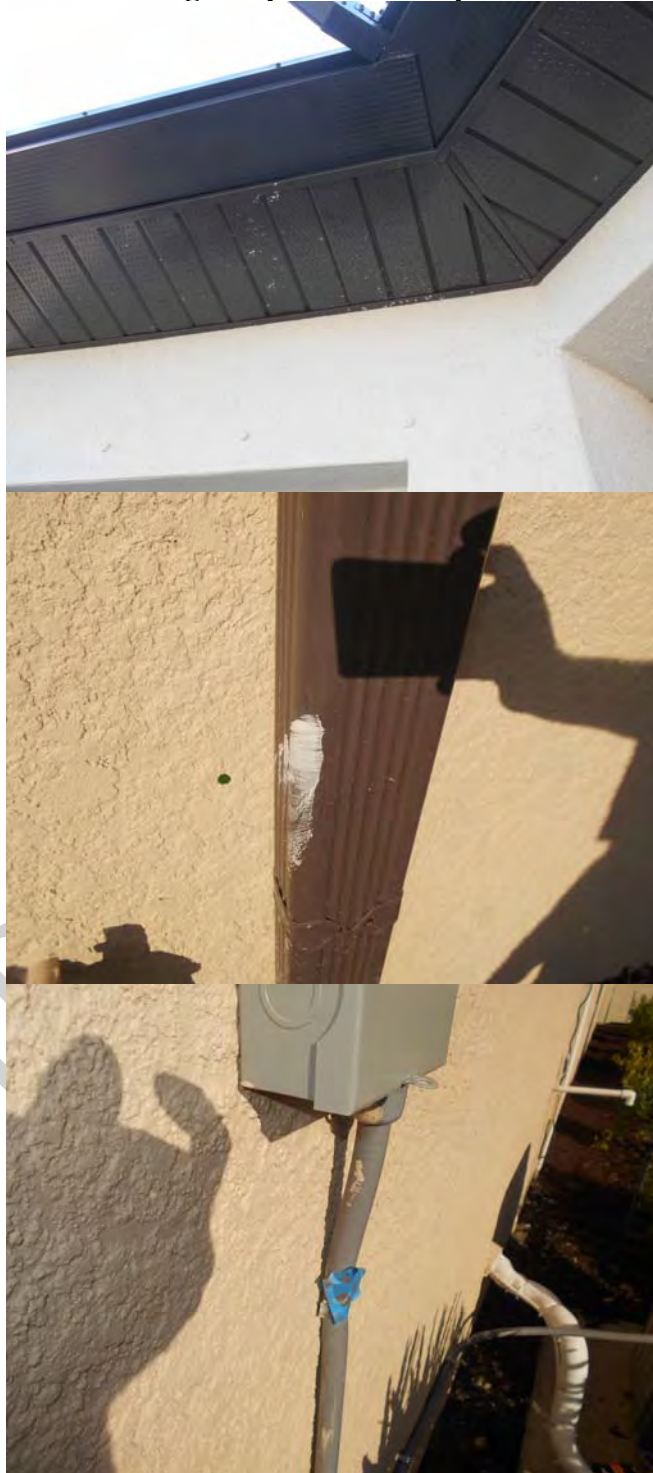
1105. Trim

Review; Wood/Metal. Paint overspray present. Paint and construction debris should be cleaned off exterior trim and other building components as required.

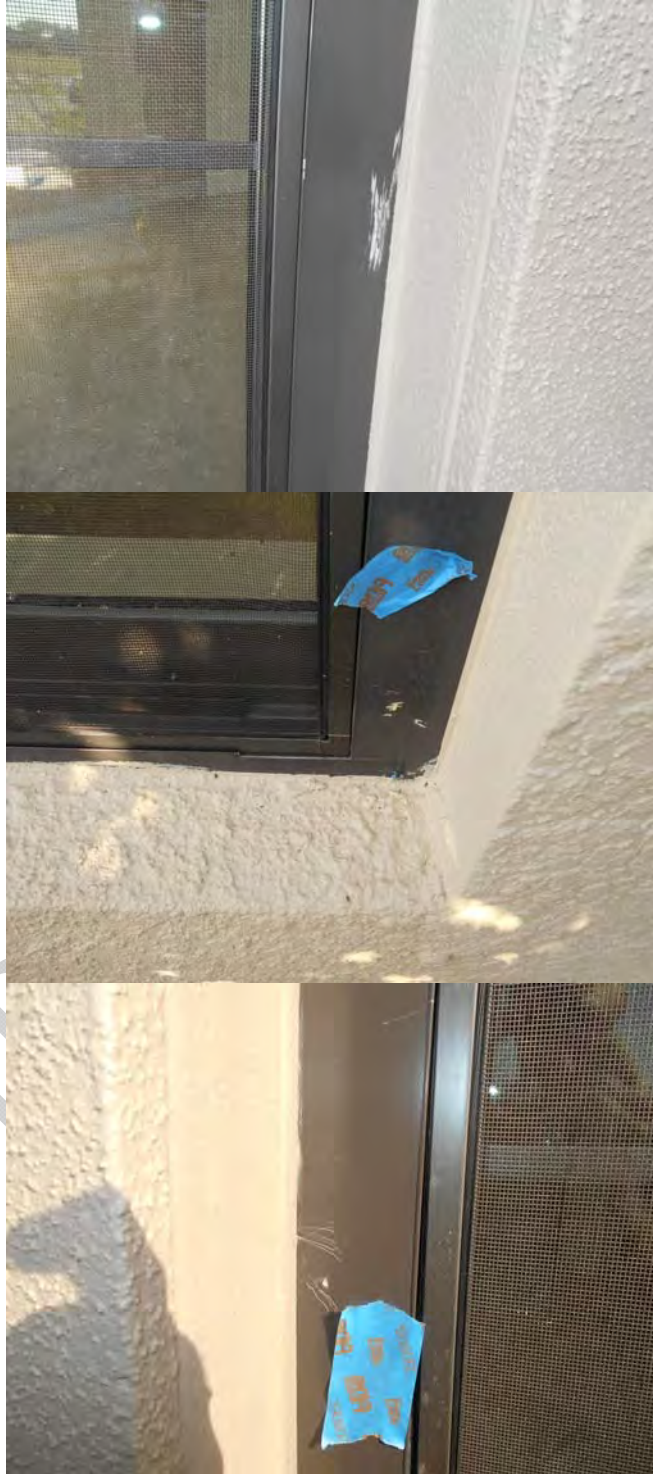
1106. Windows &
Frames

Review; Metal. Damage to frames noted inside and out. All windows/Doors should be repaired or replaced as required.

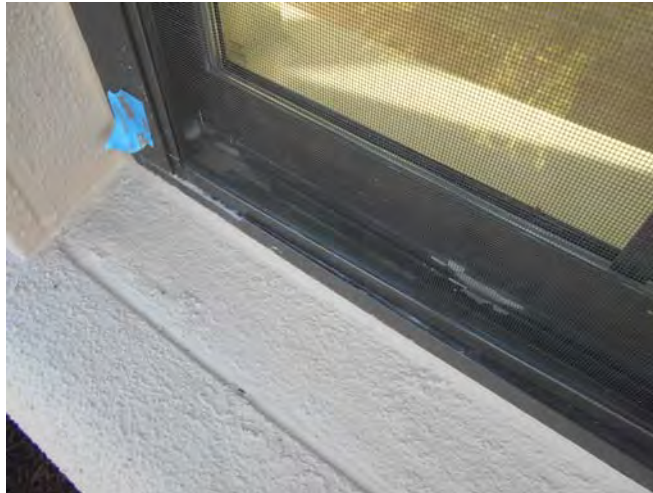
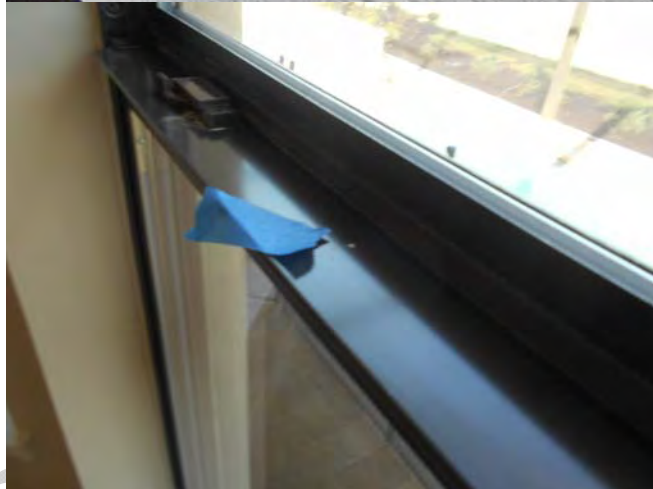
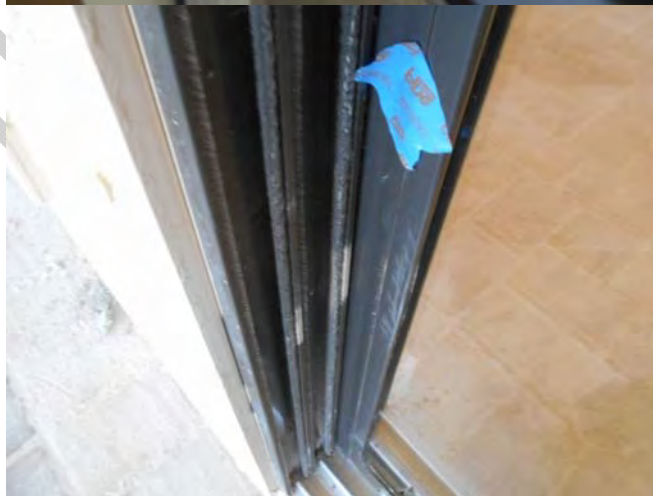
Cleaning of glazing and frames required at all locations both inside and out.

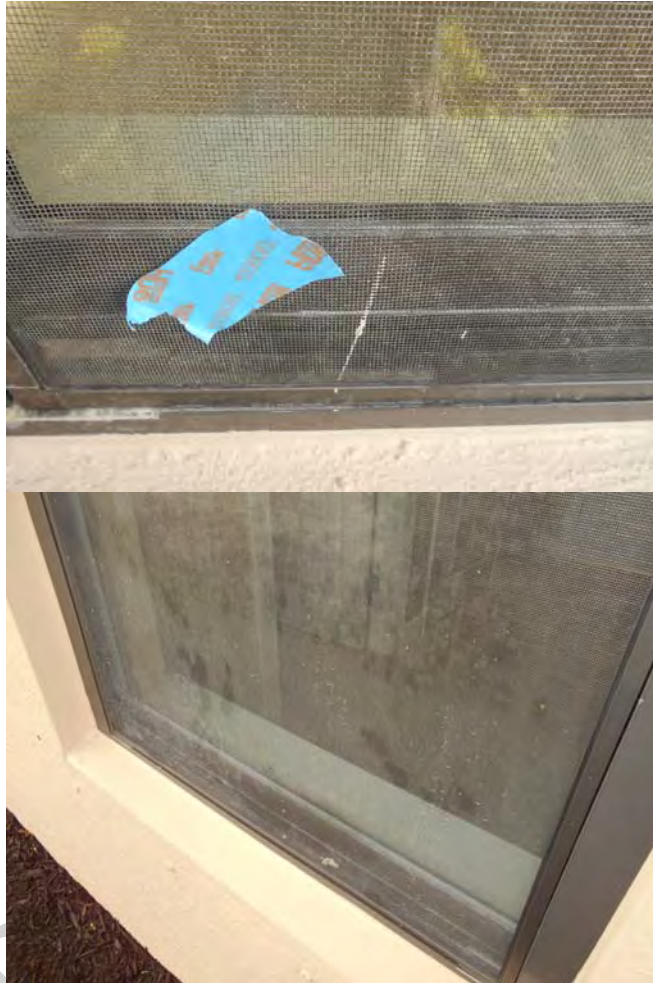
Screens dirty and glass not cleaned; screens should be removed and cleaned and replaced after final cleaning of windows/Frames.

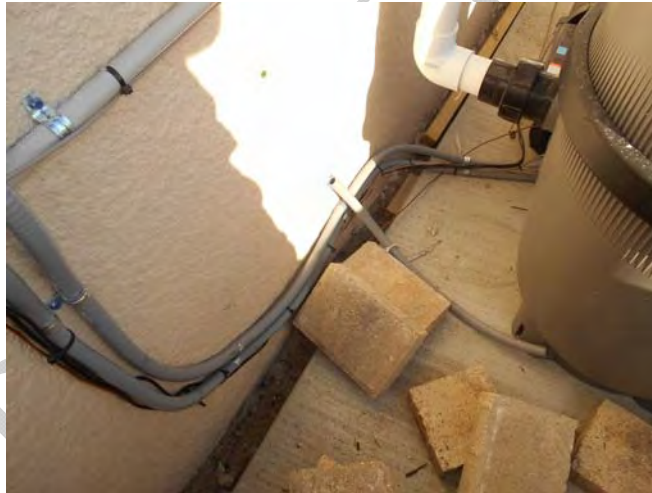
1113. Lot/Grade
Drainage

Review; Construction debris present around the site that should be removed.

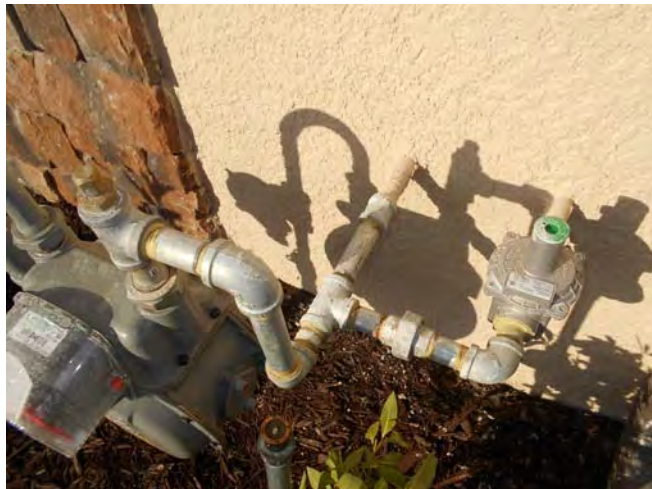
1114. Propane
Tank/Gas
Meter

Review; All gas piping should be properly painted to prevent corrosion.

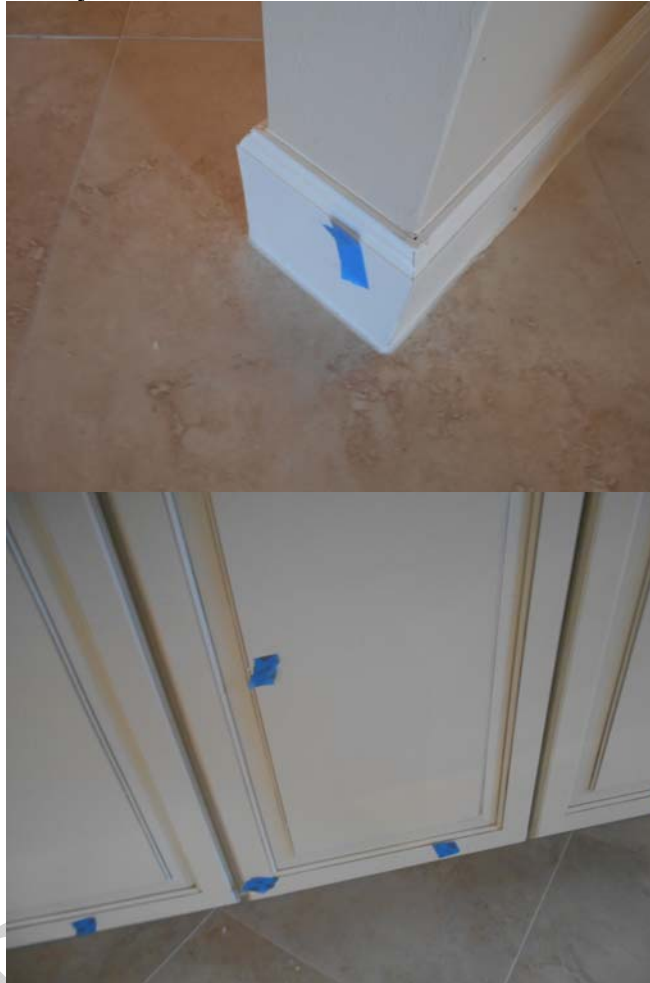
Blue tape was placed inside the home at various locations to help guide the builder as to type and extent of repairs required. See family room comments for more details.

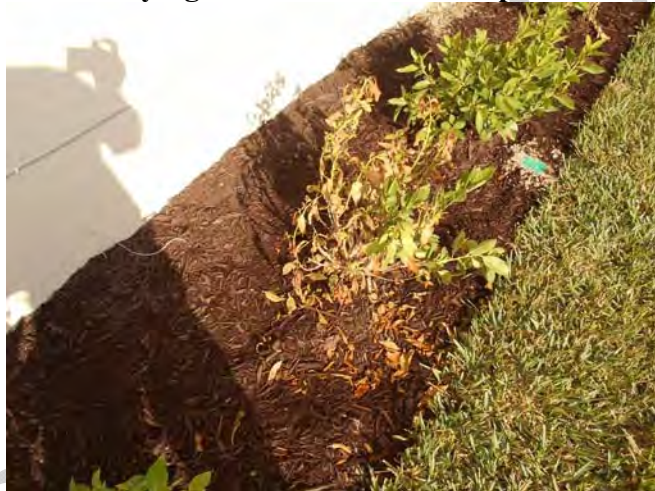
Dead or dying material should be replaced.

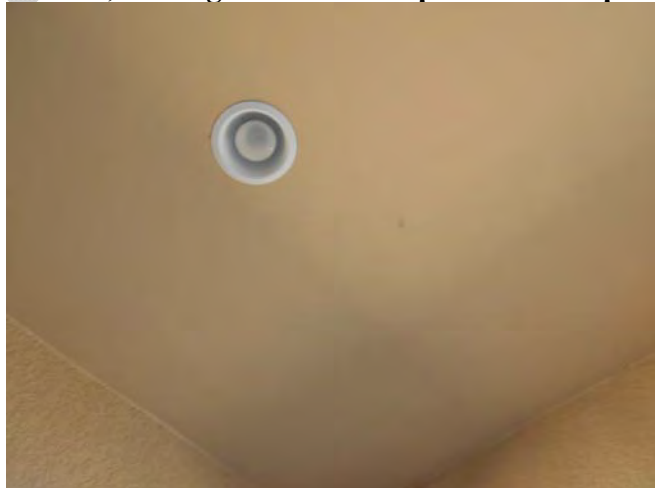
1202. Cover

Review; Ceiling needs to be repaired and repainted.

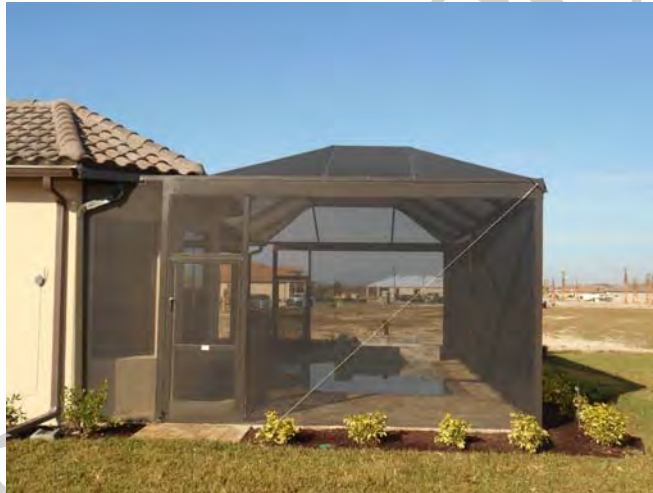
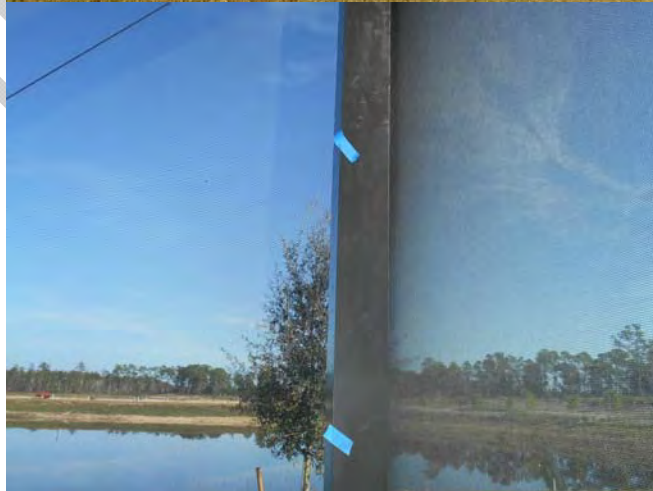
1203. Enclosure

Review; Aluminum and screen. Damage noted at frames in several locations.

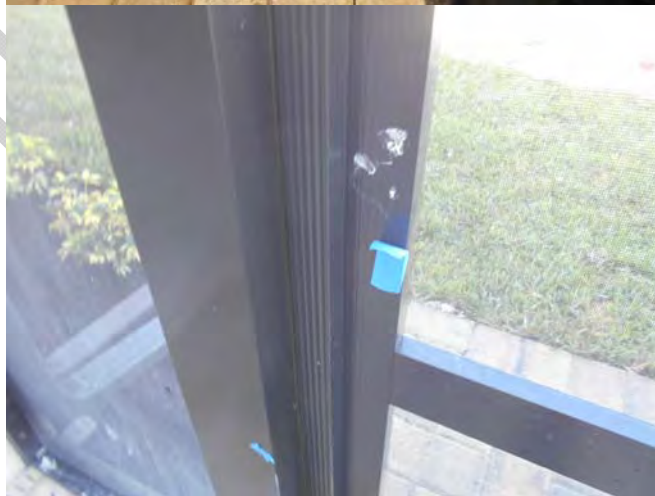
Paint should be cleaned from frames/screens.

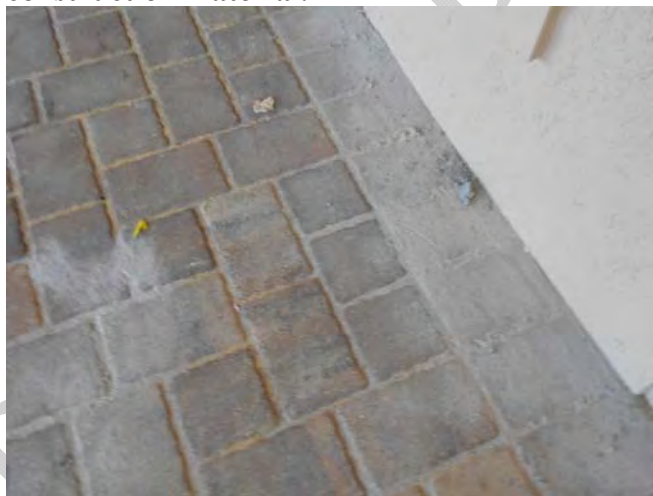
1207. Deck

Review; Brick. Decking requires cleaning of debris /paint and construction material.

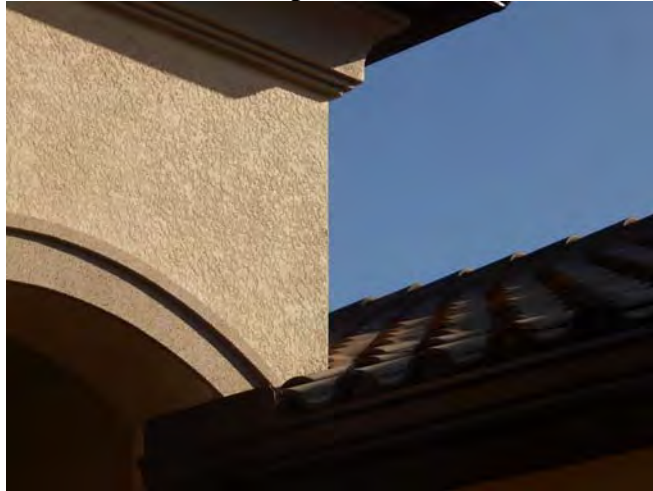
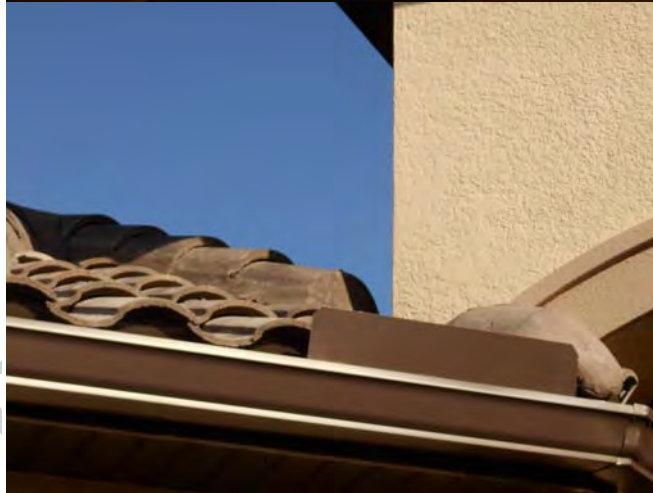
1308. Roof
 Comments

Review; Due to the construction of the roof, a valley is noted where water will accumulate during heavy rains. Suggest increased routine inspection of this area to monitor for leaks.

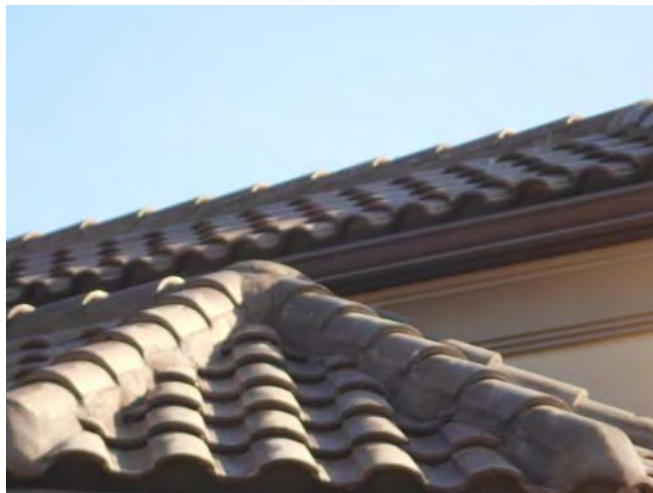
Review; Cleaning of all roof tile required. Paint over spray and construction debris noted.

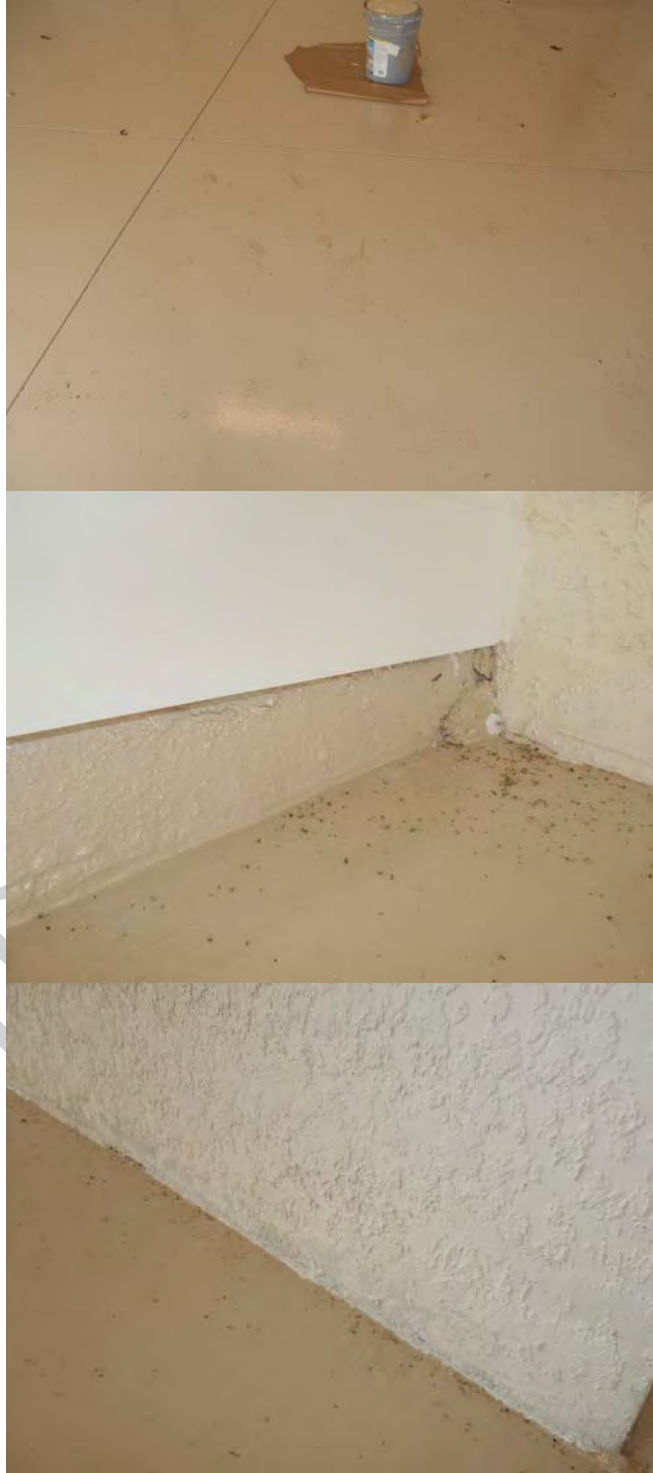
1502. Floor/Slab

Review; Concrete. Floor and walls need cleaned of construction debris and patched as required.

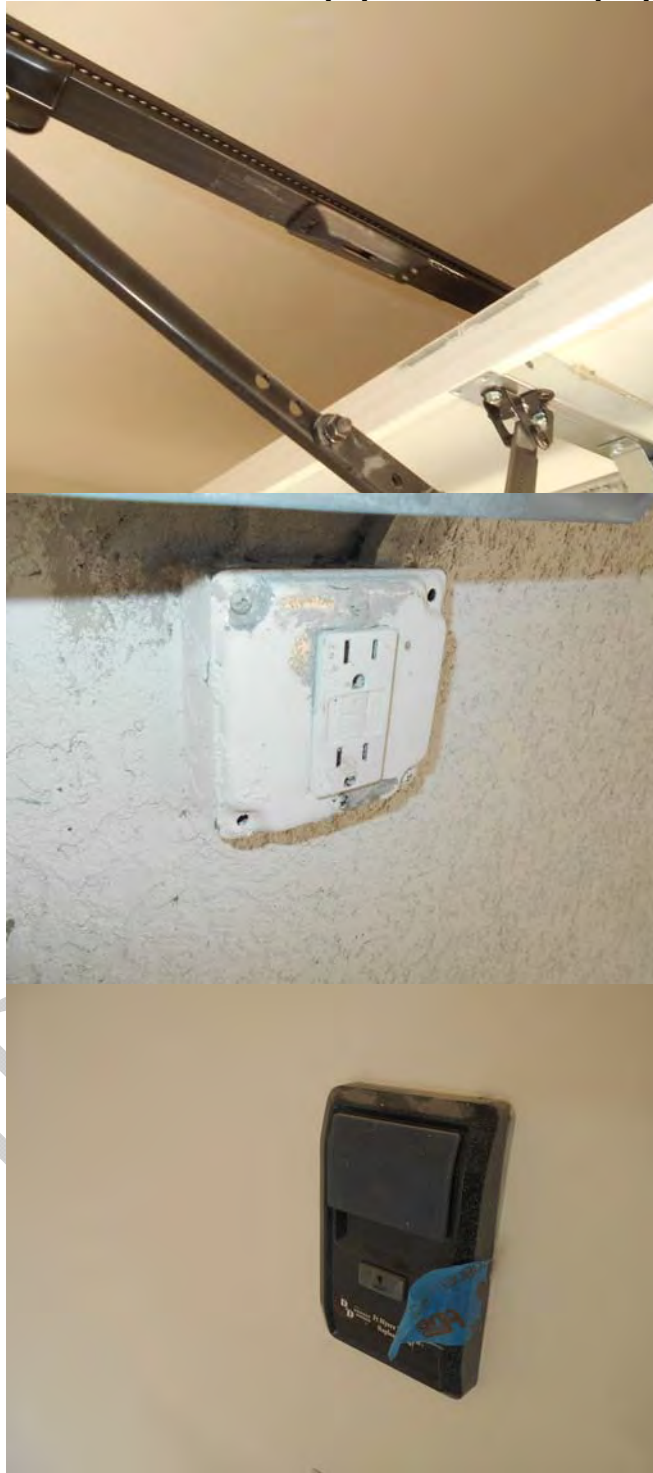
Paint on fixtures and equipment should be properly cleaned.

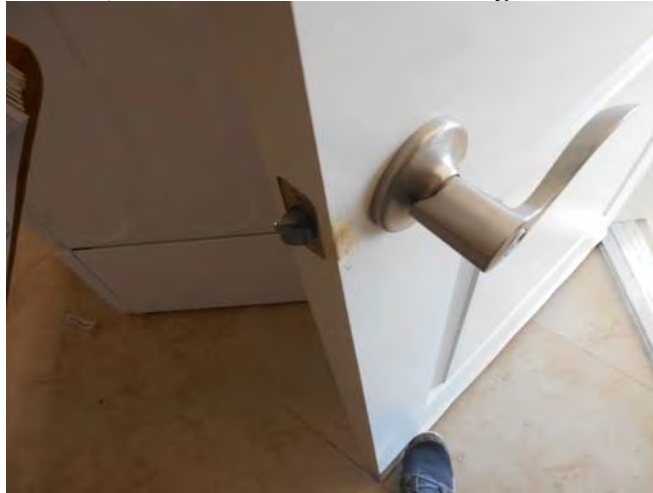
1508. Interior Door **Review; Metal/Wood. Door is damaged and sill needs cleaned.**

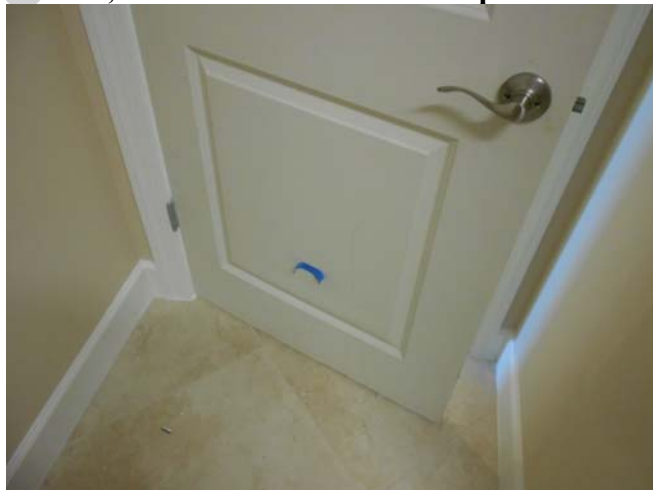
1604. Interior Doors

Review; Wood. Door has not been painted.

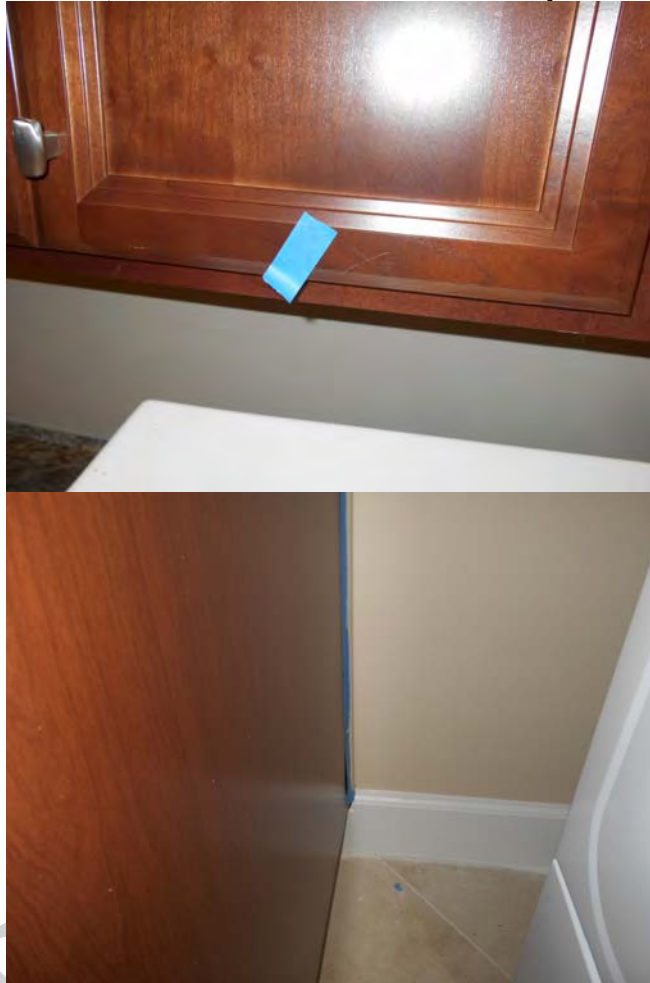
1607. Cabinets **Review; Scratches noted. Trim not completed.**

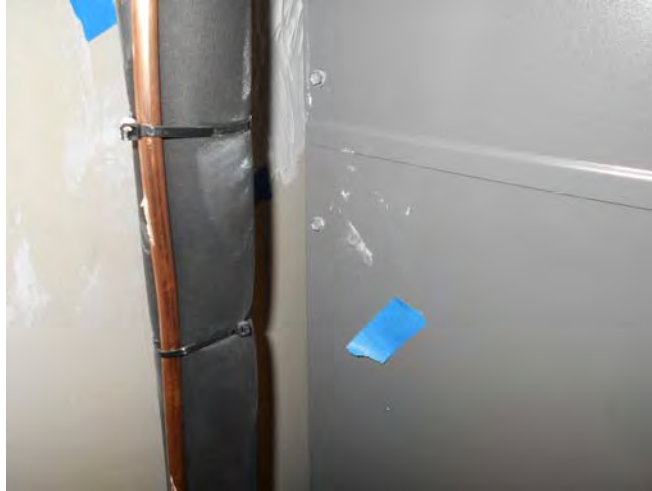
1803. Heater
 Manufacturer

Review; Unit and components should be cleaned of paint and other debris.

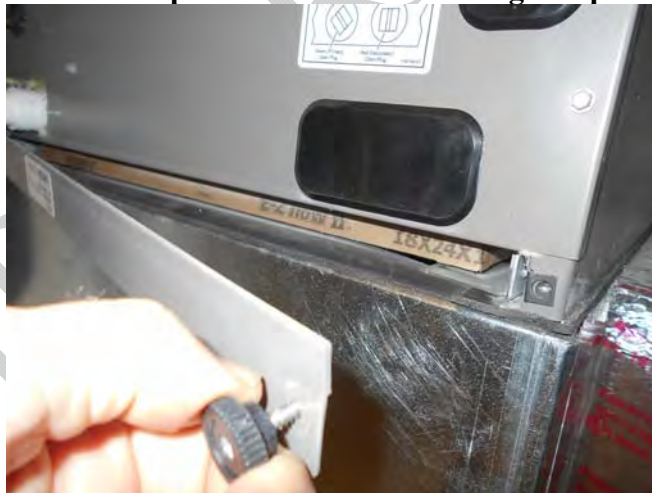
1806. Filter

Review; Located at the unit. Home was not even broom clean at the time of inspection and construction dust/debris not protected from return air locations. Ductwork should be cleaned and filter replaced after final cleaning completed.

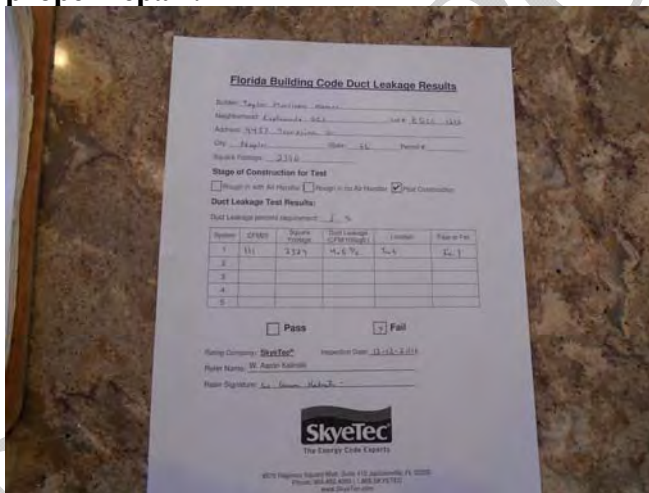
1807. Ducting

Review; Ducts failed leak test. Suggest review with builder on proper repair.

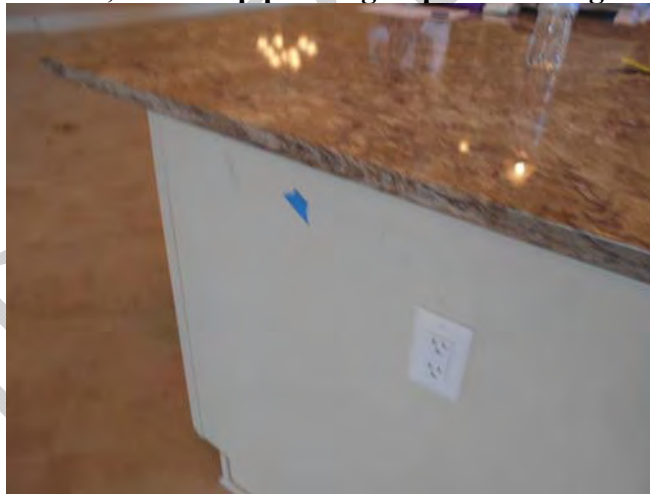
2102. Walls

Review; Touch up painting required throughout.

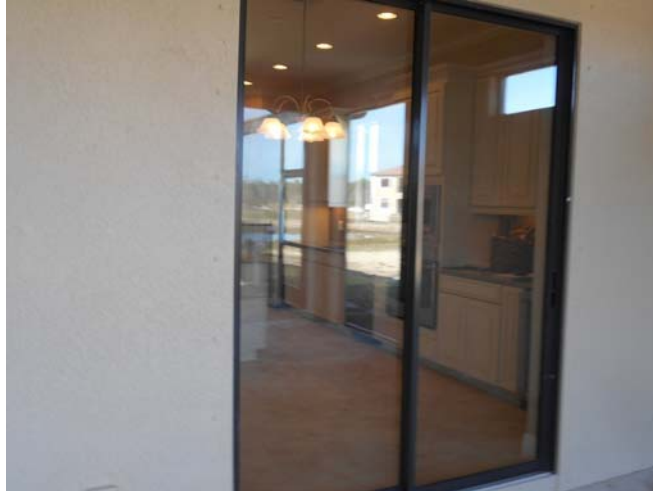
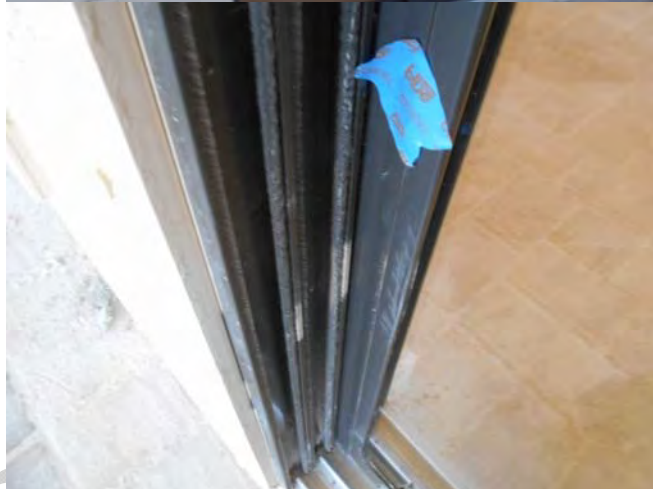
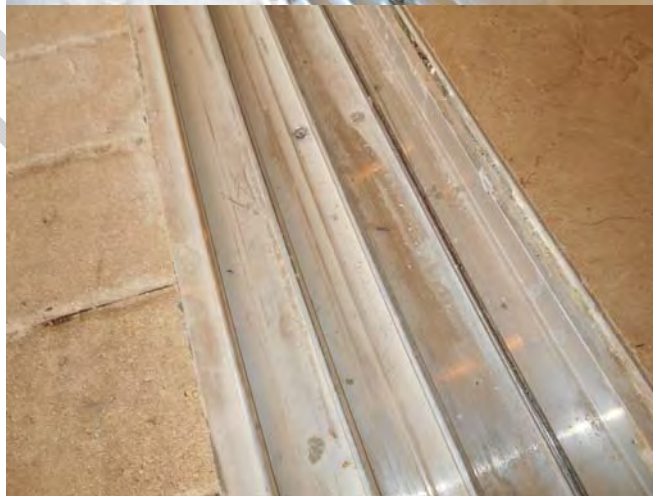
2105. Exterior Doors **Review; Exterior doors damaged and need properly repaired or replaced. Tracks require cleaning.**

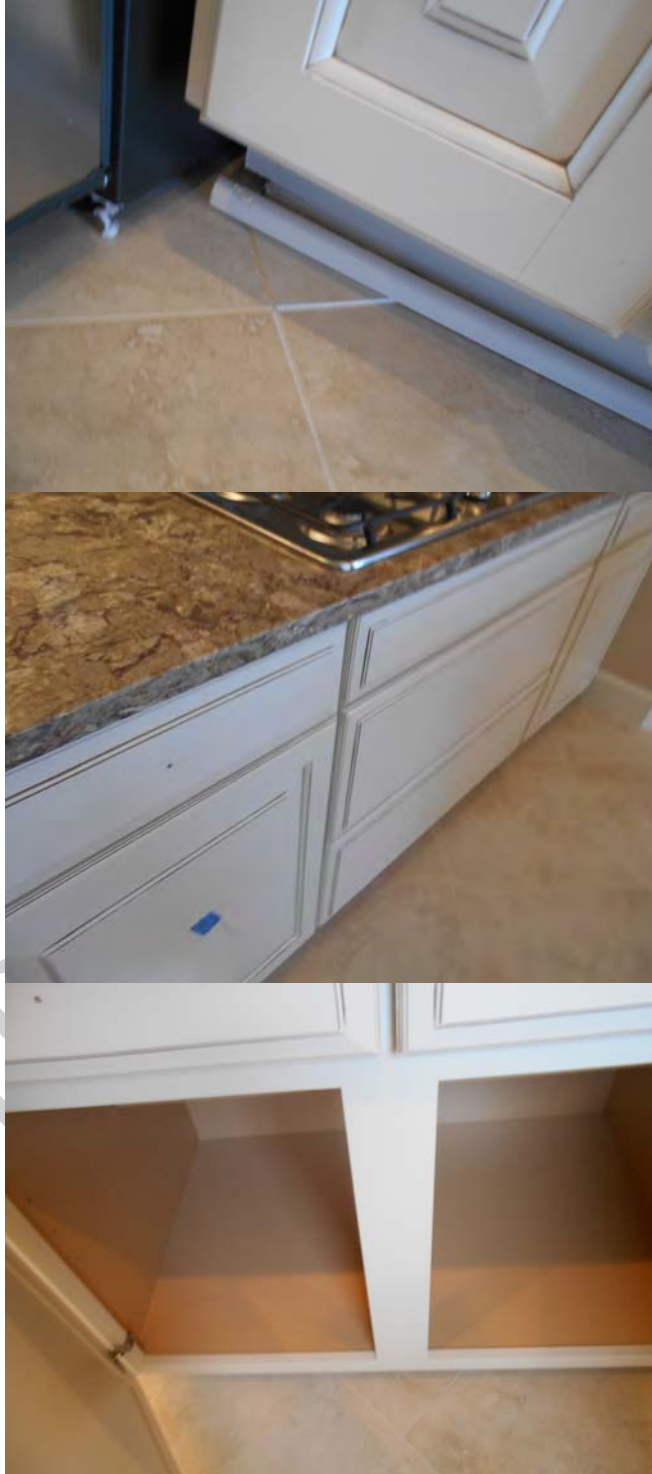
2107. Cabinets

Review; Cabinet installation incomplete. Loose trim; missing pulls; missing shelving noted.

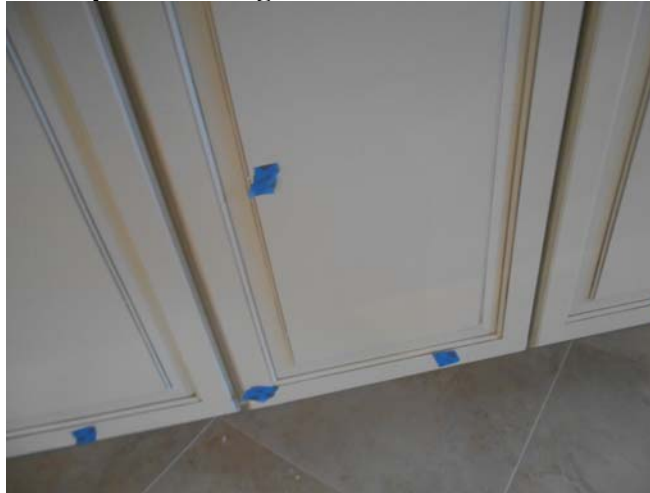
Widespread damage noted on cabinets.

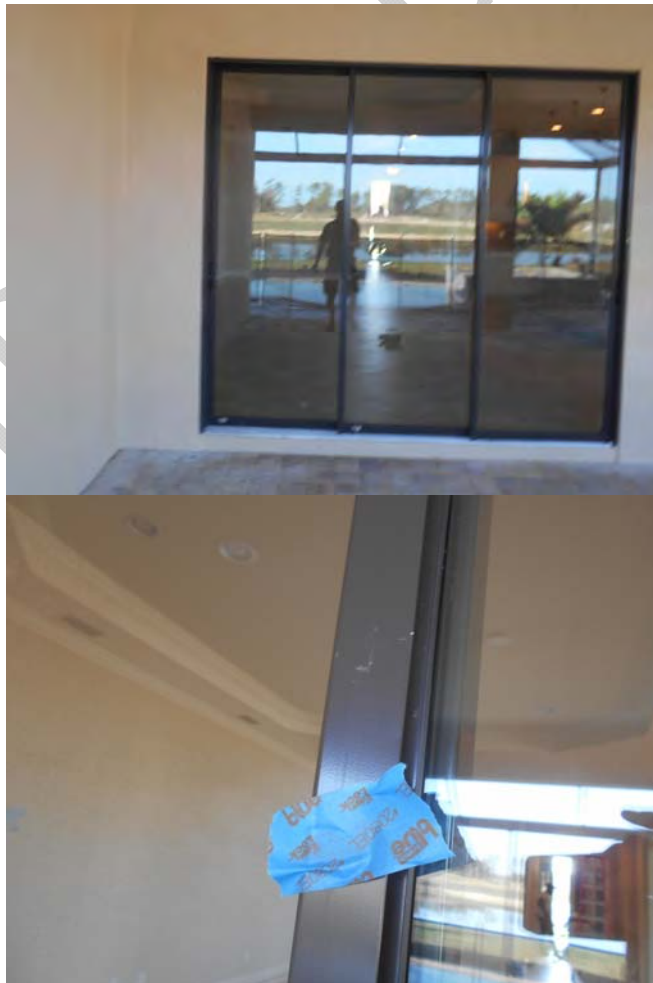
2205. Exterior Doors

Review; Aluminum sliding glass. Widespread damage noted at these doors. Doors need properly repaired or replaced. Tracks need cleaned.

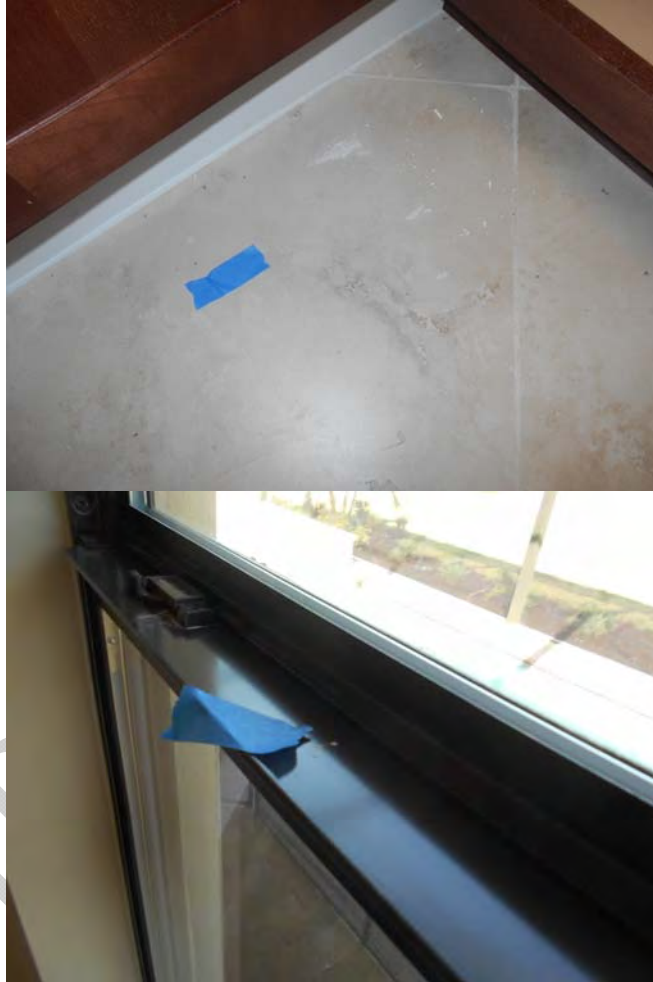
Paint on flooring; cabinets and other fixtures and devices;

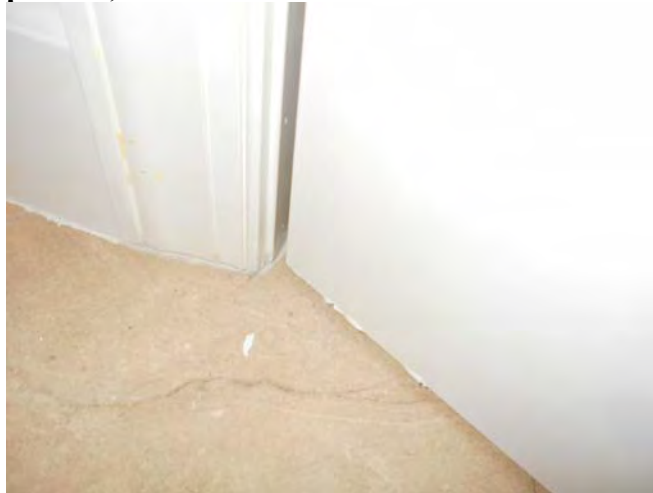
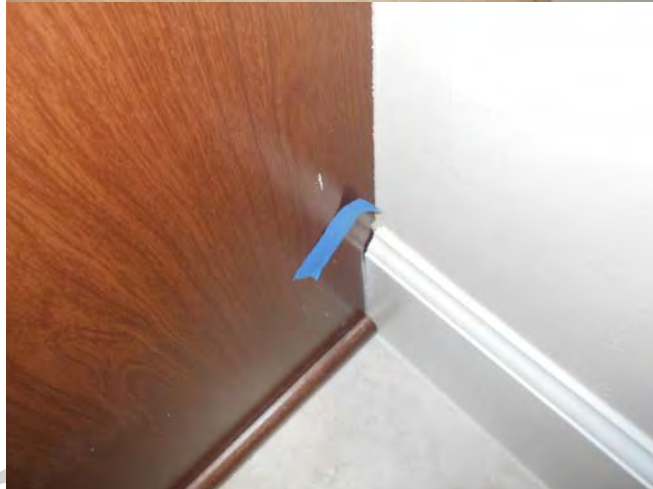
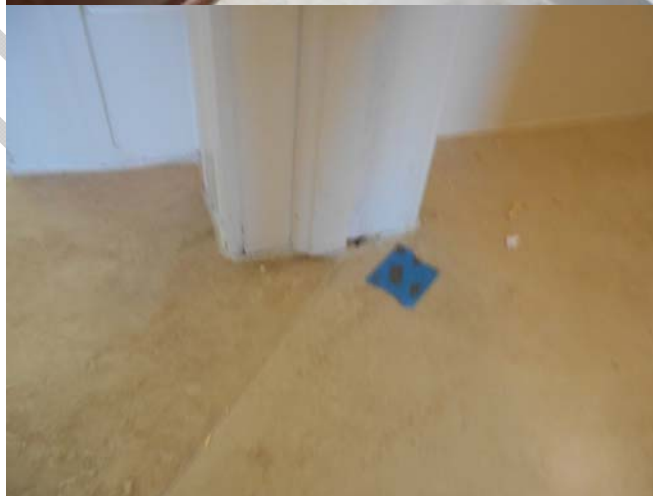
Damaged doors present and improperly completed wood work present;

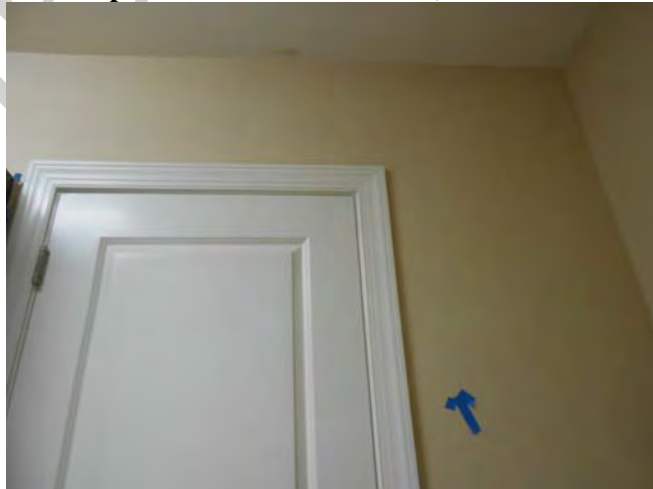
Ceilings in most rooms have repairs requiring the entire ceiling to be repainted in each location;

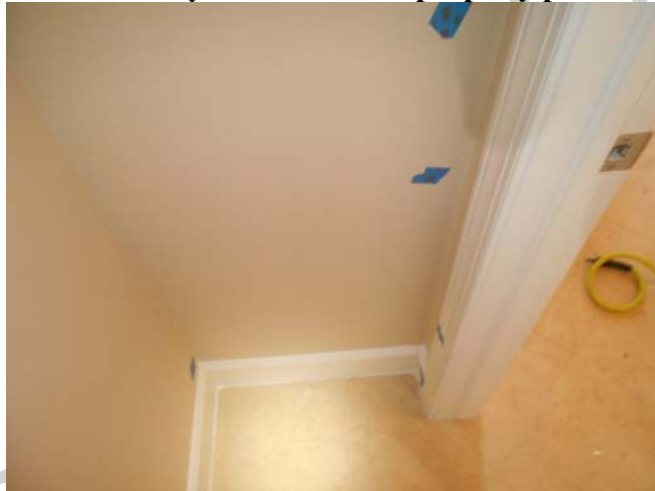
Numerous drywall defects/ improperly painted area present;

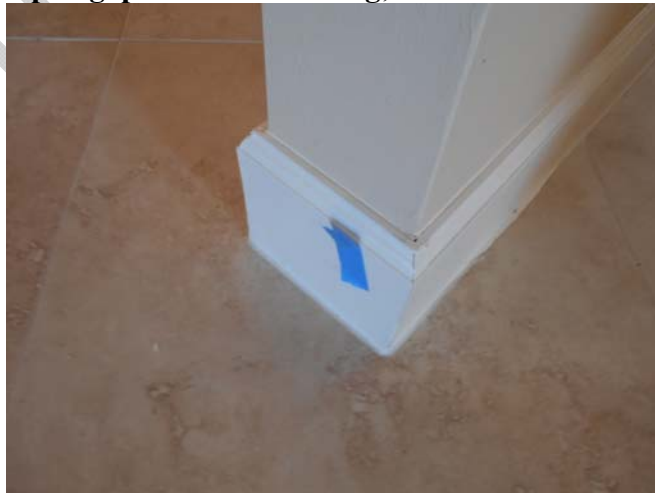
Open gaps in woodworking;

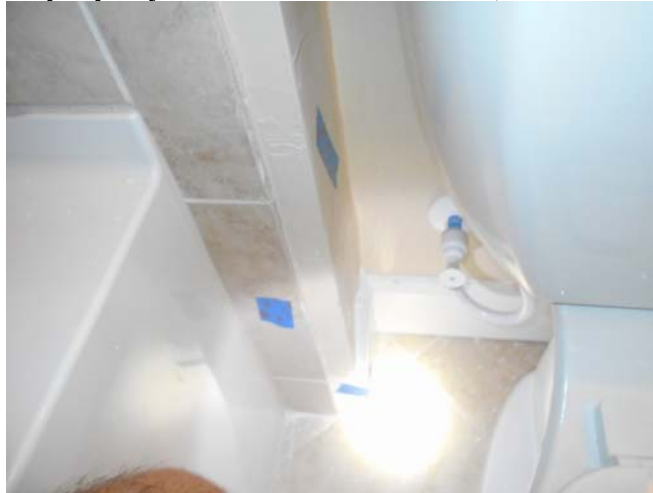
Improperly finished doors and trim;

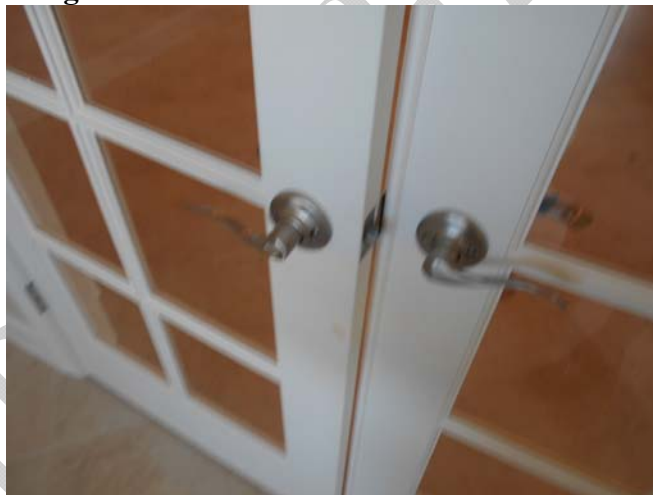
2404. 1. Interior Doors

Review; Wood/Glass, French. Door is binding and will not close using normal force.

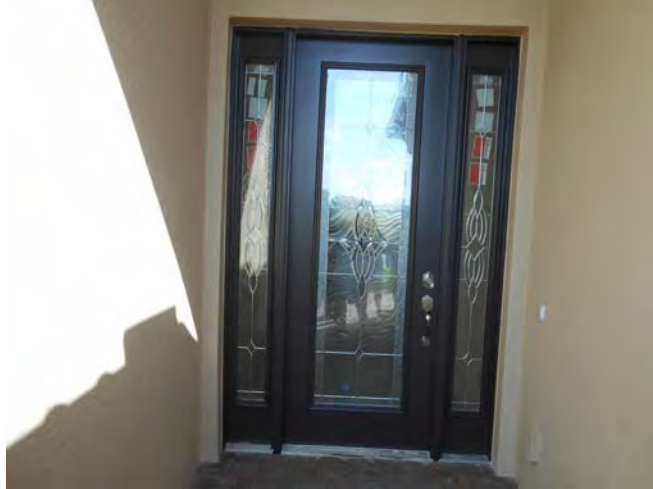
2504. Exterior Doors **Review. Wood/Metal/Glass, with side lite. Door missing weather stripping. Cleaning and final painting still in progress.**

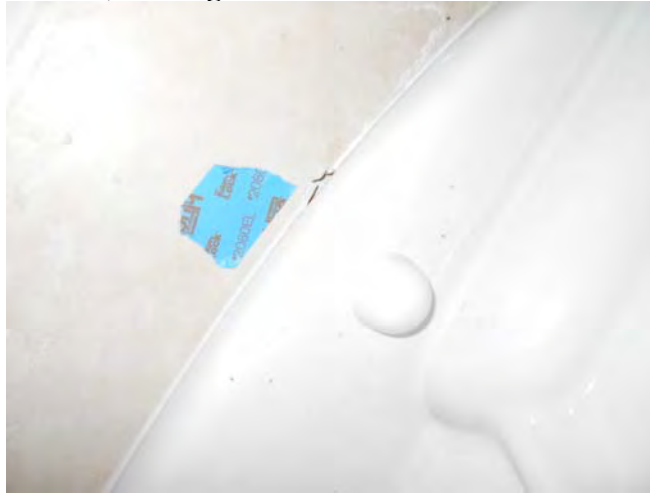
2701. Floor

Review; Damaged tile noted at toilet.

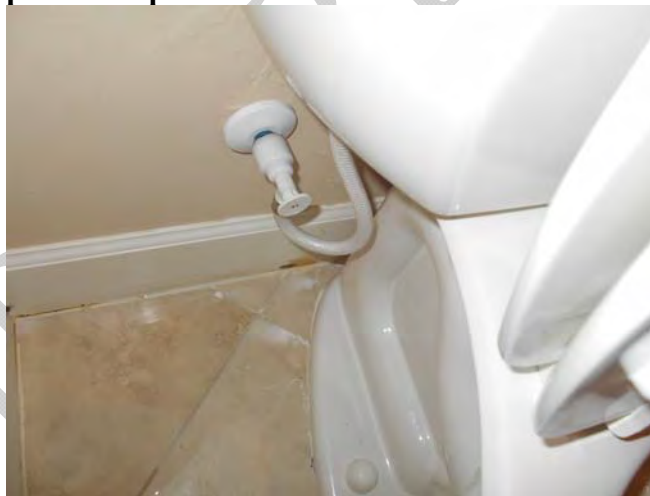
2702. Walls

Review; Water damage noted at toilet room with standing water present; proper water damage protocols should be followed which includes removal of finish materials and proper drying prior to repairs.

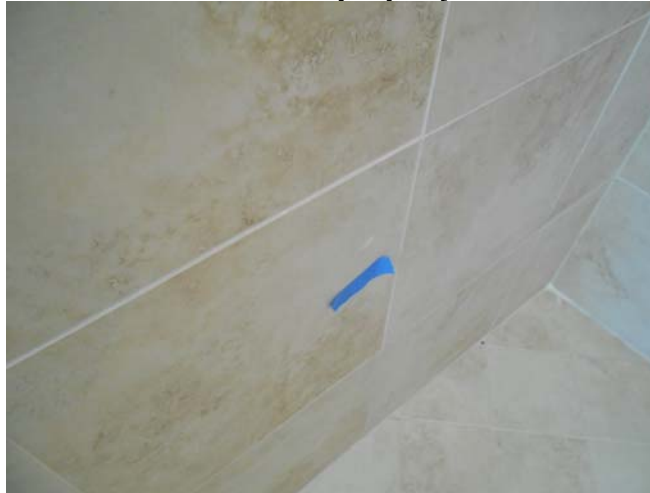
2713. Shower /
Surround

Review. Tile. Tile needs properly cleaned.
