HAZELBAKER CONSTRUCTION SERVICES
8965 QUARRY DRIVE
NAPLES, FLORIDA
(239)213-8046

Doc #: 1412-000
Dwelling Address: 123 Sunshine Way # 204, Estero, Florida 33928
Client Name: John Doe
Inspector: Joel Hazelbaker, **Licensed Florida State Home Inspector: License No. HI874**

The Summary Report does not constitute our entire report and may not include all the items a client may consider important to home ownership, therefore, the client is advised to read the Inspection Report in its entirety.

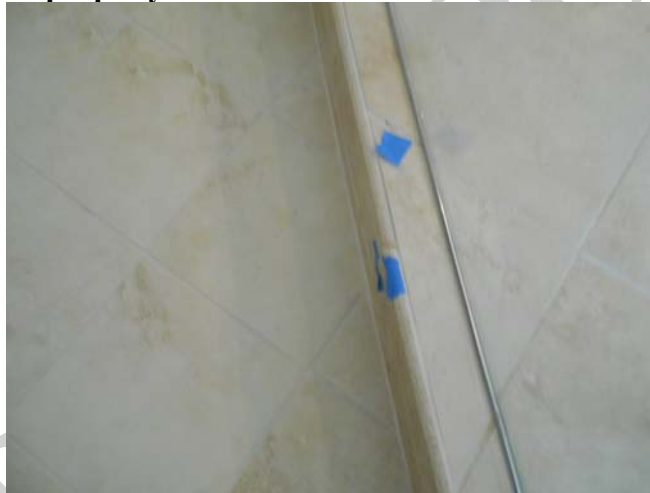
Improperly installed tile noted.

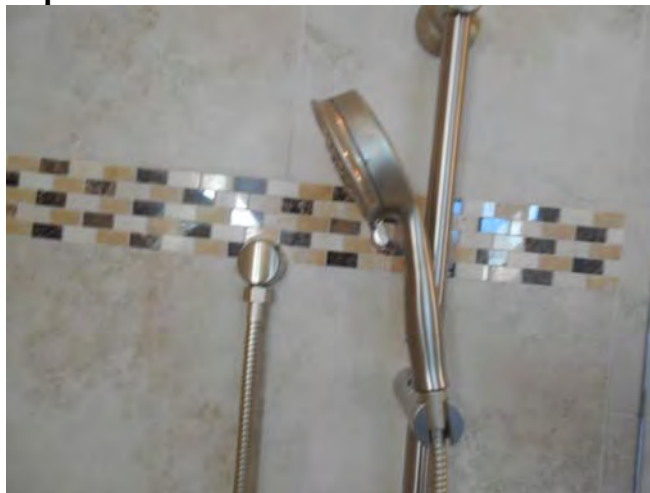
2716. Shower Faucet

Review; No water coming out of shower heads; leaking present at toilet room wall indicating leak in wall. Immediate repairs required.

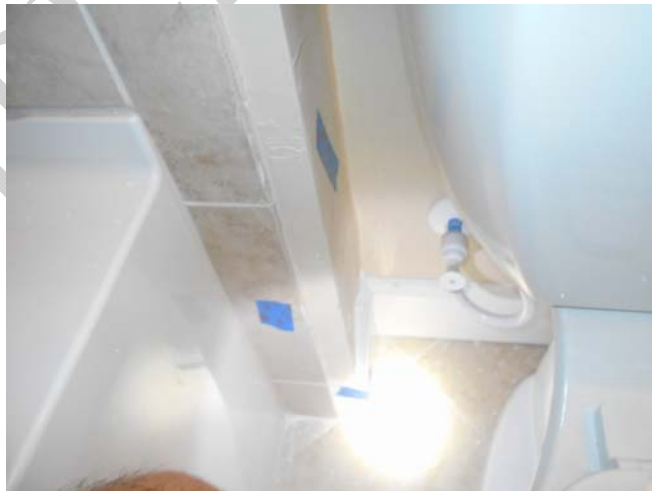
2802. 2. Walls **Review; Poor finish quality and improper installation of**
baseboard noted.

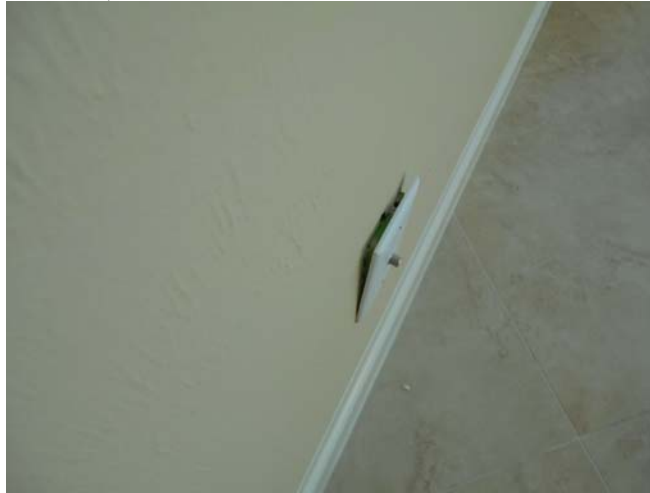
2907.2. Electrical

Review; Loose coaxial outlet noted.

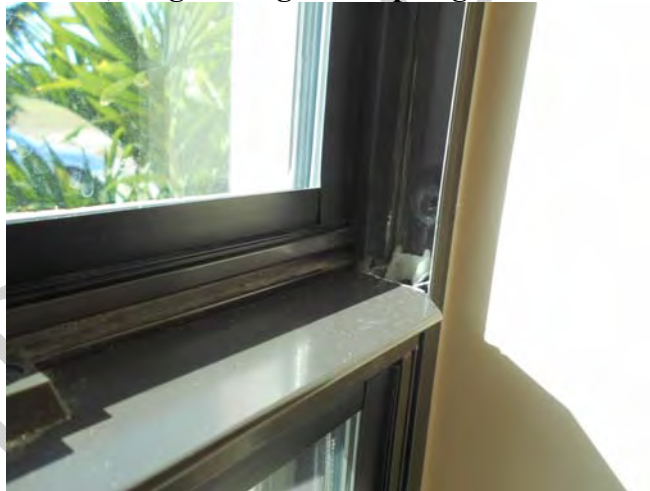
**BEDROOM LEFT**2906.3. Windows /
Screens**Review; Single Hung. Sash springs loose at one unit.**

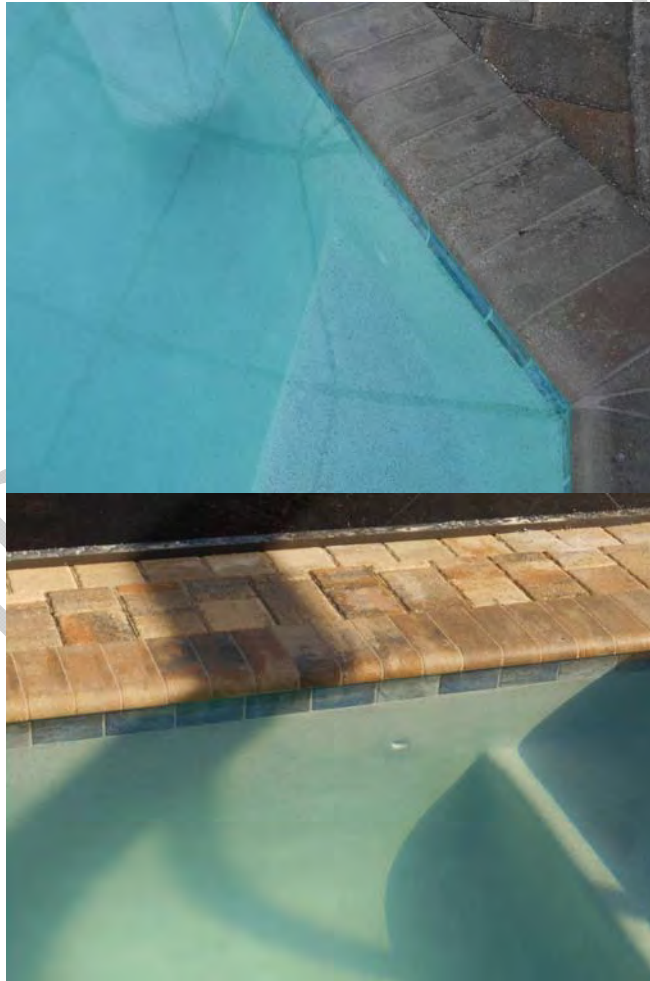
Trim not installed at inlets.

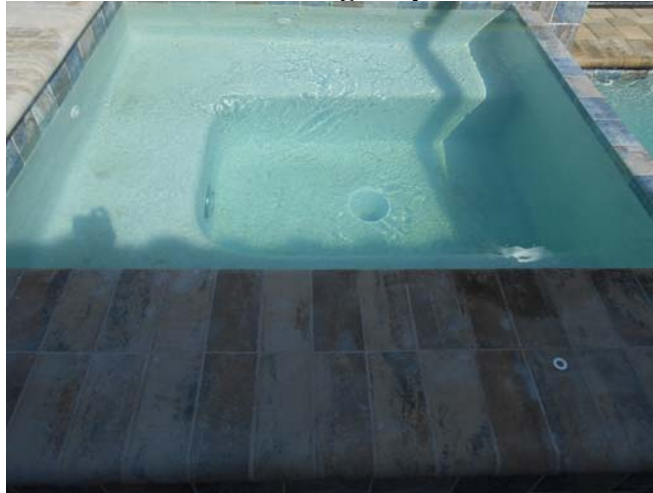
Main drain cover missing at spa.
