## FULL PROPERTY INSPECTION REPORT

Doc #: 2509-003 Inspection Date: 9/9/2025

Dwelling Address: XXXX Cedar Hammock Circle #714, Naples, FL 34112

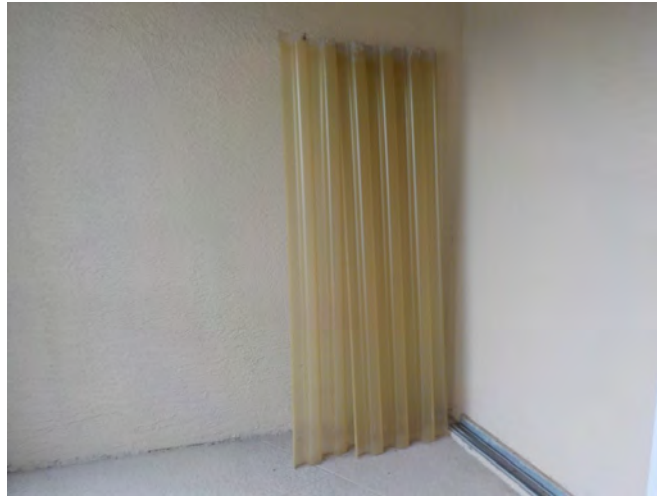
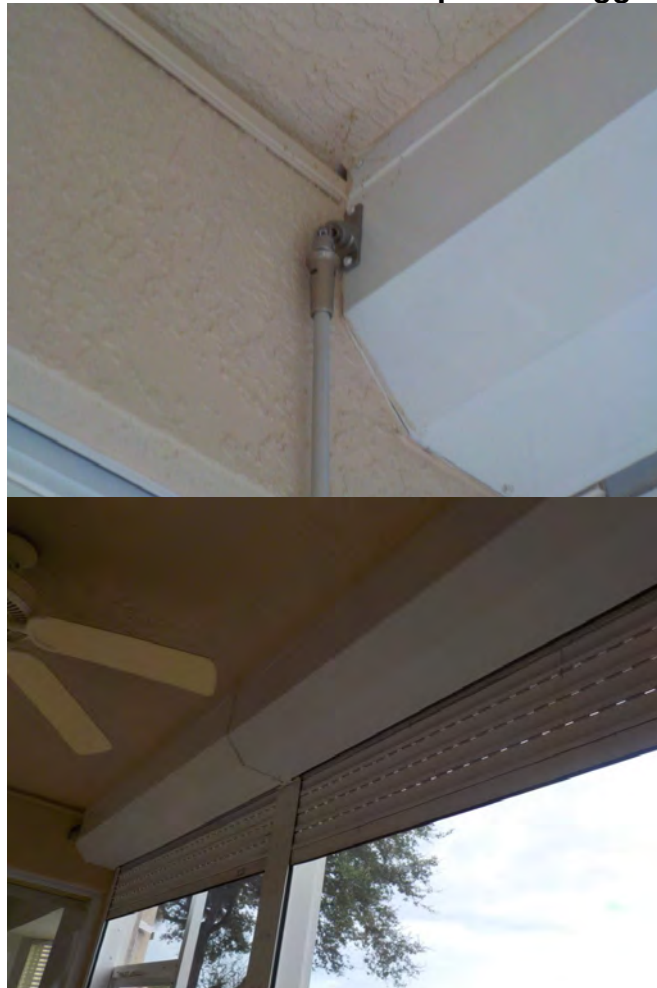
1116. Shutters

**Review; Loose bracket noted at crank for roll down shutter at lanai. Shutter is difficult to operate. Suggest service.**

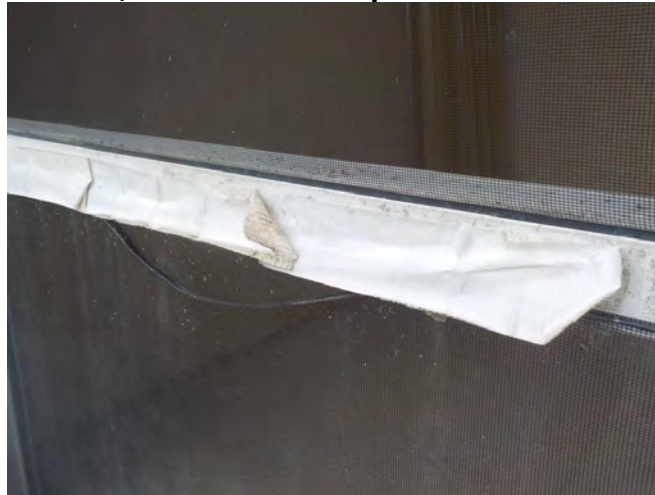
**Review; Loose screen/spline noted at rear side lanai area.**

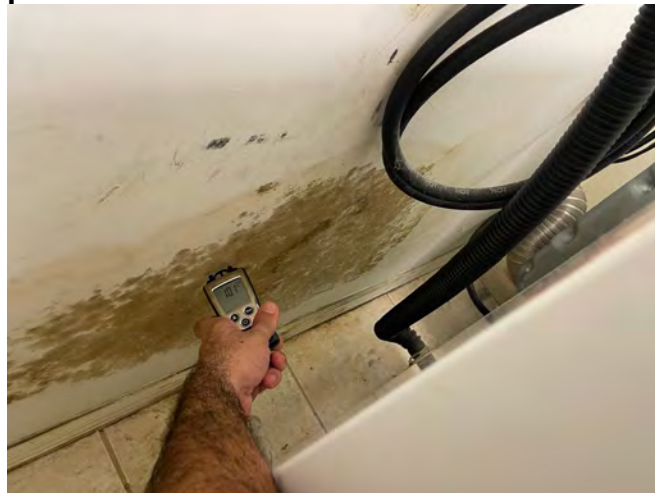
| 1602. | Walls | |

**Review; Staining consistent with possible mold growth noted at laundry room wall behind washing machine. Area was dry at time of inspection. Suggest review of mold air quality test performed on 9/9/2025.**

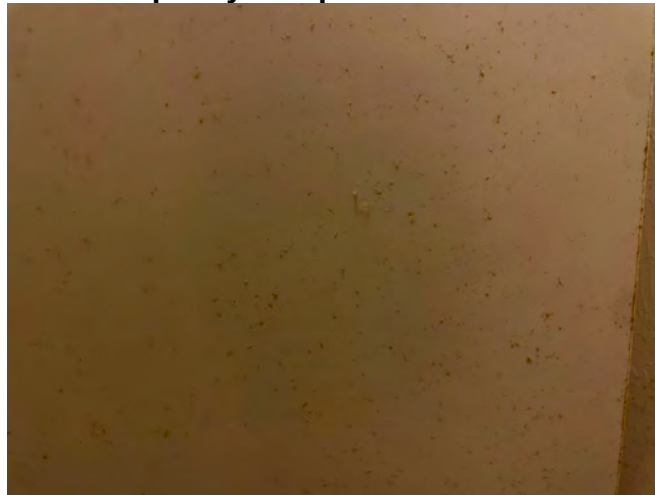
1604. Interior Doors **Review; Wood bi-fold. Staining consistent with possible mold growth noted at backside of bi-fold doors. Suggest review of mold air quality test performed on 9/9/2025.**

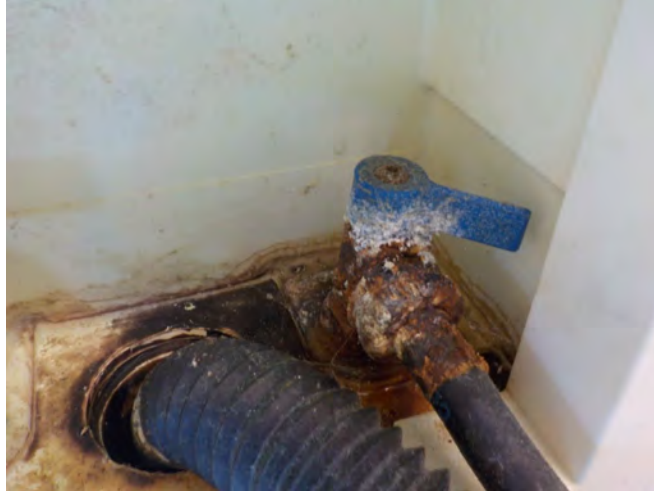
**Review; Leak noted at cold water supply valve at washer hook up. Suggest review/repair by a qualified plumber.**

**Review; Washing machine was making loud unusual noise during spin cycle. Suggest review by a qualifeid appliance repairman.**

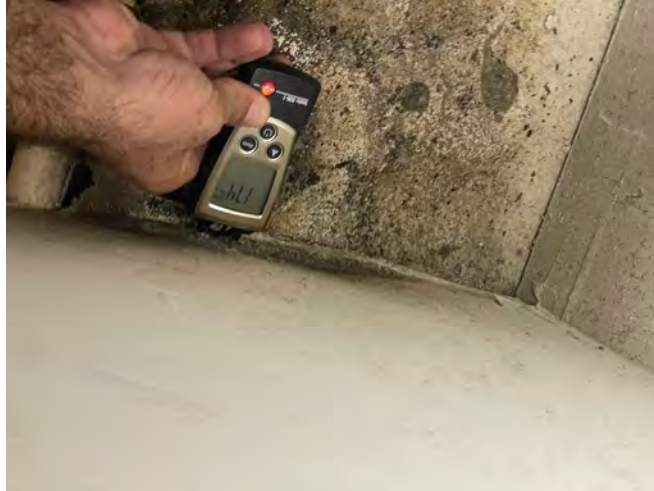
| Step # | Component | Comment |
|---|---|---|
| 1801. | Heating | Functional; Electric; Split system; Forced air. Unit is located at hall closet.<br><br><b>Review; Staining consistent with possible mold growth noted at right side wall inside air handler closet. Area had slightly elevated levels of moisture at time of inspection. Suggest review of mold air quality test performed on 9/9/2025.</b> |

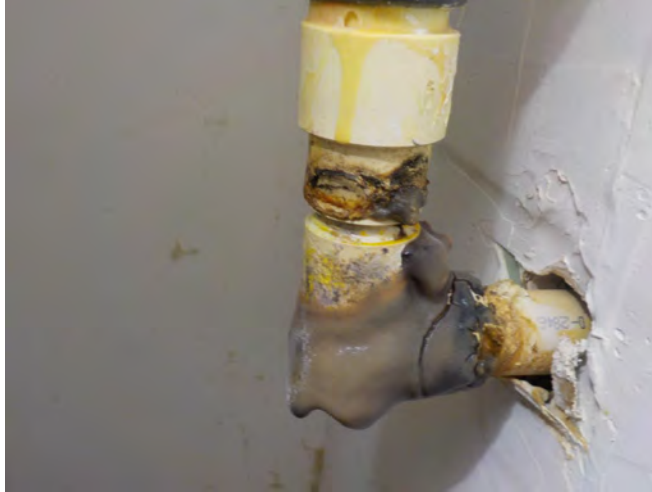
Review; Leak noted at supply connection at main water shut off. Suggest review/repair by a qualified plumber.

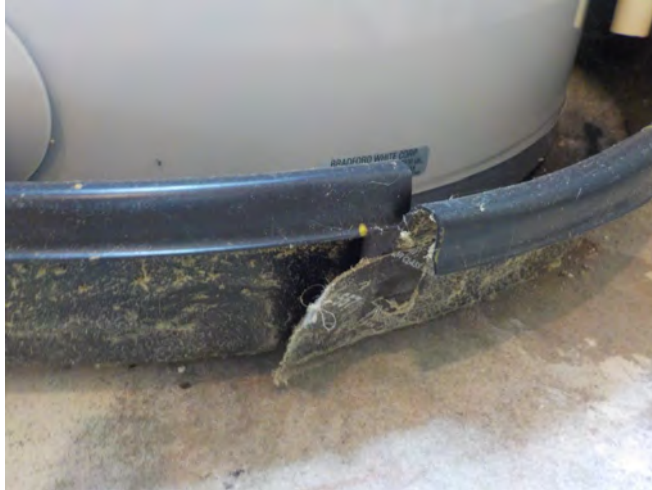
**Review; Damaged overflow pan noted for water heater.**

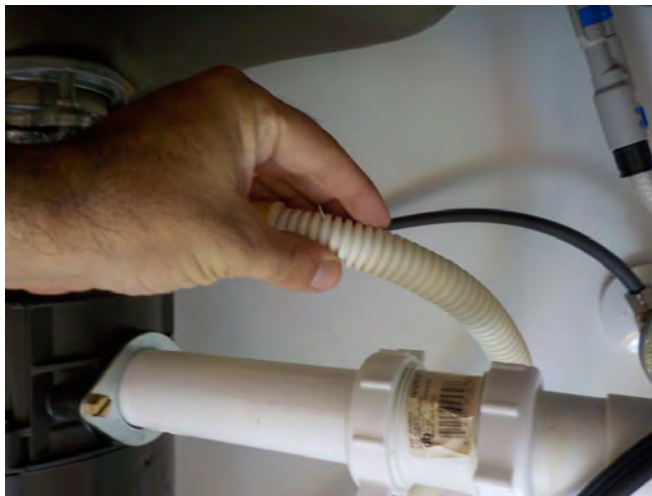
**Review; No loop in drain line at dishwasher. A loop in drain line is required to prevent dirty drain water from entering the dishwasher.**

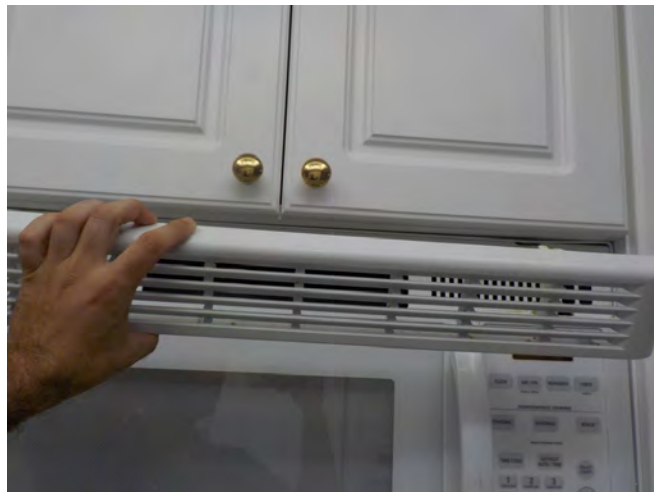
**Review; Damaged clips/detached cover noted at microwave exhaust fan. Missing filter screens noted at underside of microwave.**

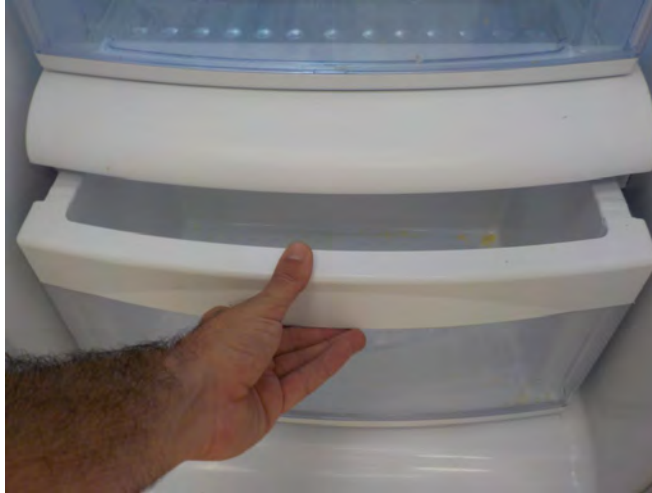
**Review; Bottom drawer at fridge does not operate properly.**

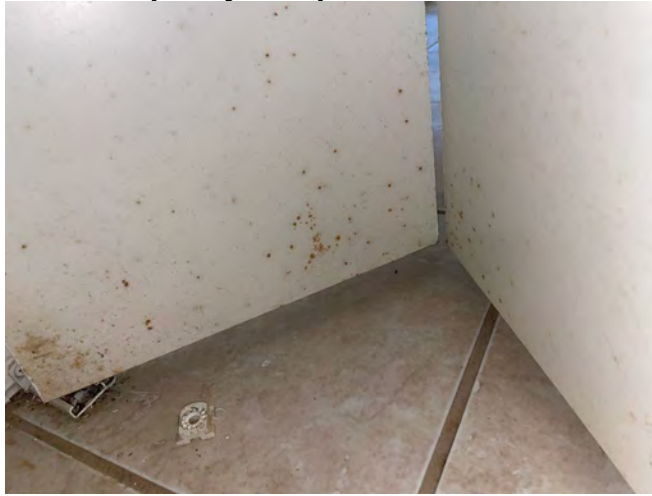
**Review; Wood-fold. Staining consistent with possible mold growth noted at backside of bi-fold doors. Suggest review of mold air quality test performed on 9/9/2025.**

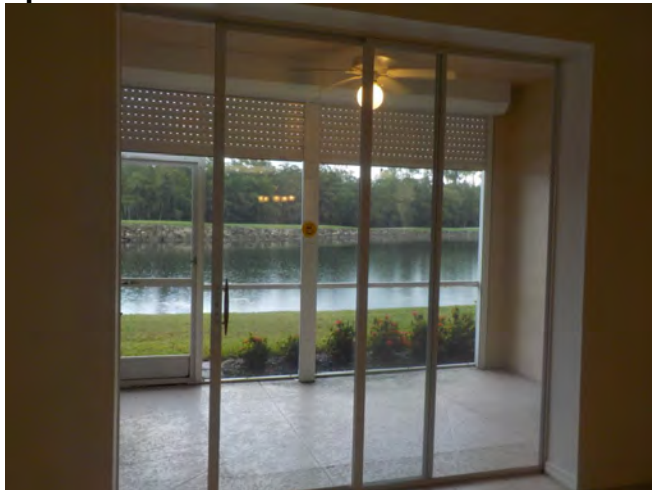
| 2205. | Exterior Doors | <b>Review; Aluminum sliding glass. Suggest service for smoother operation.</b> |

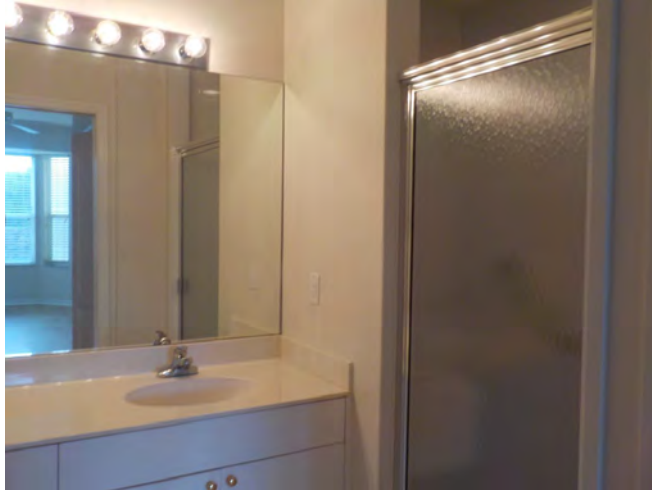
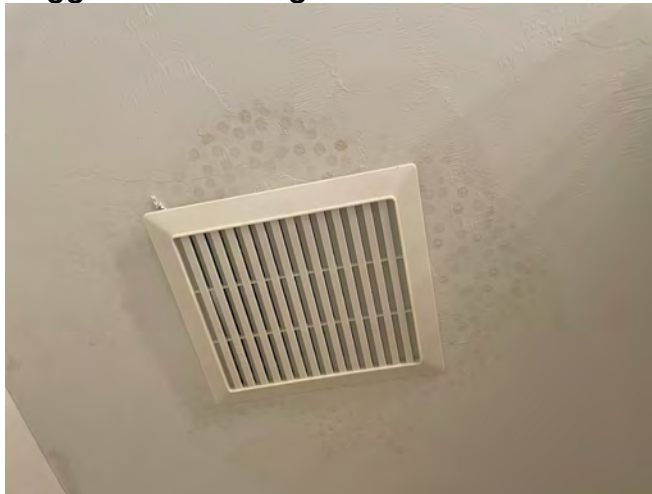
| Step # | Component | Comment |
|---|---|---|
| 2703. | Ceiling | <b>Review; Stain noted at master bathroom exhaust vent. Origin of staining unknown. Area was dry at time of inspection. Suggest monitoring.</b> |

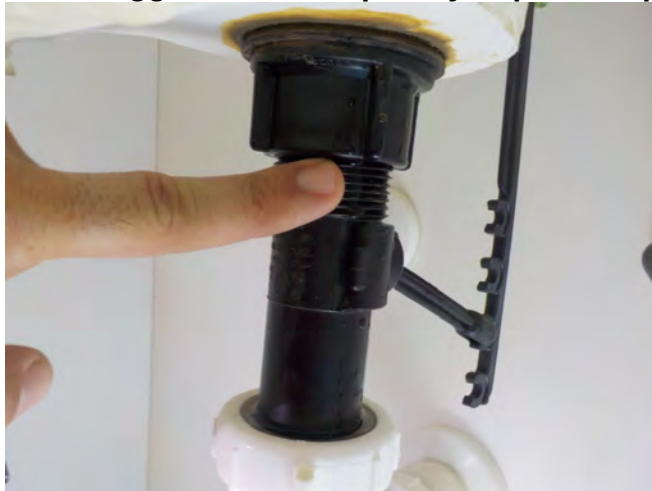
**Review; Leak noted at top of drainpipe underneath right side sink. Suggest review/repair by a qualified plumber.**

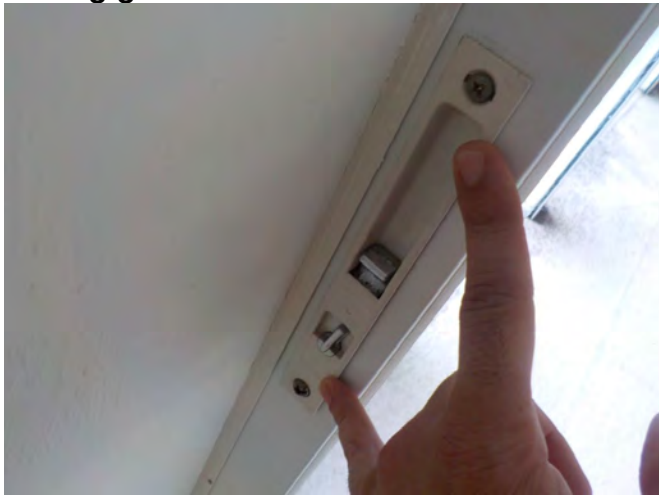
| Step # | Component | Comment |
|---|---|---|
| 2905. | Exterior Doors | <b>Review; Aluminum sliding glass. Loose lock hardware noted at sliding glass door.</b><br> |

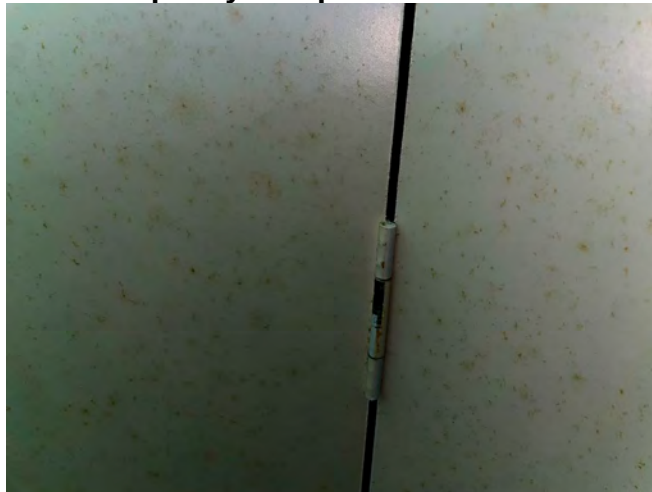
| 2910.2. | Closet | <b>Review; Wood-fold. Staining consistent with possible mold growth noted at backside of bi-fold doors. Suggest review of mold air quality test performed on 9/9/2025.</b> |
