NEW CONSTRUCTION SUMMARY REPORT

Doc #: 2510-038 Inspection Date: 10/10/2025
Dwelling Address: XXXXX Old Coast Rd #302, Naples, FL 34110
Client Name: John Doe
Inspector / Owner: John "Jack" Defossez, **Licensed Florida State Home Inspector**

HAZELBAKER INSPECTION SERVICES

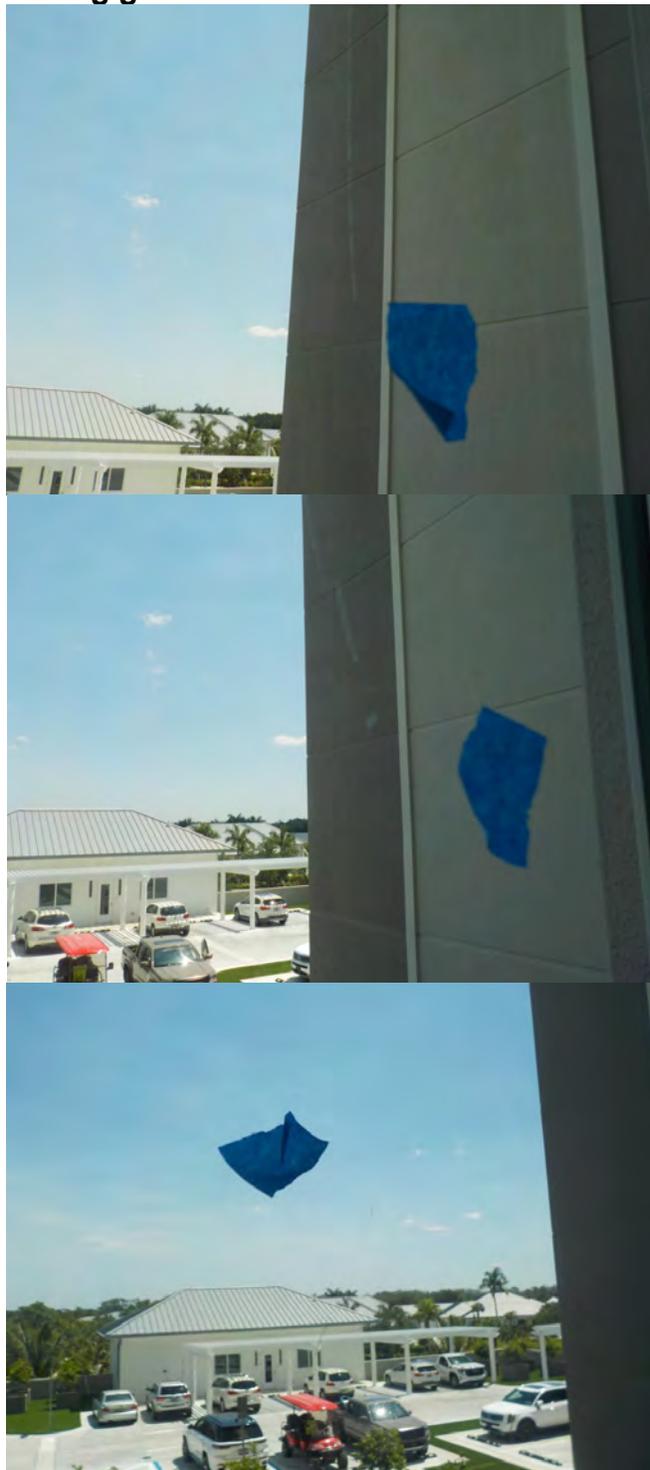
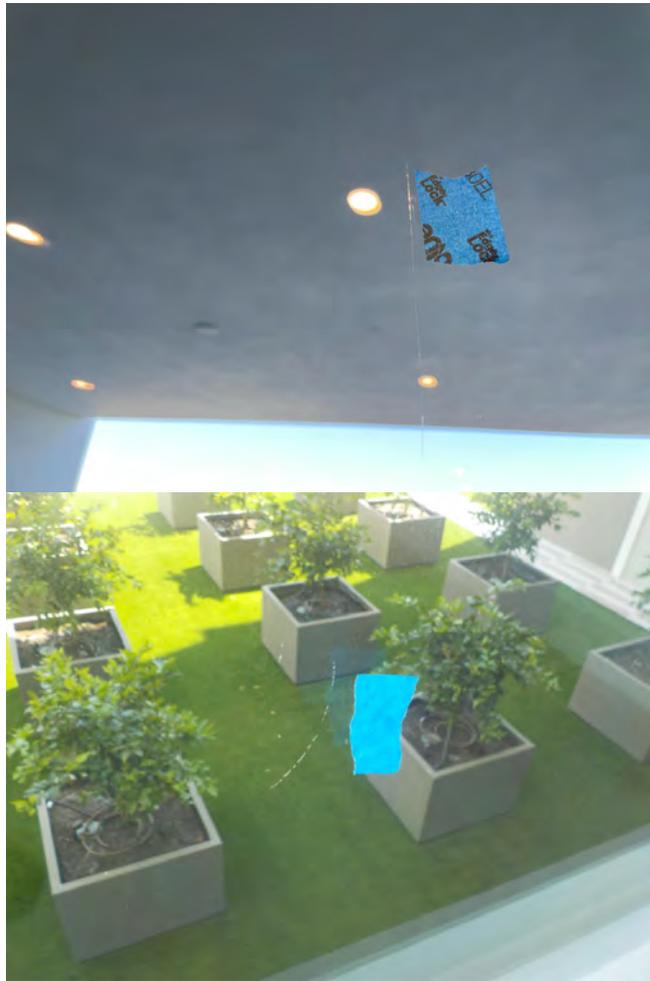
Windows &
Frames

Review; Scratched glazing noted at bedroom windows and family room sliding glass doors.

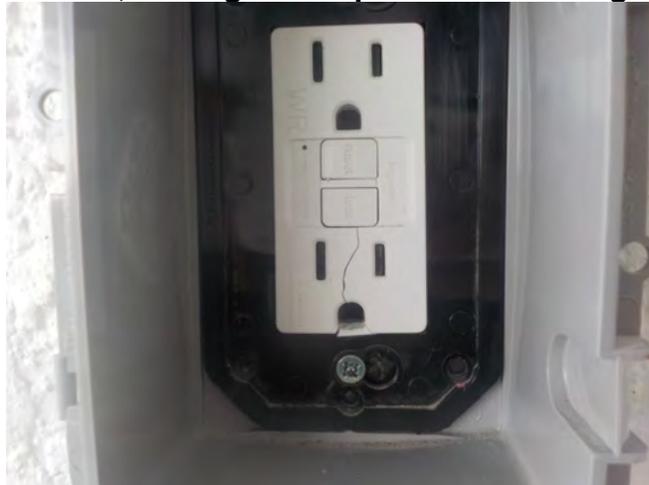
Electrical

Review; Damaged receptacle noted at right side of lanai area.

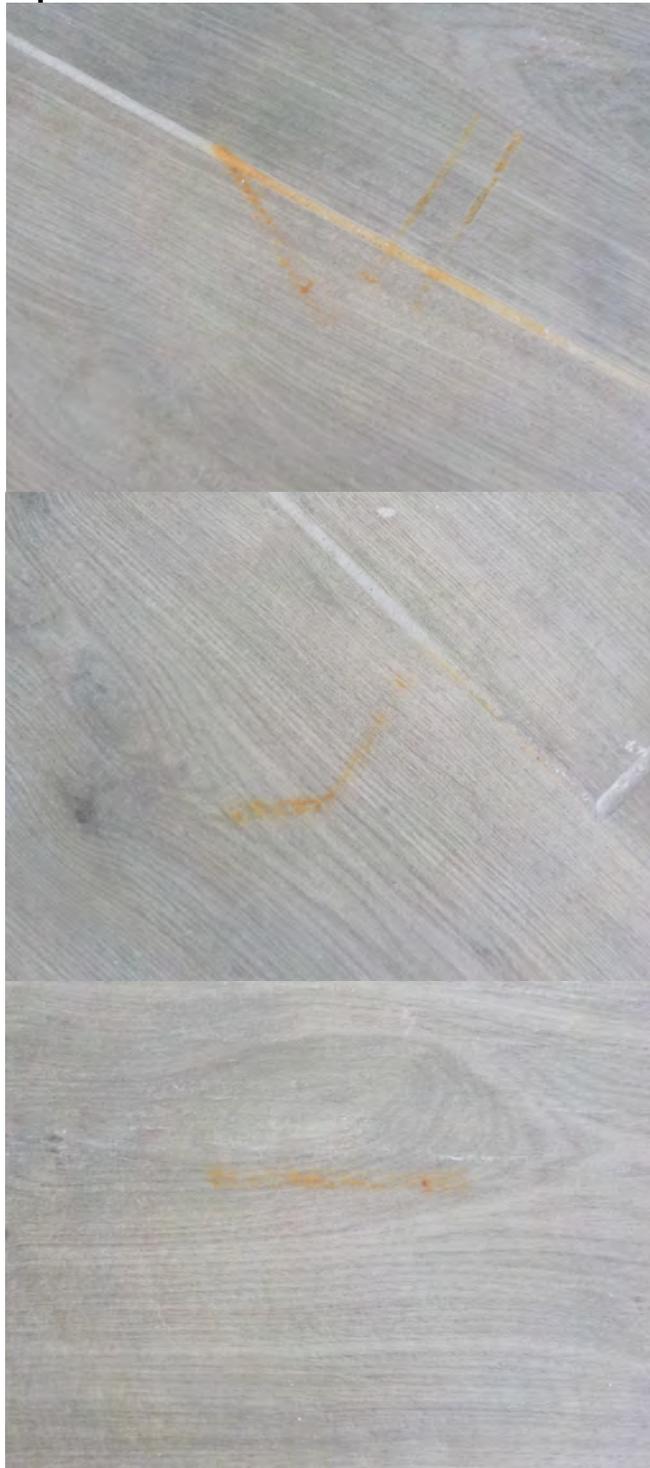
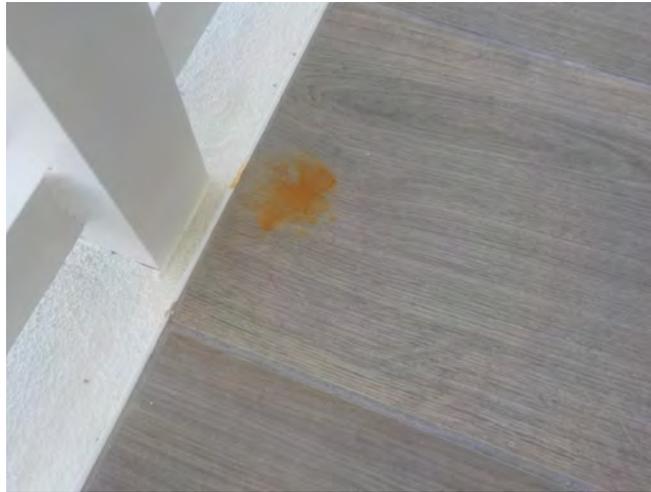
Deck

Review; Rust staining noted at some tiles. Rusted tiles should be replaced.

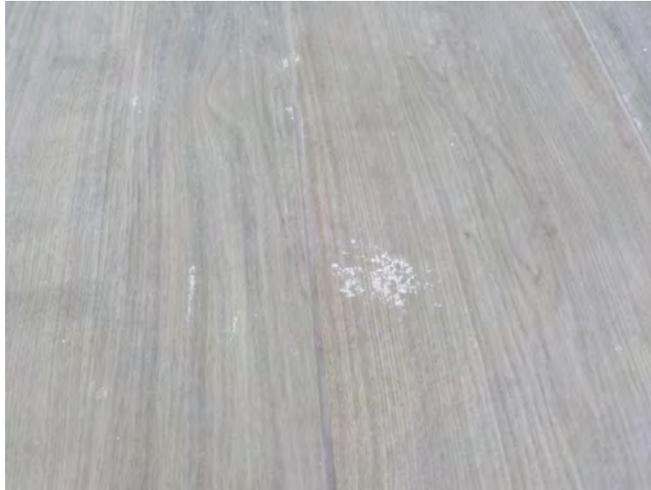
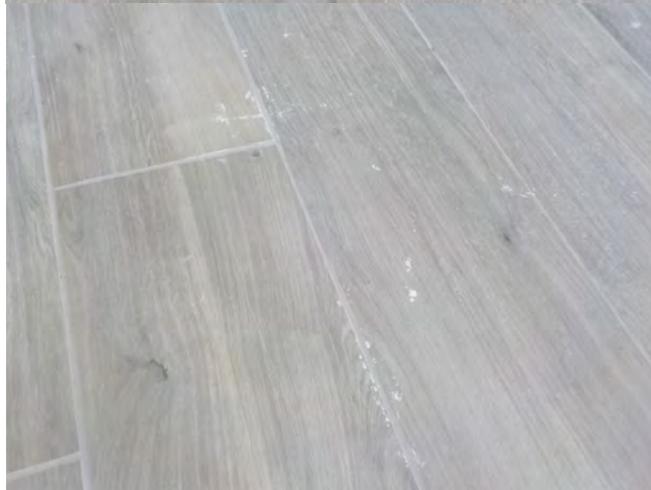
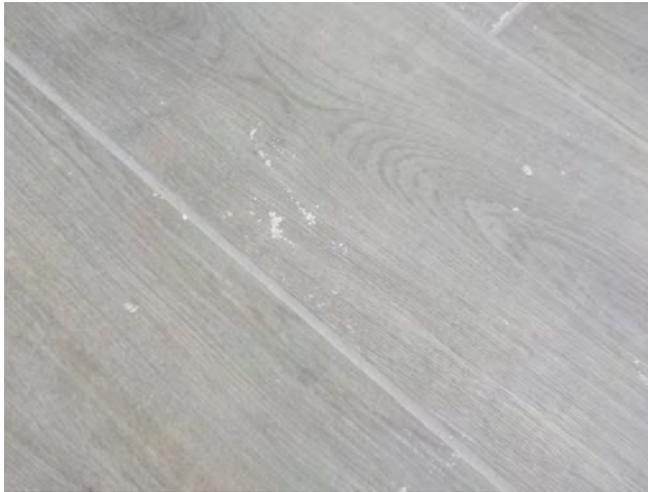
Review; Construction debris noted tiles. Proper cleaning required.

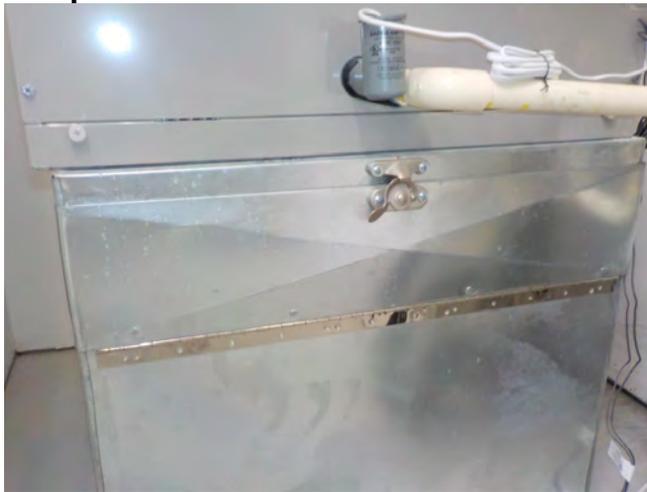
Filter

Review; Located at the unit. Builder to replace filters after repairs completed in the home.

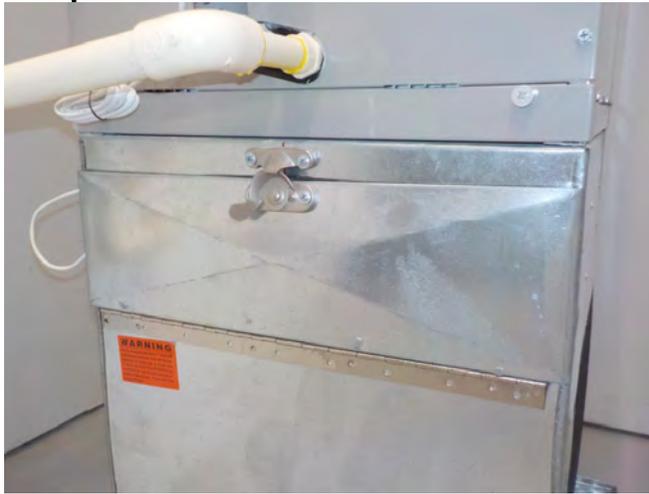
Filter

Review; Located at the unit. Builder to replace filters after repairs completed in the home.

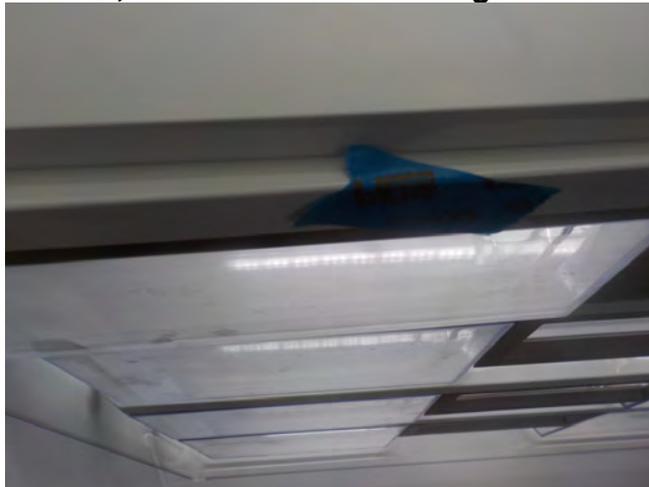
Refrigerator

Review; One drawer inside fridge does not operate properly.

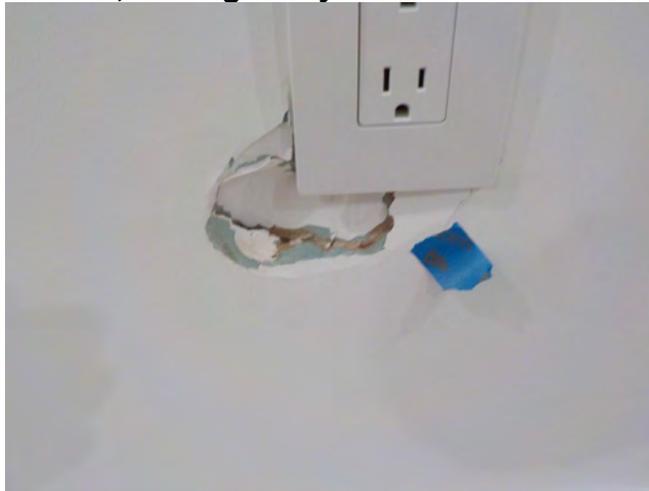
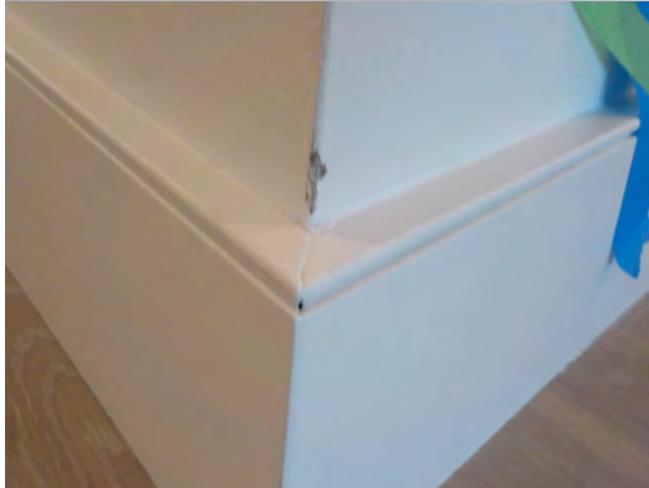
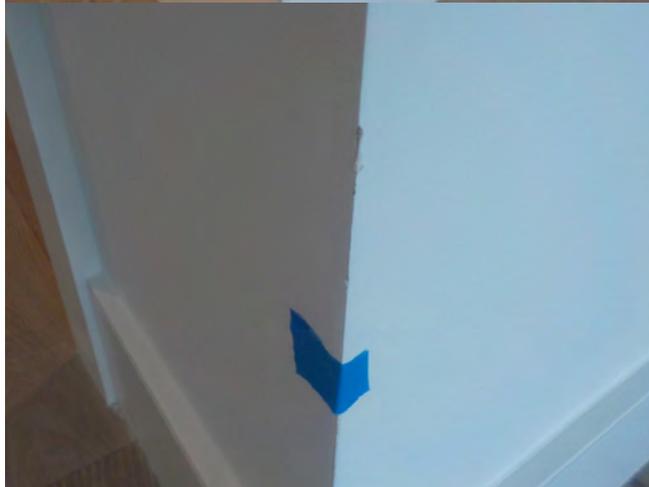
Review; Damaged drywall noted.

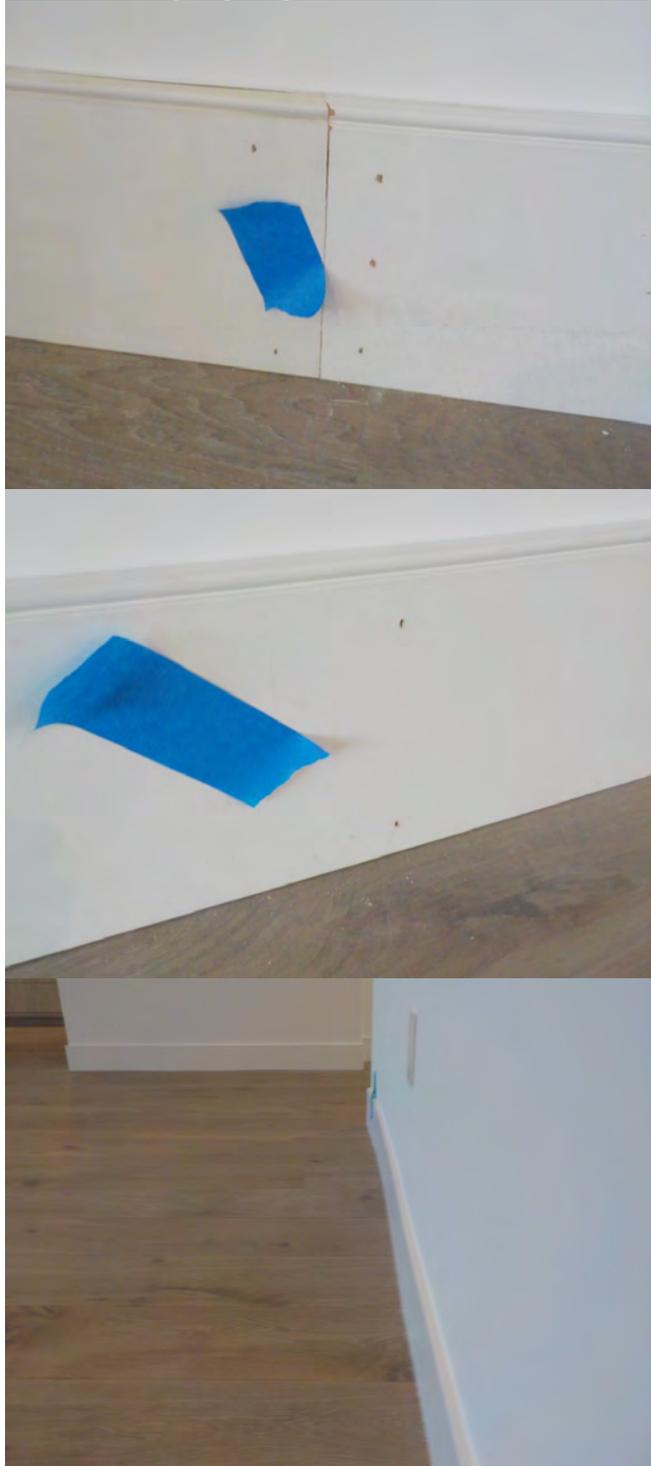
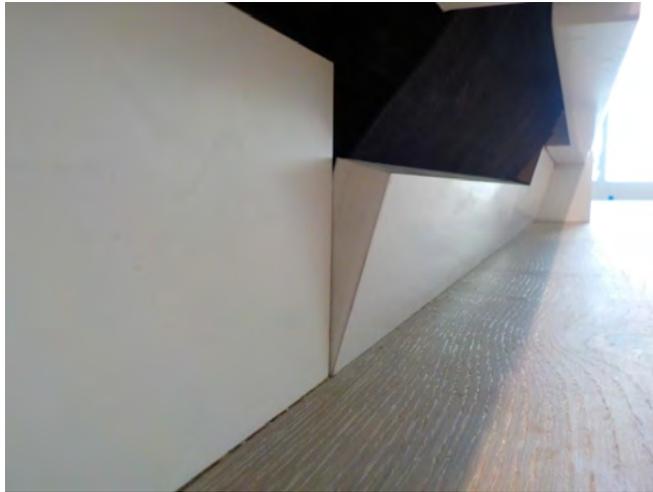
Review; Improperly finished, and bowed trim noted at some locations.

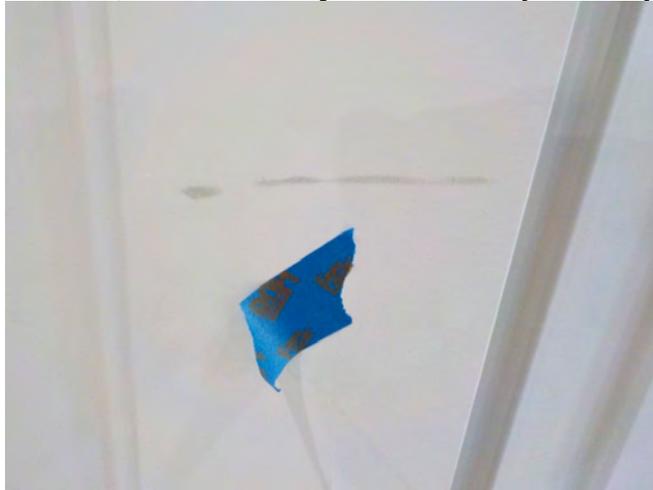
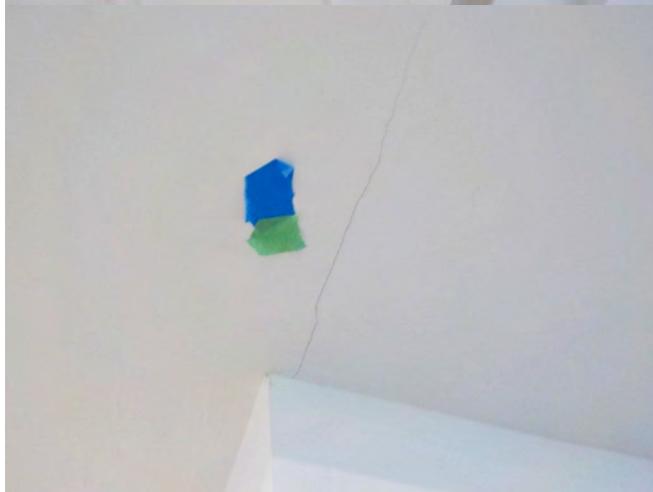
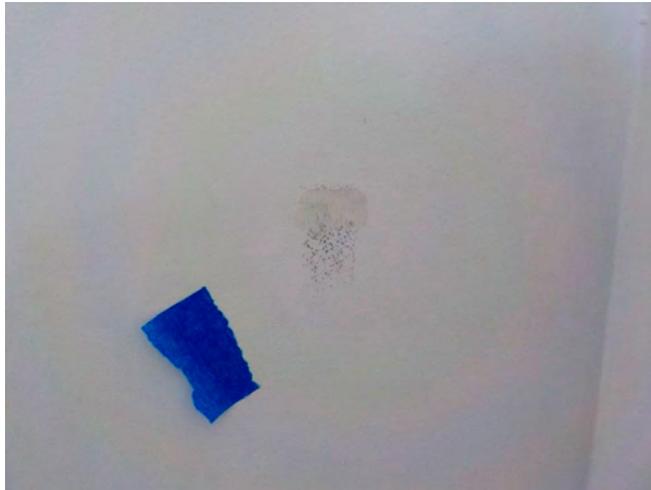
Review; Paint and drywall touch up incomplete.

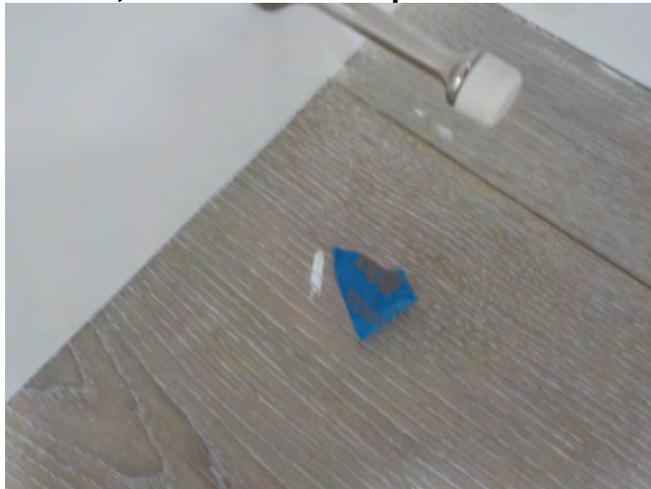
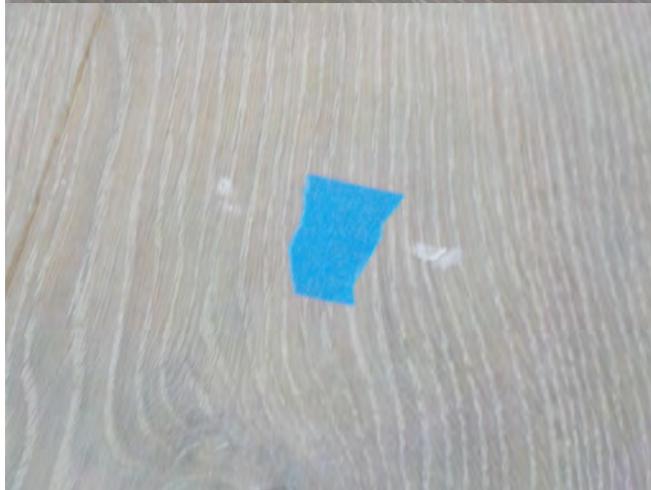
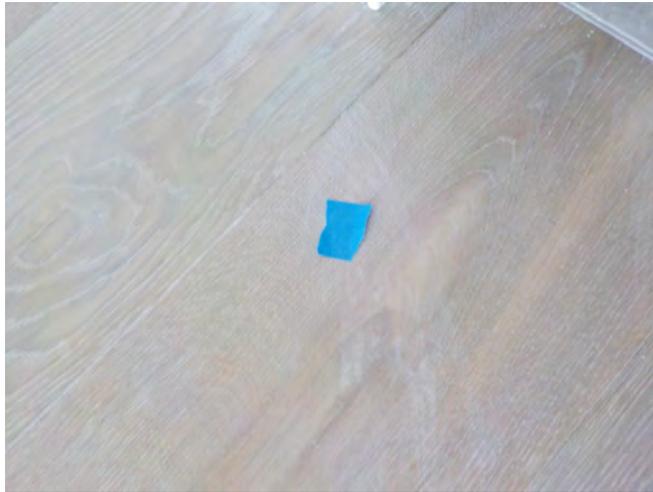
Review; Paint and debris present on flooring throughout the home.

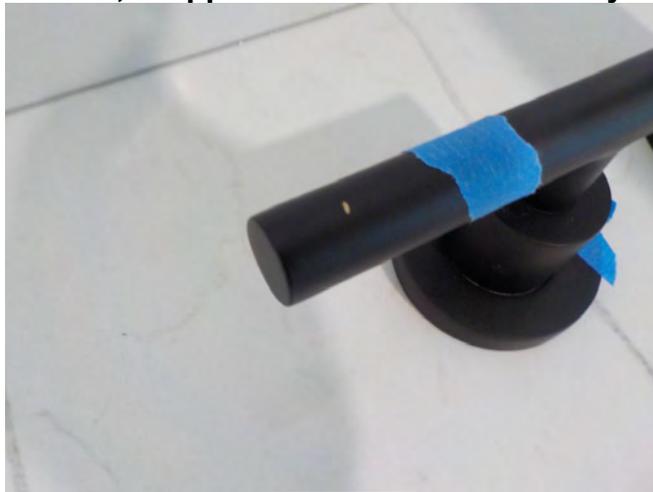
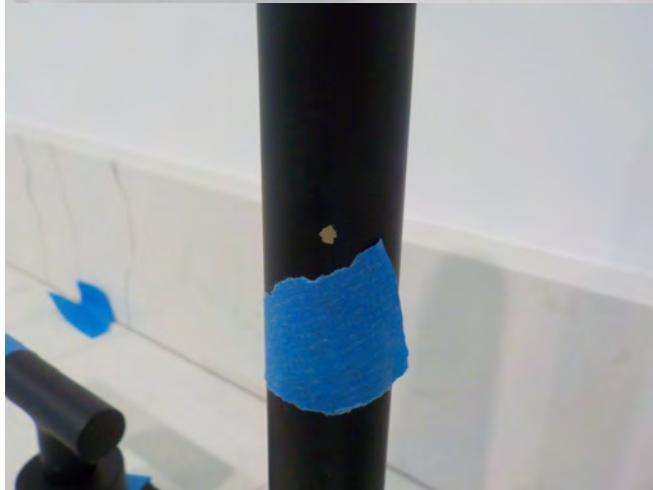
Review; Chipped finishes noted at vanity hardware.

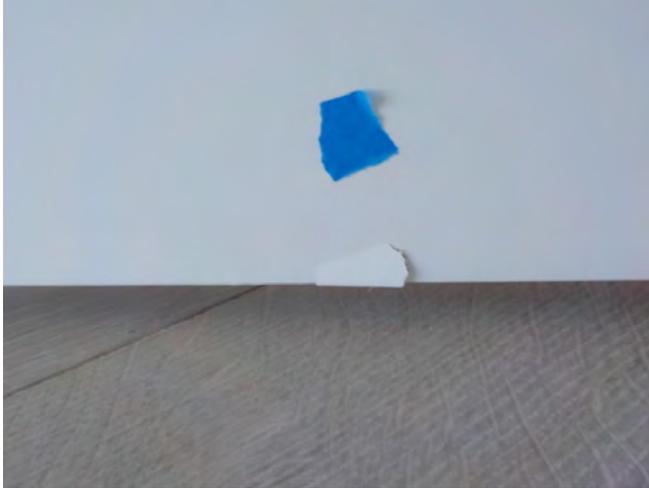
Review; Nicks and damage to wood trim and doors noted.

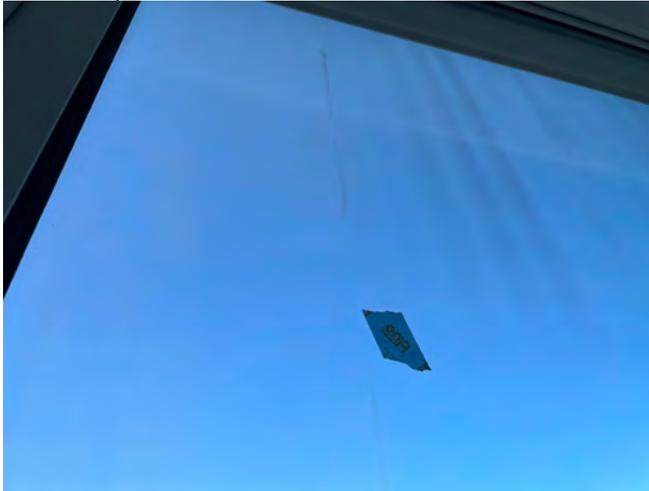
Review; Paint/construction debris on windows.

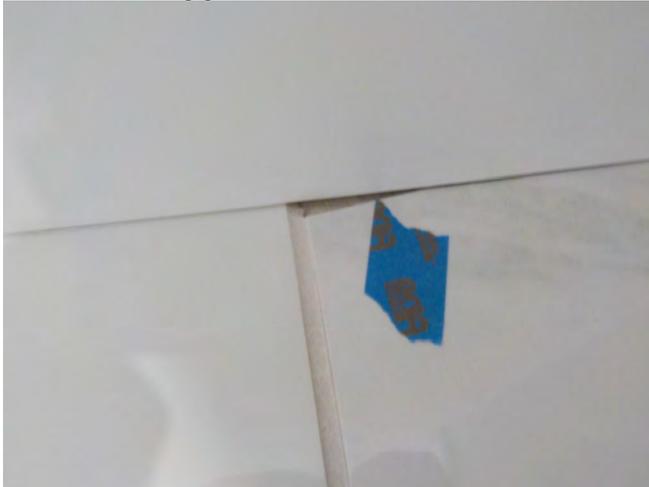
Review; Chipped tile noted at Master Bathroom.

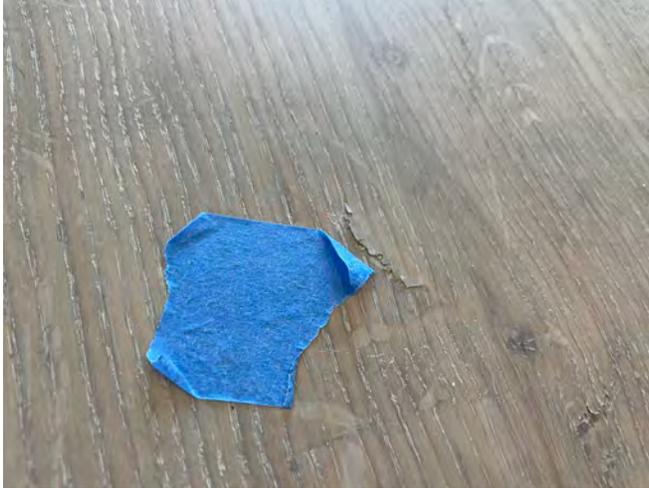
Review; Damaged wood flooring noted at Family Room.
