## SUMMARY REPORT

Doc #: 2509-003 Inspection Date: 9/9/2025

Dwelling Address: XXXX Cedar Hammock Circle #714, Naples, FL 34112

## HAZELBAKER INSPECTION SERVICES

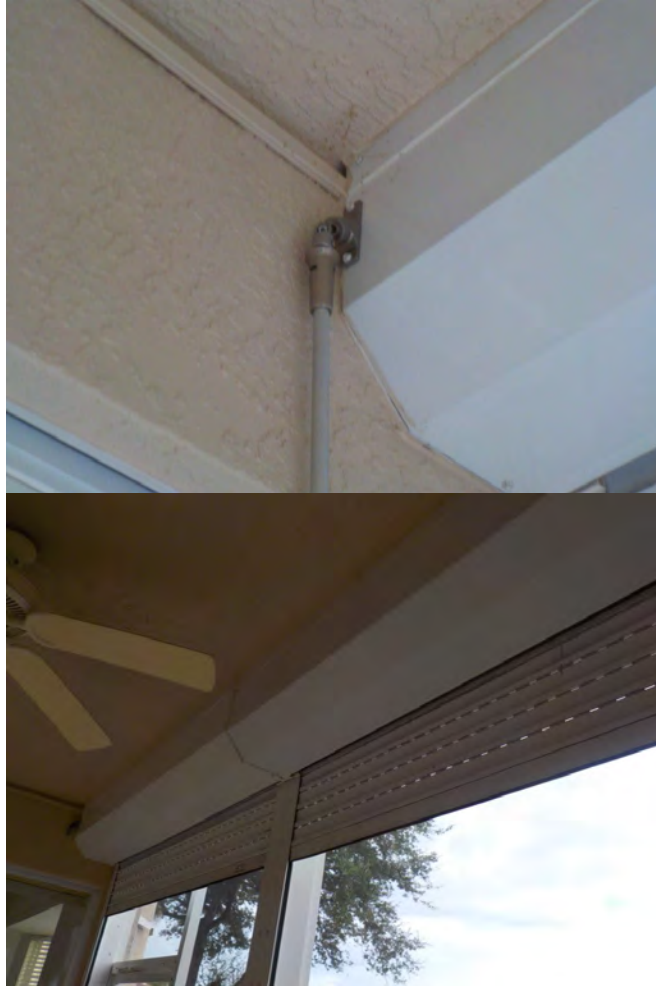
1116. Shutters

**Review; Loose bracket noted at crank for roll down shutter at lanai. Shutter is difficult to operate. Suggest service.**

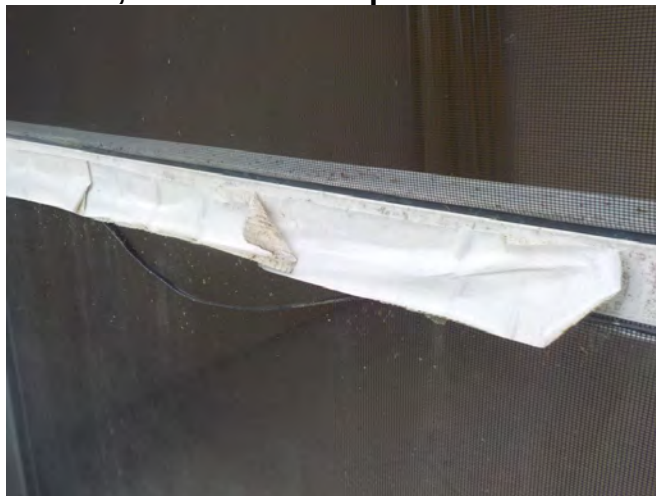
1203. Enclosure

**Review; Loose screen/spline noted at rear side lanai area.**

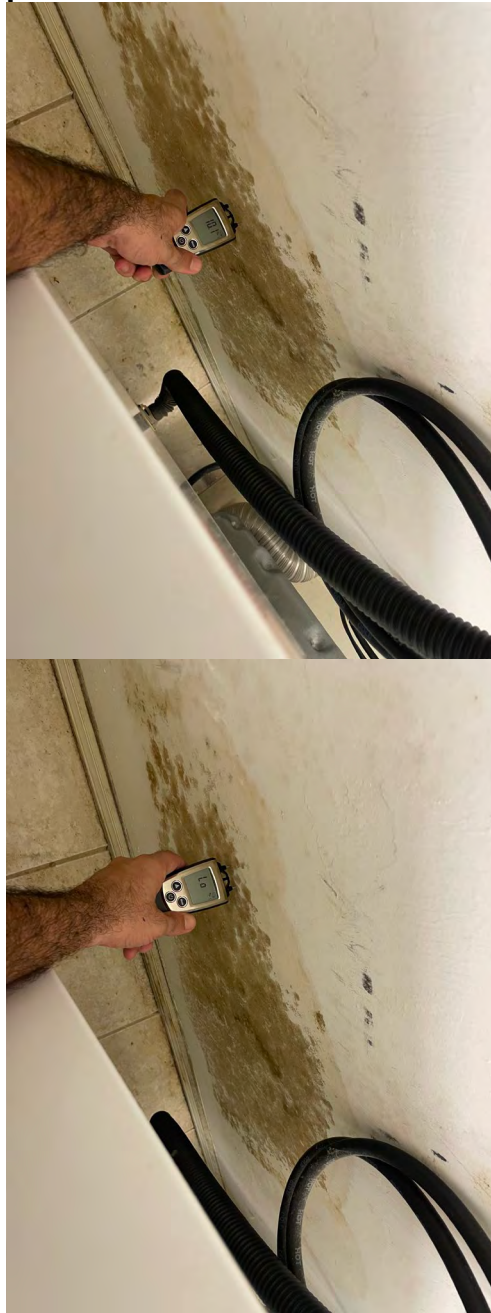
1602. Walls

**Review; Staining consistent with possible mold growth noted at laundry room wall behind washing machine. Area was dry at time of inspection. Suggest review of mold air quality test performed on 9/9/2025.**

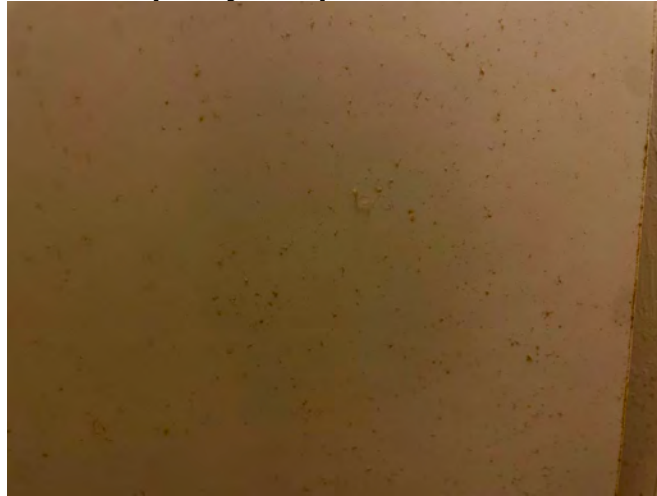
1604. Interior Doors

**Review; Wood bi-fold. Staining consistent with possible mold growth noted at backside of bi-fold doors. Suggest review of mold air quality test performed on 9/9/2025.**

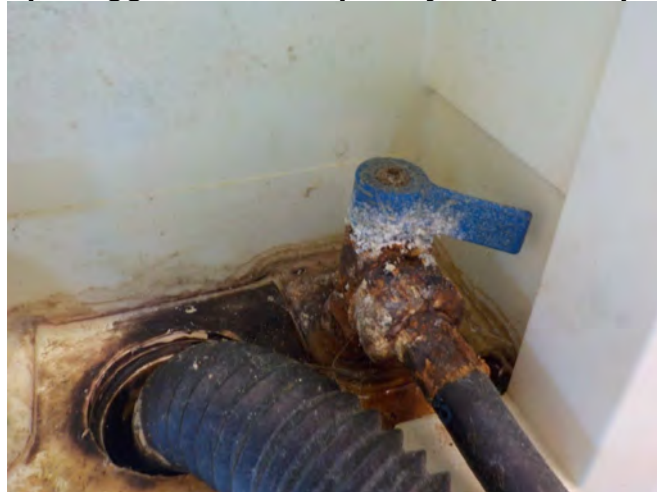
1610. Washer & Hook-ups

**Review; Leak noted at cold water supply valve at washer hook up. Suggest review/repair by a qualified plumber.**

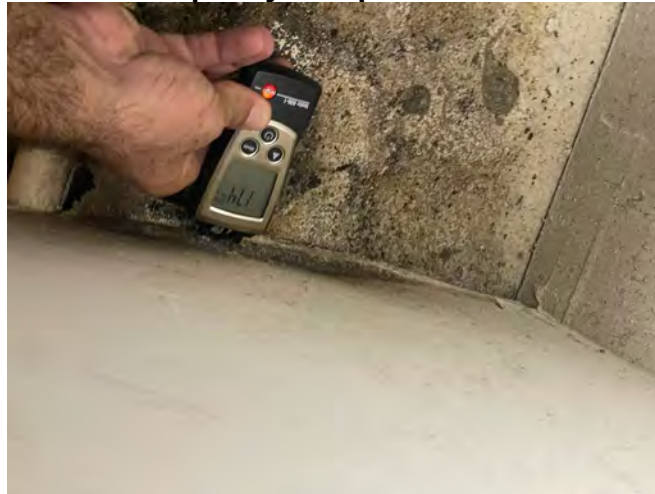
1801. Heating

**Review; Staining consistent with possible mold growth noted at right side wall inside air handler closet. Area had slightly elevated levels of moisture at time of inspection. Suggest review of mold air quality test performed on 9/9/2025.**

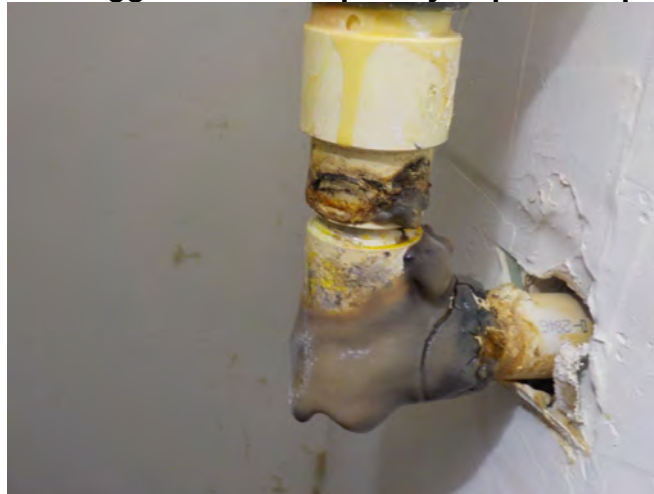
1903. Supply Pipes

**Review; Leak noted at supply connection at main water shut off. Suggest review/repair by a qualified plumber.**

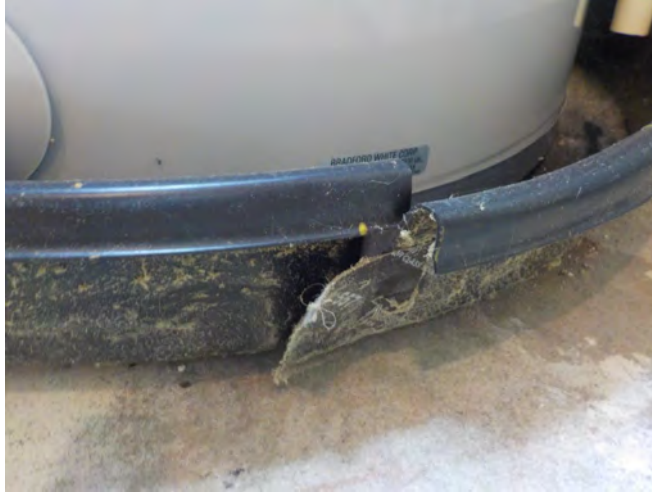
1908. Water Heater  
Manufacturer

**Review; Damaged overflow pan noted for water heater.**

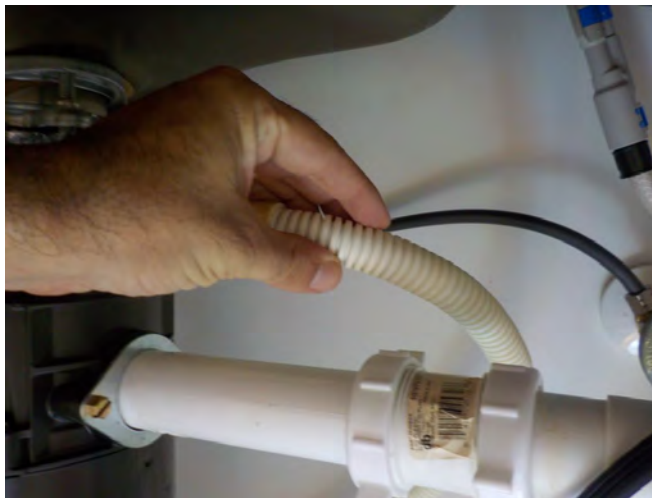
2114. Dishwasher

**Review; No loop in drain line at dishwasher. A loop in drain line is required to prevent dirty drain water from entering the dishwasher.**

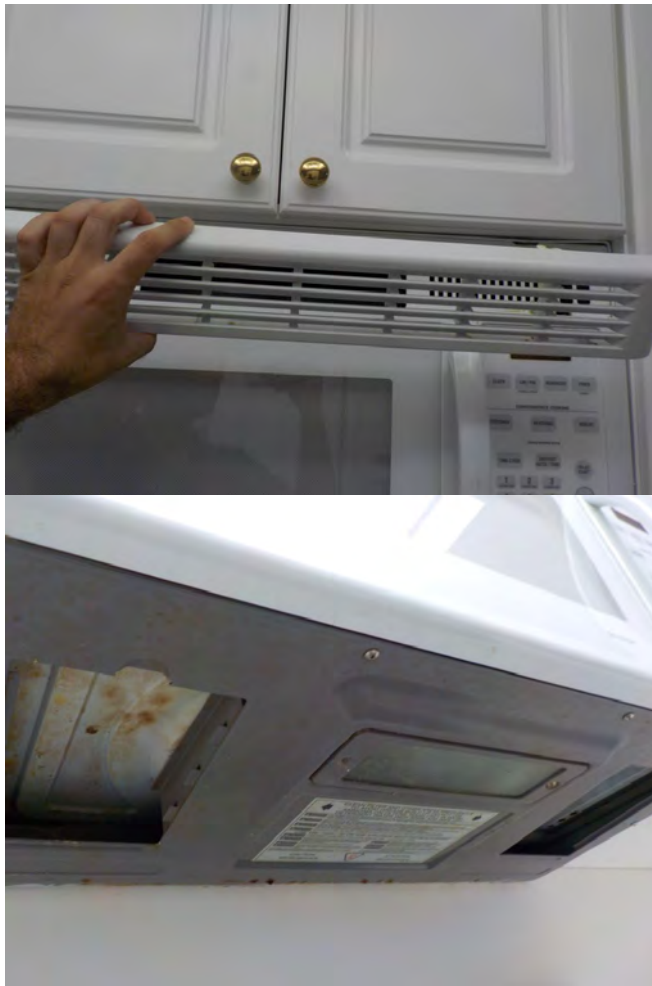
2118. Microwave

**Review; Damaged clips/detached cover noted at microwave exhaust fan. Missing filter screens noted at underside of microwave.**

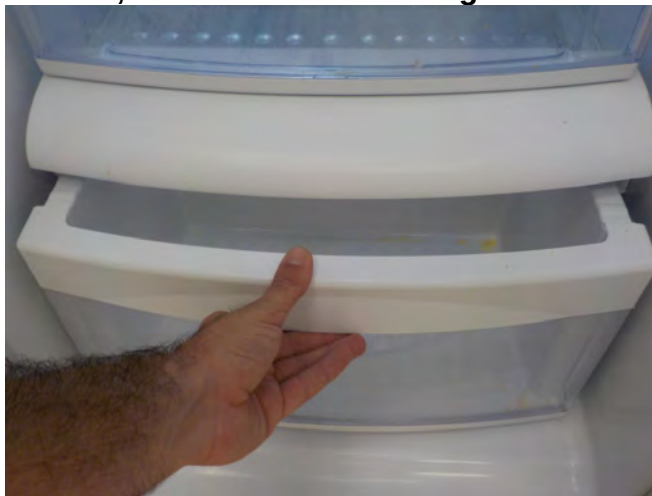
2119. Refrigerator

**Review; Bottom drawer at fridge does not operate properly.**

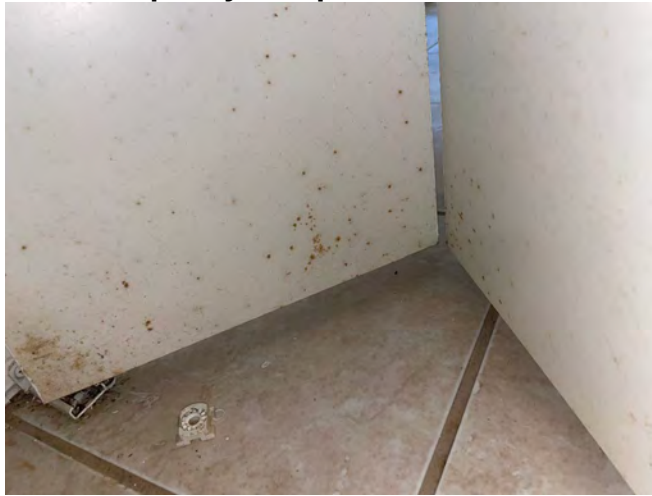
2124. Closet

**Review; Wood-fold. Staining consistent with possible mold growth noted at backside of bi-fold doors. Suggest review of mold air quality test performed on 9/9/2025.**

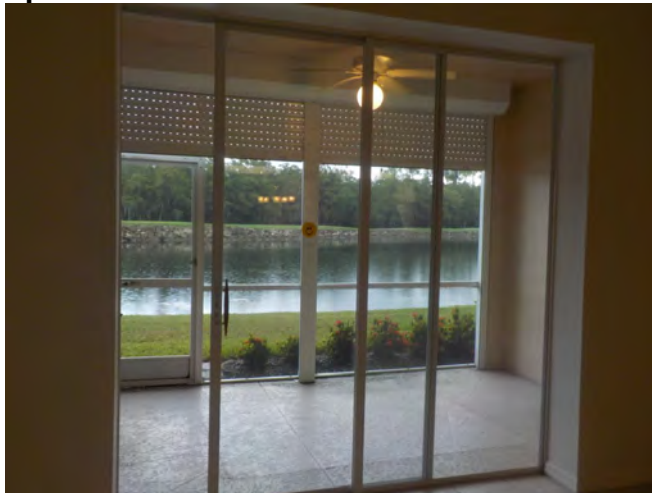
2205. Exterior Doors

**Review; Aluminum sliding glass. Suggest service for smoother operation.**

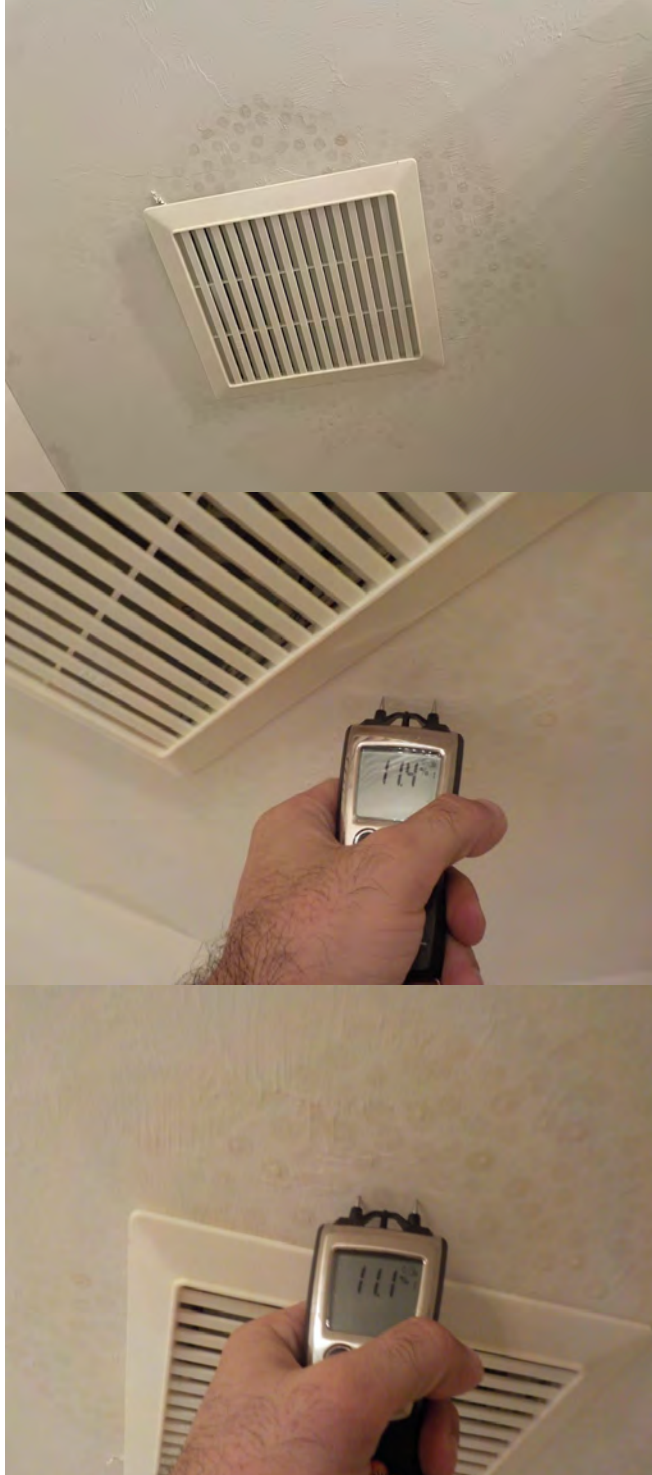
2703. Ceiling

Review; Stain noted at master bathroom exhaust vent. Origin of staining unknown. Area was dry at time of inspection. Suggest monitoring.

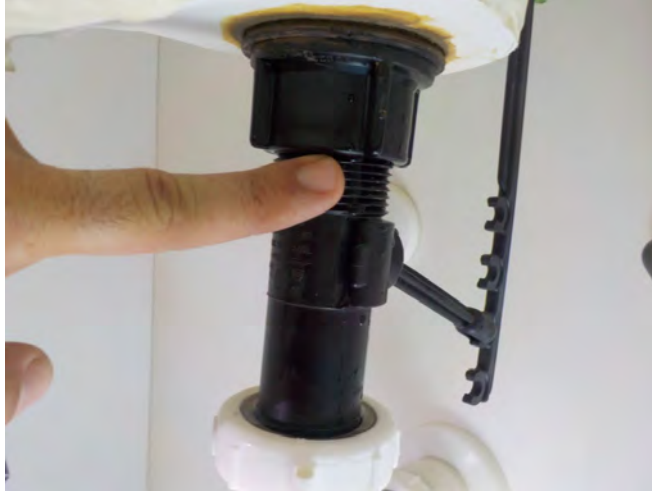
2719. Traps/Drain  
/Supply

**Review; Leak noted at top of drainpipe underneath right side sink. Suggest review/repair by a qualified plumber.**

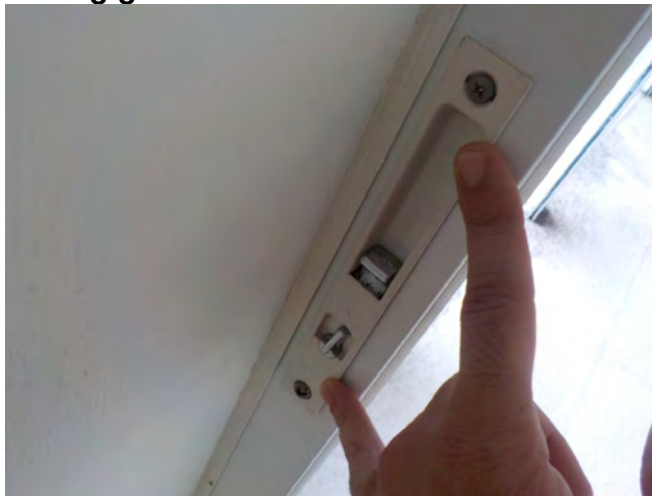
2905. Exterior Doors

**Review; Aluminum sliding glass. Loose lock hardware noted at sliding glass door.**

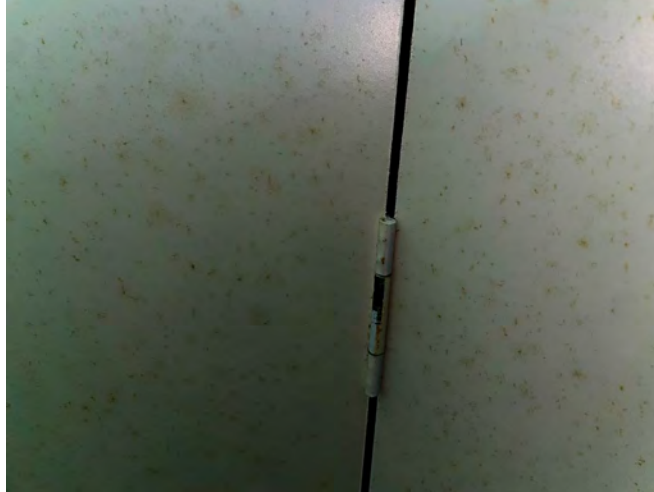
2910.2. Closet

**Review; Wood-fold. Staining consistent with possible mold growth noted at backside of bi-fold doors. Suggest review of mold air quality test performed on 9/9/2025.**
