## FULL PROPERTY INSPECTION REPORT

Doc #: 2508-003 Inspection Date: 8/8/2025

Dwelling Address: XXXXX Vanderbilt Drive, Naples, FL 34108

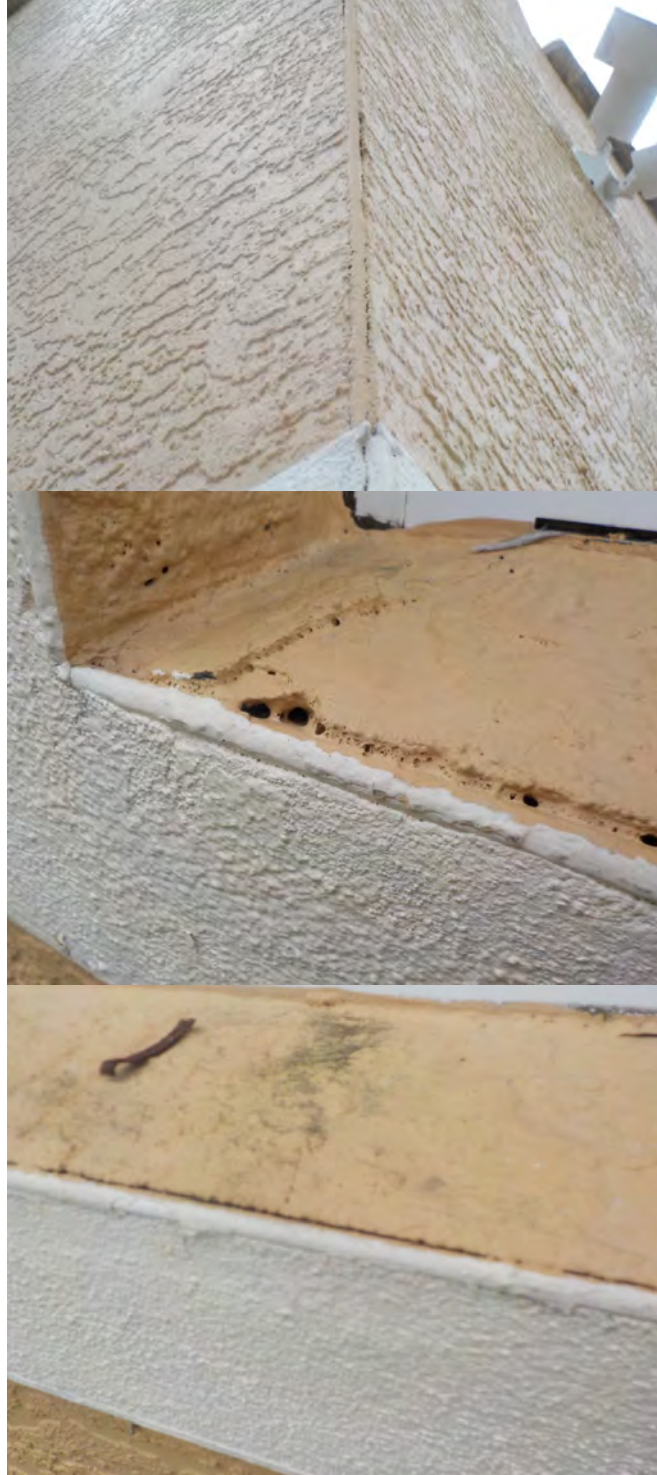
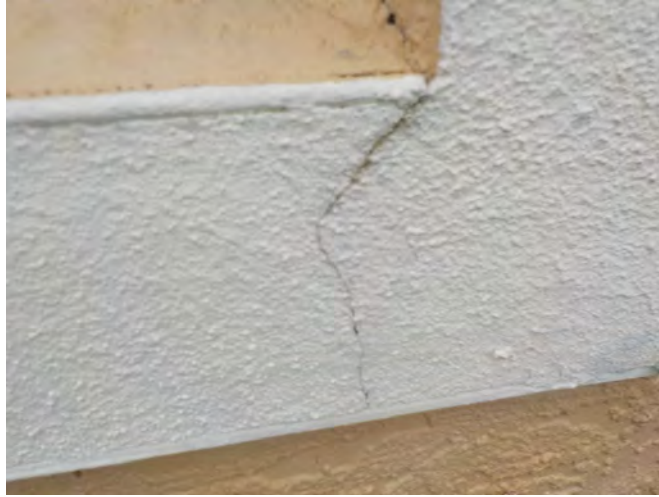
**Review; Common cracking noted at stucco at multiple areas. Suggest sealing to prevent moisture and insect intrusion.**

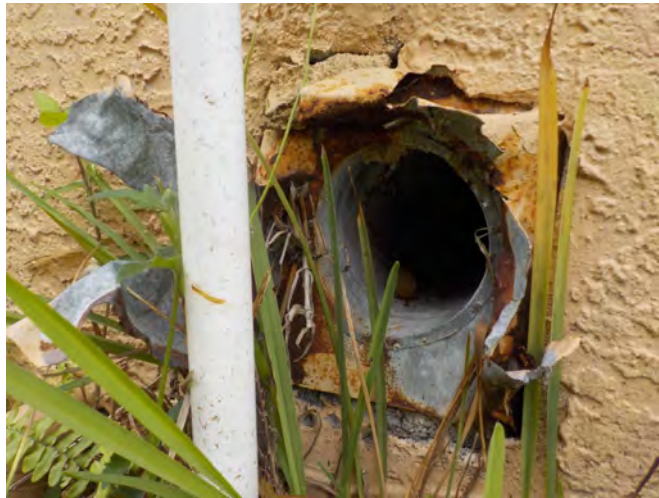
**Review; Missing cover noted at dryer vent termination at left side of home.**

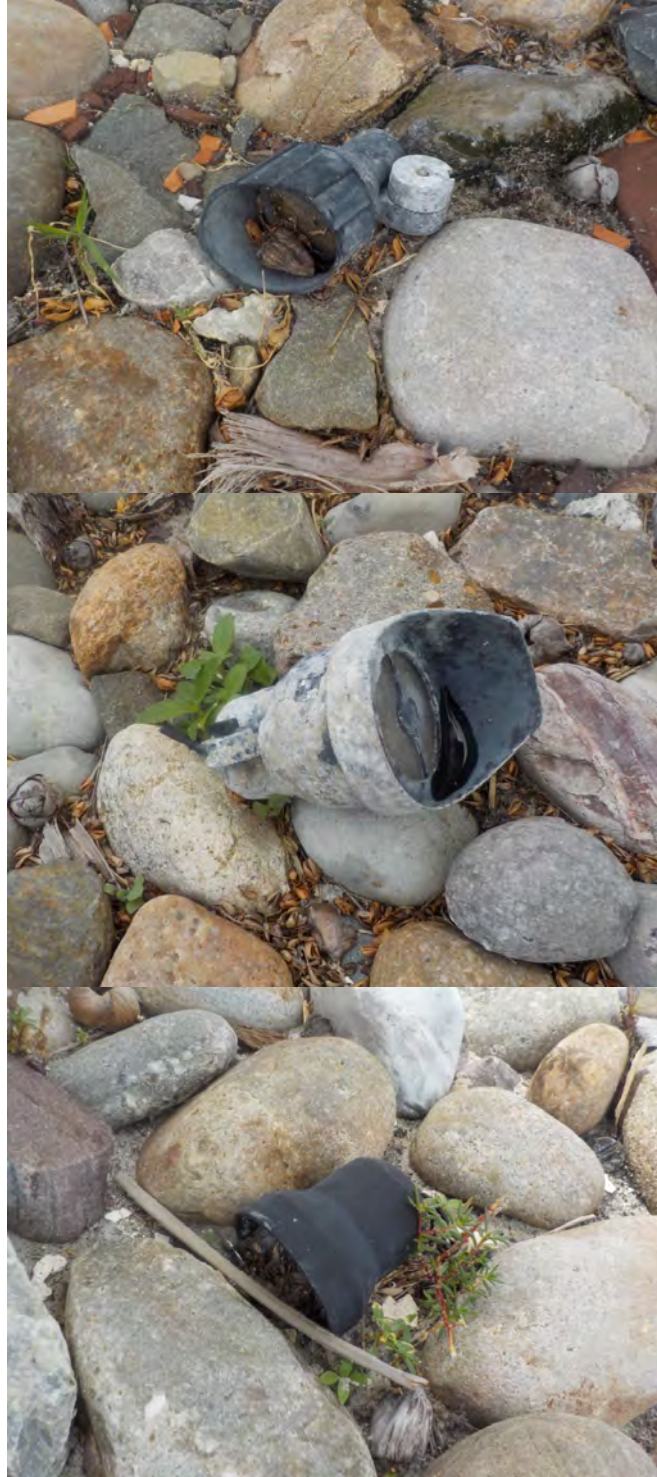
**Review; Landscape lighting system is not functional. Damaged lights noted.**

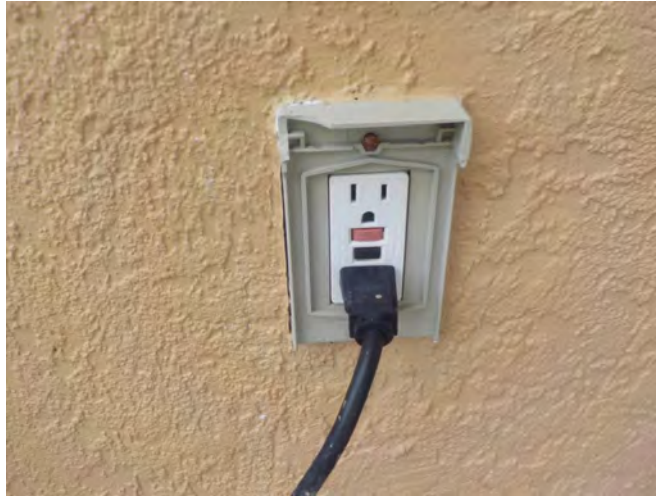
**Review; Missing weather cover noted at outlet at rear side of home.**

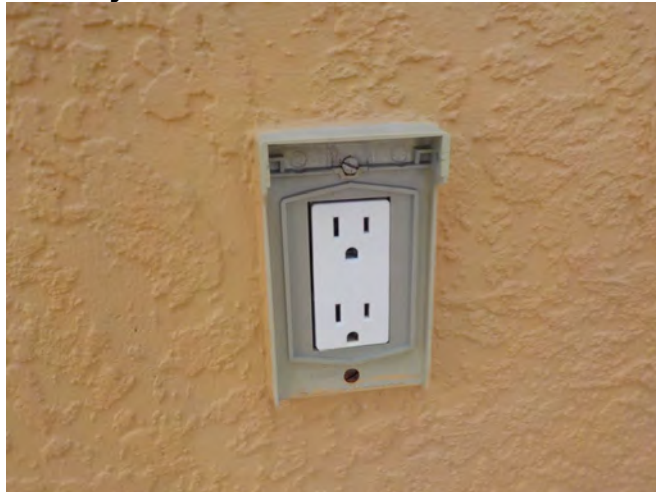
**Review; Missing weather cover noted at outlet at 2<sup>nd</sup> floor balcony area.**

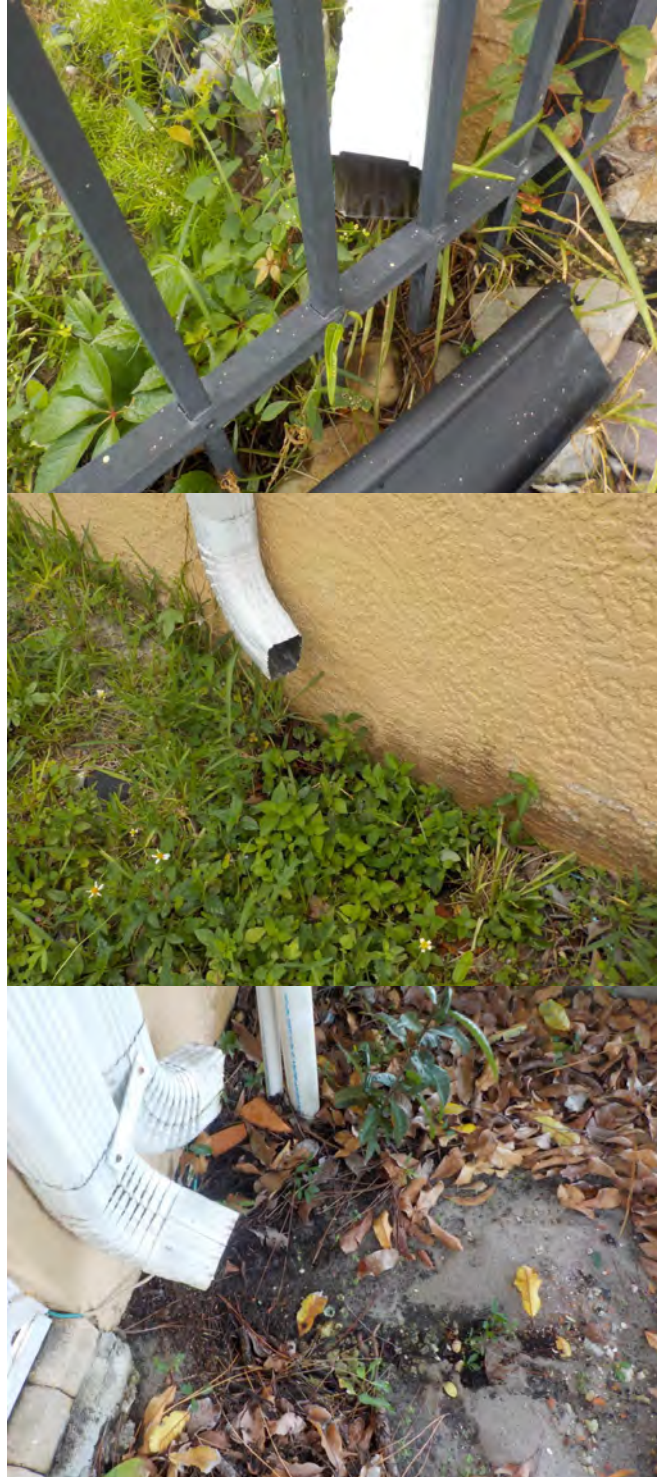
**Review; Missing splash blocks noted at multiple gutter downspouts. Erosion noted.**

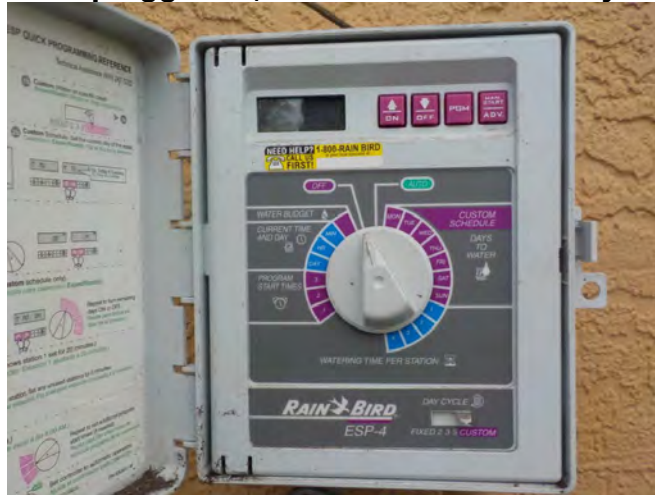
1110. Sprinkler System **Review; 4 Zones present. Irrigation system is not functional. System was unplugged at start of inspection. System had power once plugged in, but unable to manually start.**

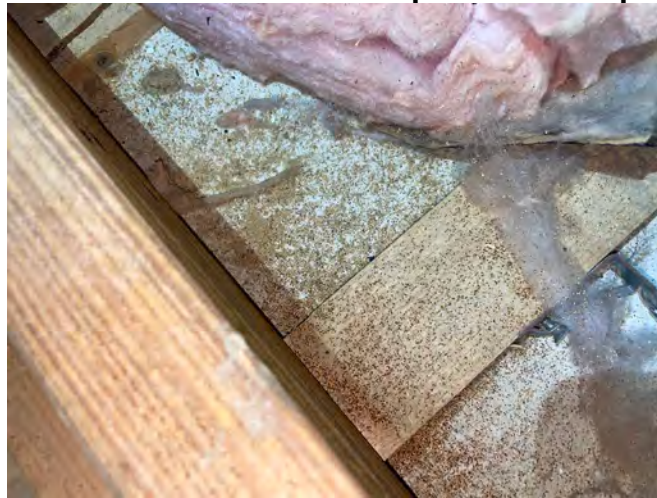
**Review; Signs of termite activity noted at upstairs attic area.  
Termite frass found near upstairs attic opening.**

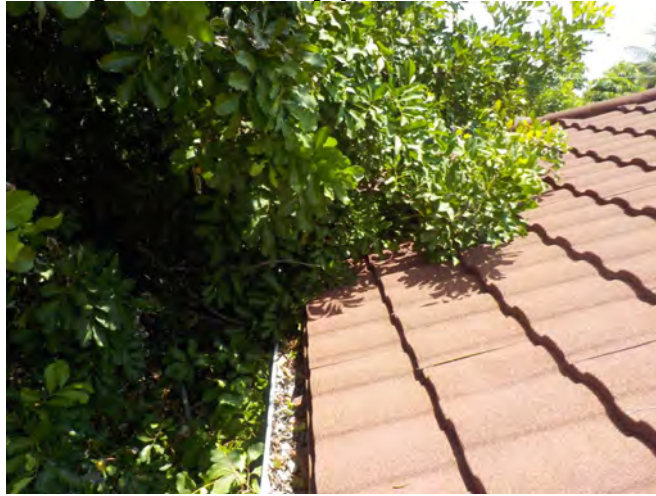
**Review; Suggest trimming or removing plantings to prevent damage or access by pests to roof area.**

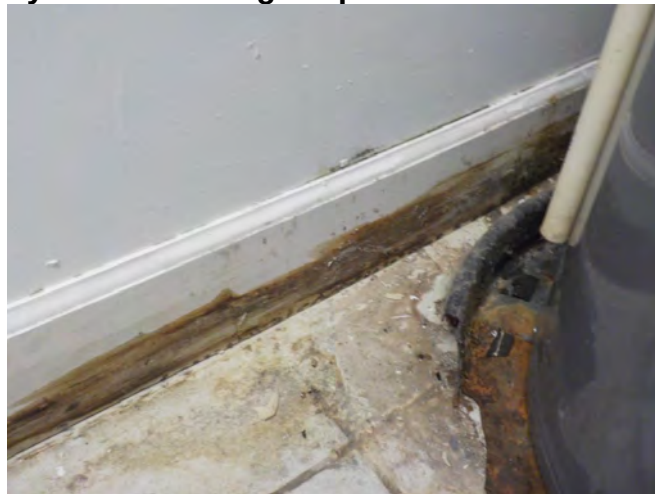
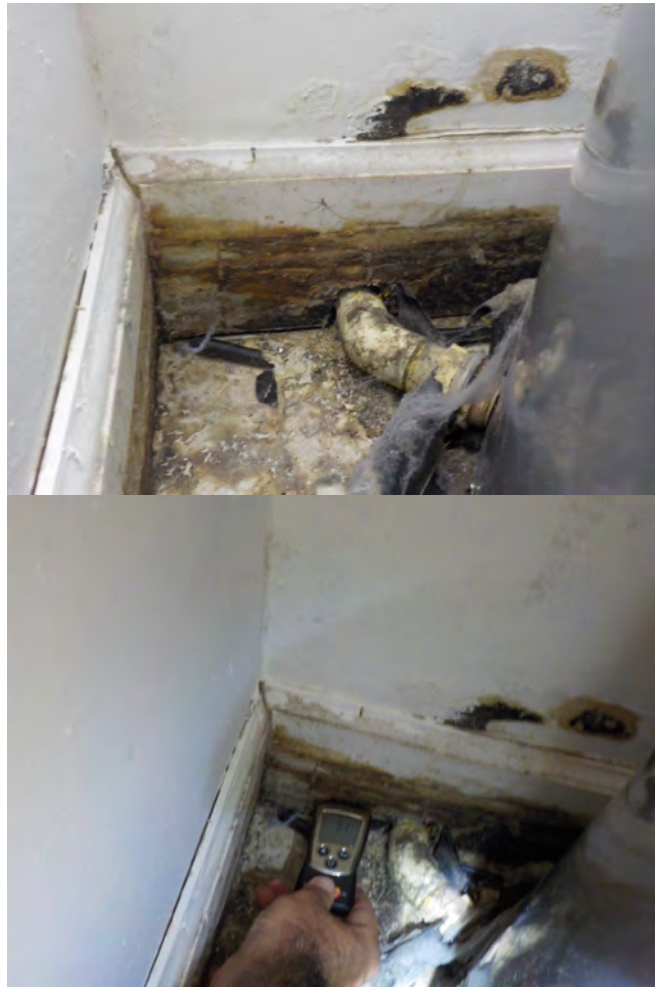
1602.   Walls

**Review; Water damage noted at baseboard behind water heater/dryer. Area was dry at time of inspection. Suggest review by a water damage expert.**

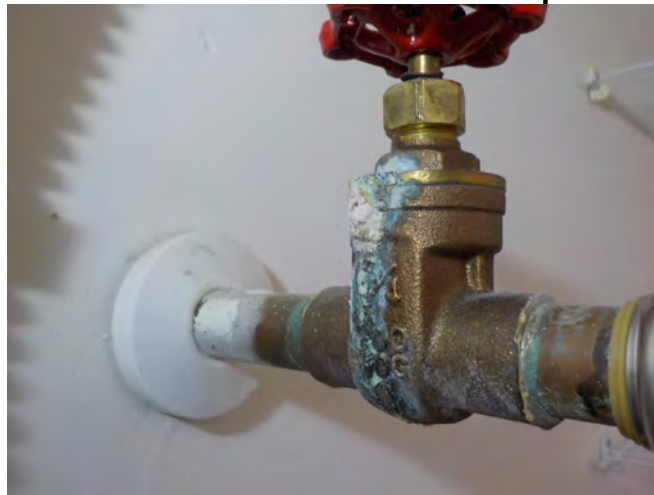
**Review; Corrosion noted at shut off valve at upstairs water heater. No active leak at time of inspection.**

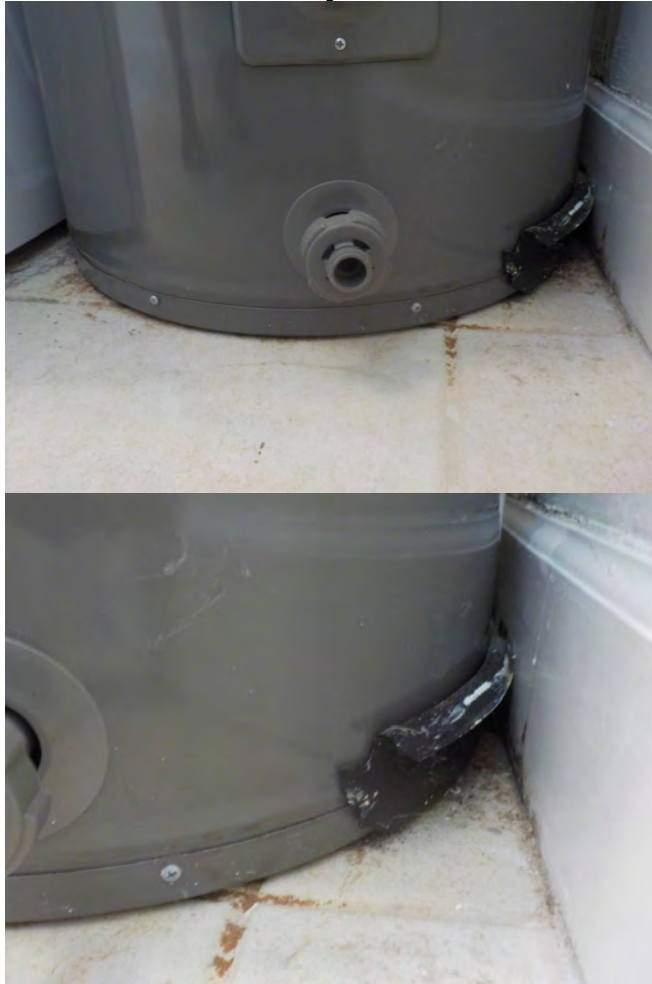
Review; Damaged/missing overflow pan noted at water heater located inside laundry room.

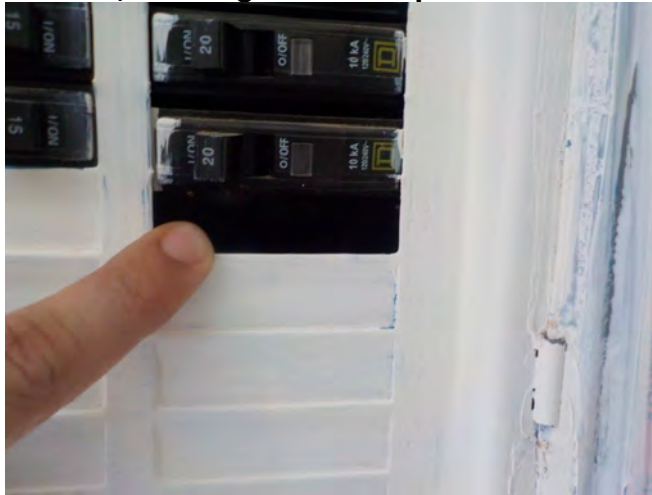
Review; Missing knockout panel noted at left side panel.

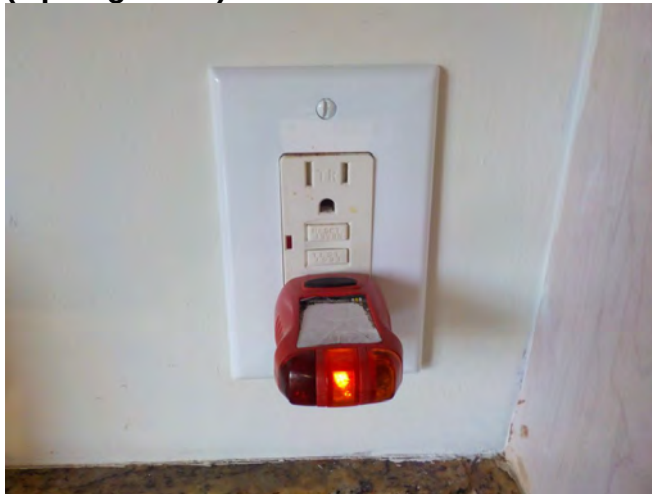
**Review; Improperly wired outlet noted at right side of stove.  
(Open ground).**

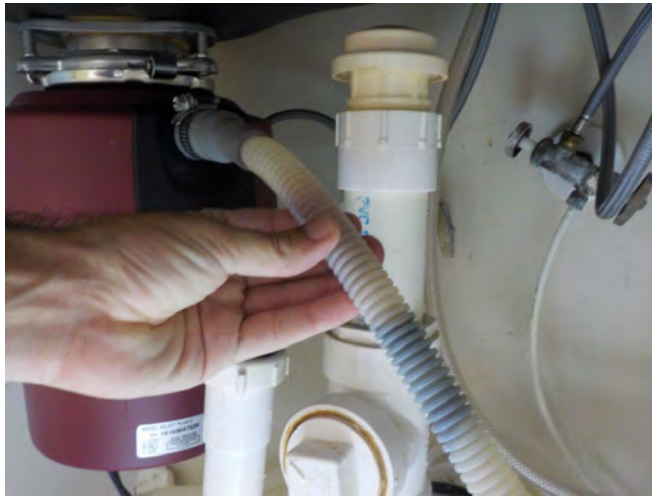
Review; No loop in drain line at dishwasher. A loop in drain line is required to prevent dirty drain water from entering the dishwasher.

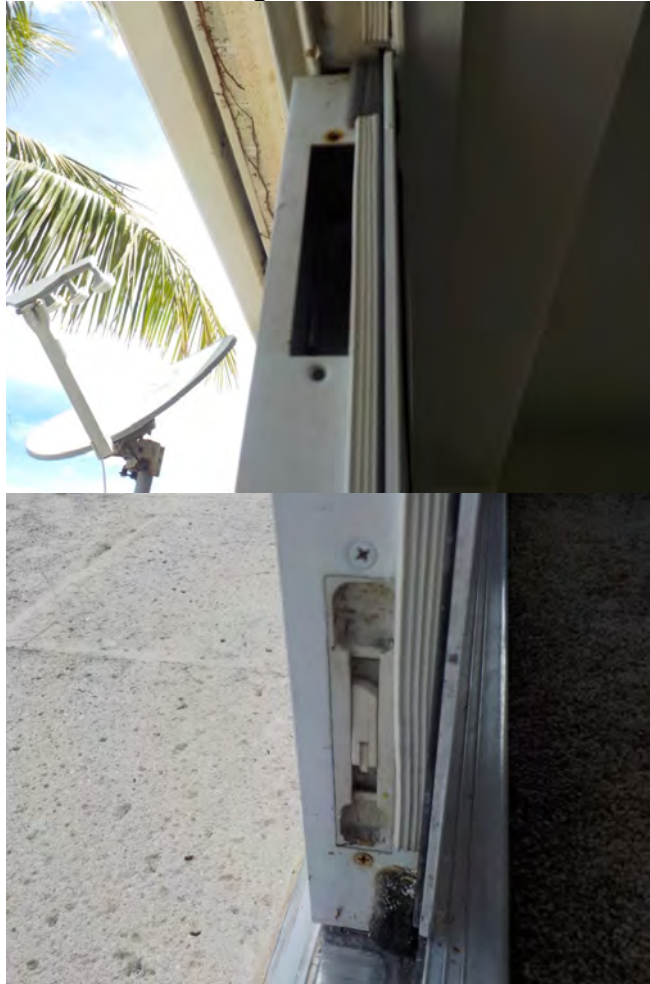
2305. Exterior Doors **Review; French Metal/Glass. Missing soffit strike noted at fixed side door. And damaged sill strike noted at fixed side door.**

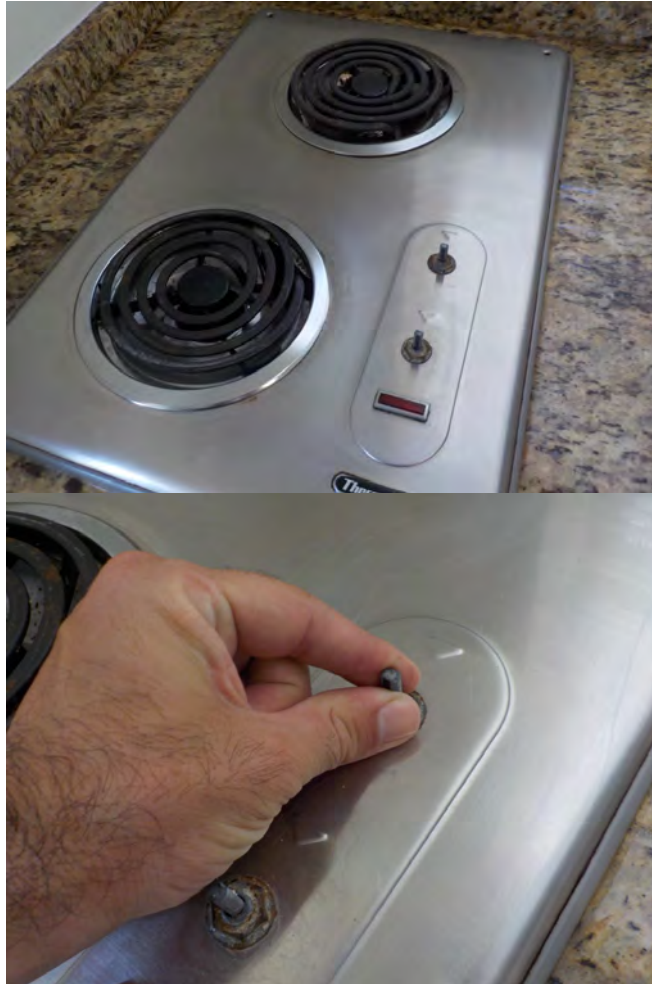
Review; Kitchenette stovetop is not functional. Missing knobs noted.

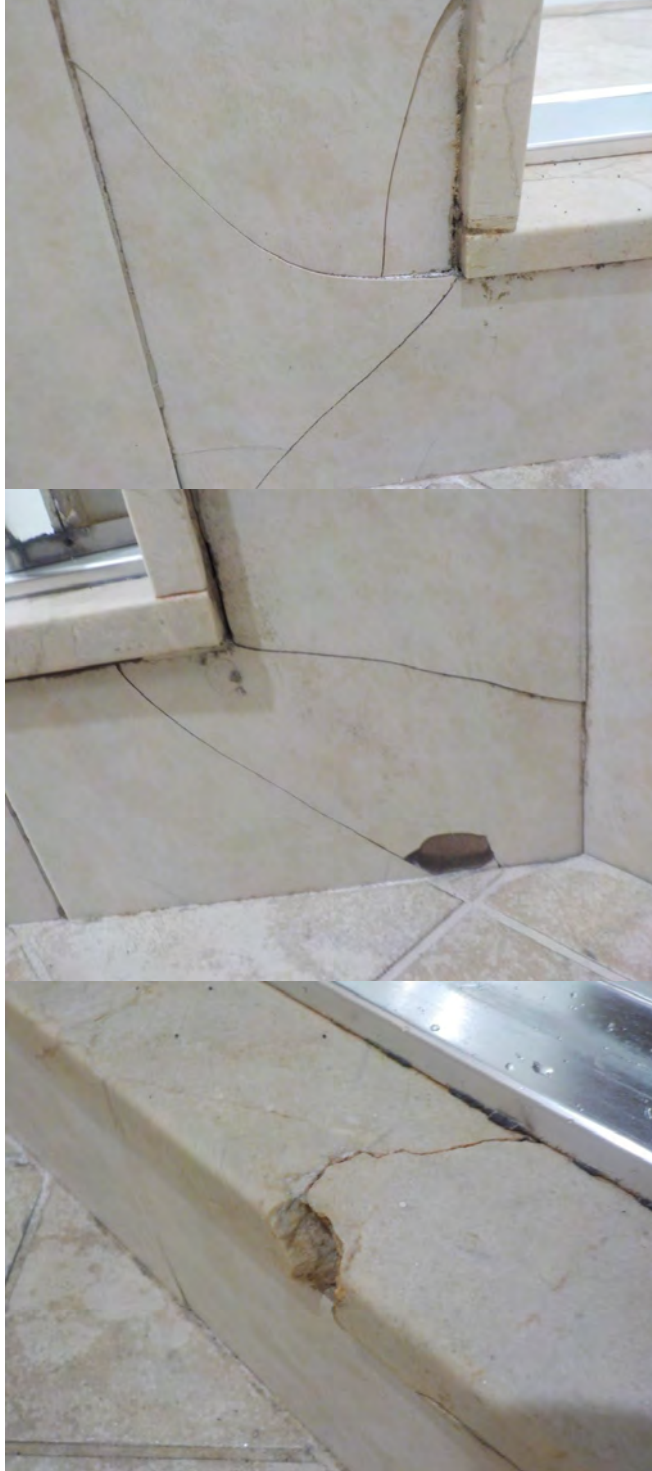
**Review; Tile. Cracked tiles and open grout joints noted. Suggest replacing grout or caulking to prevent future/further moisture penetration and damage/deterioration to interior walls. This damage is not always visible or accessible to the inspector at the time of inspection.**

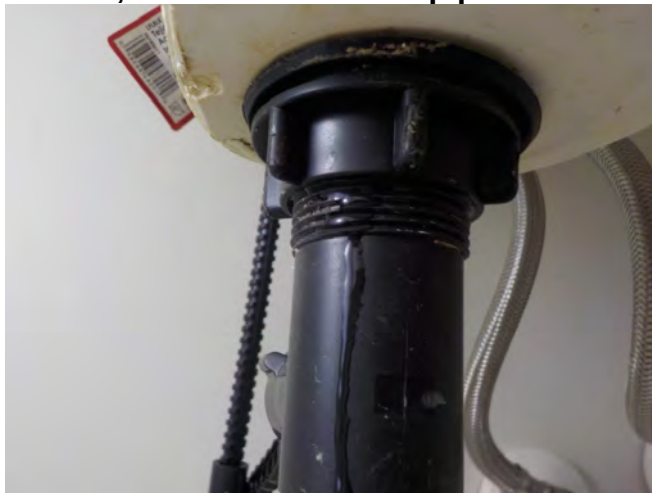
**Review; Leak noted at drainpipe underneath left side sink.**

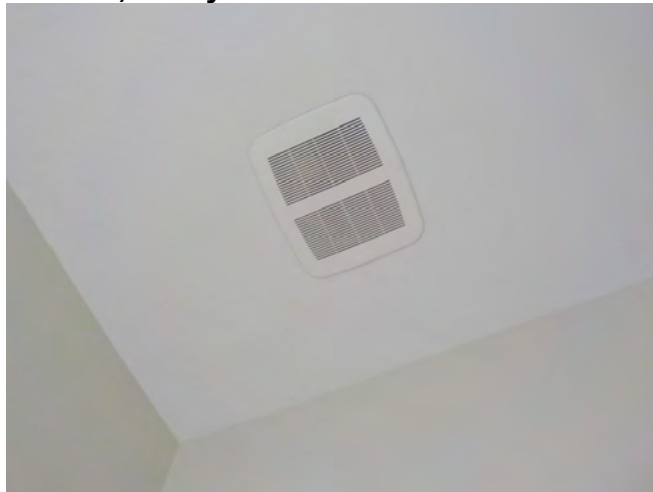
**Review; Noisy exhaust fan noted.**

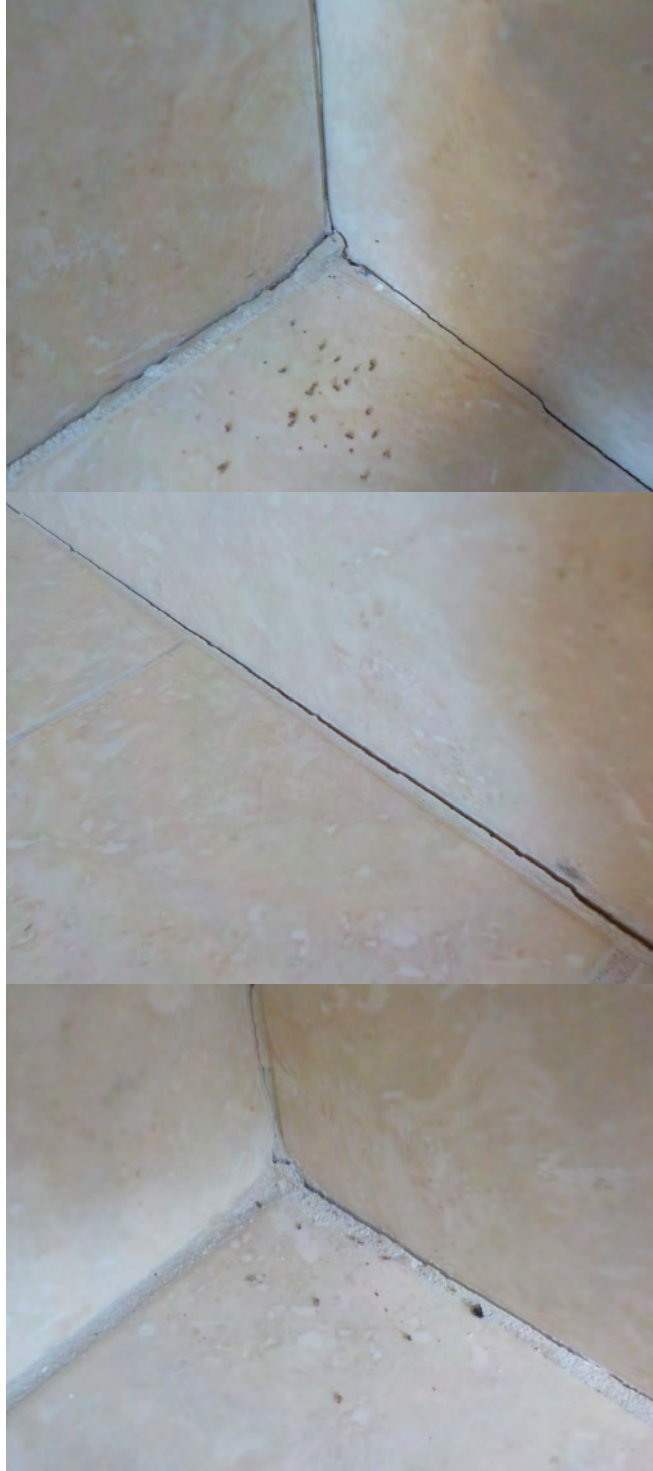
**Review; Tile. Open grout joints noted. Suggest replacing grout or caulking to prevent future/further moisture penetration and damage/deterioration to interior walls. This damage is not always visible or accessible to the inspector at the time of inspection.**

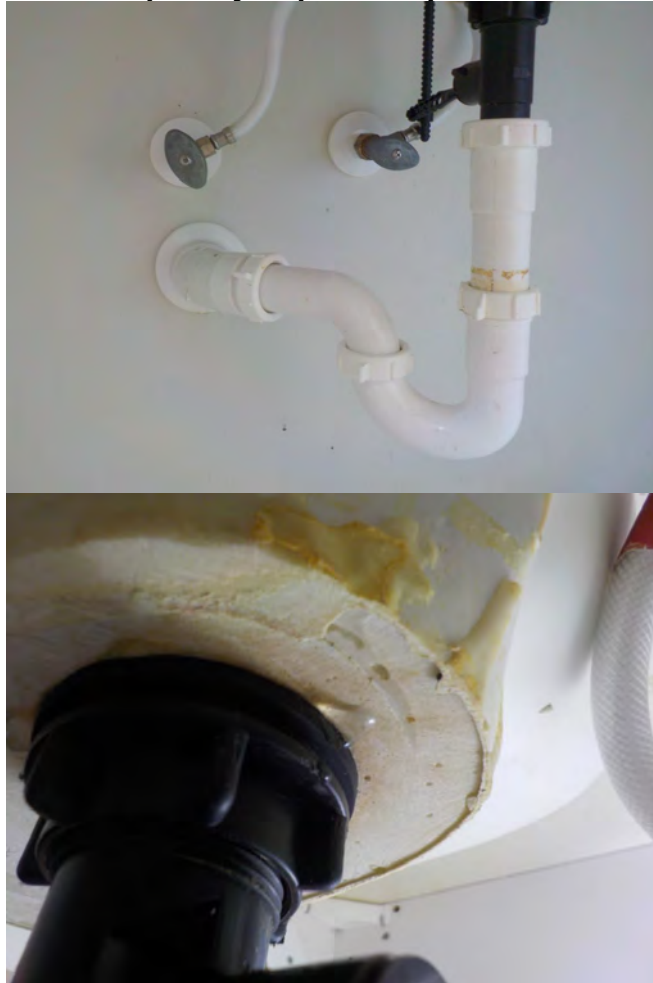
2819. Traps/Drain /Supply **Review; Leak noted at drainpipe underneath sink. Suggest review/repair by a qualified plumber.**

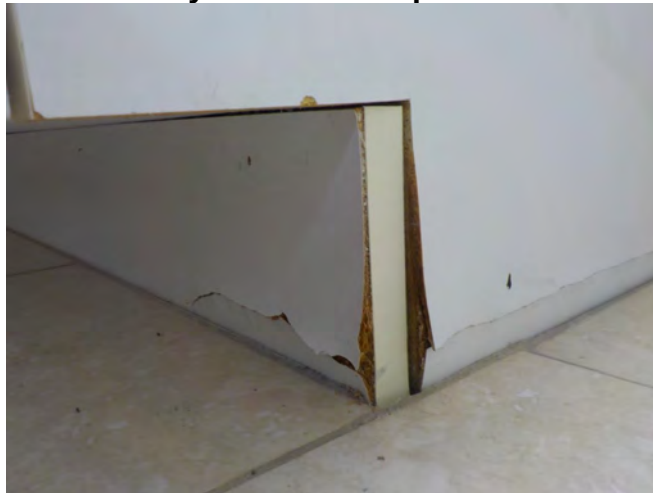
**Review; Signs of water damage noted at vanity cabinet base. Area was dry at time of inspection.**

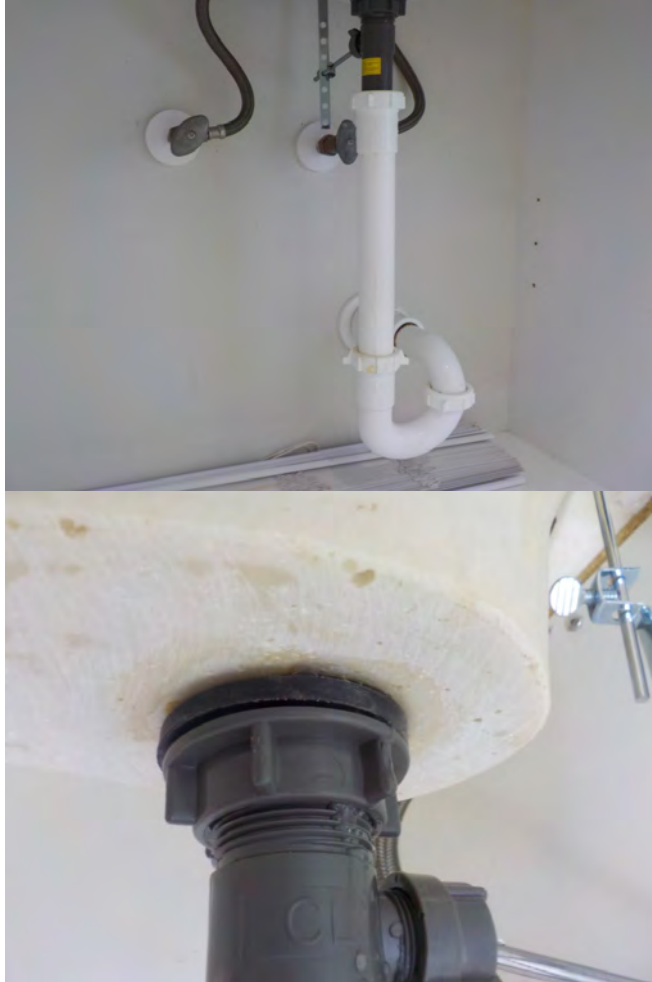
**Review; Leak noted at drainpipe underneath sink. Suggest review/repair by a qualified plumber.**

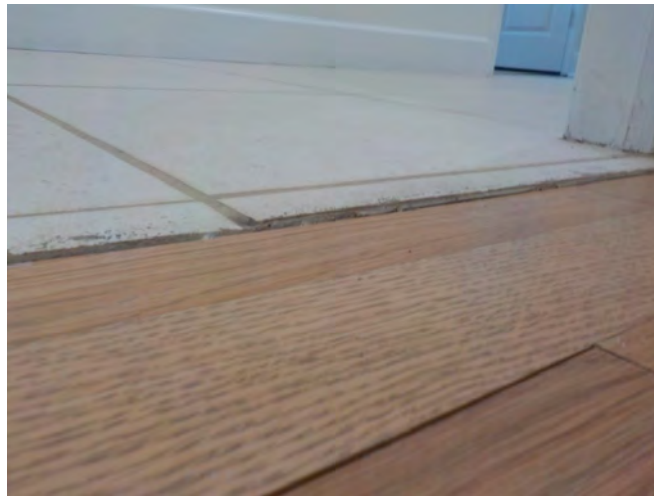
**Review; Laminate. Missing threshold noted at bedroom entry area.**

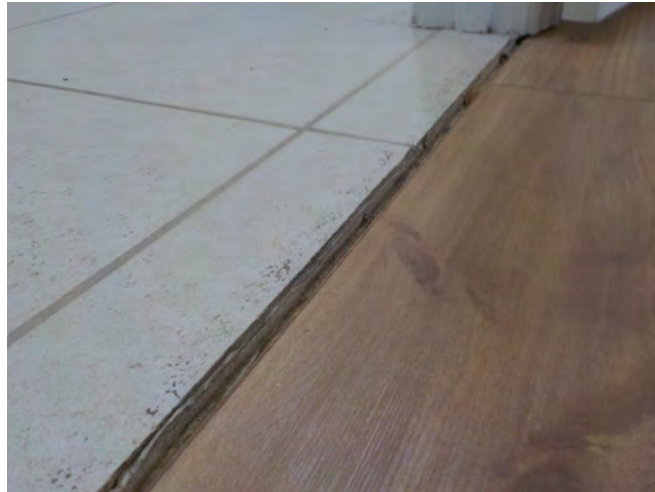
**Review; Laminate. Missing threshold noted at bedroom entry area.**

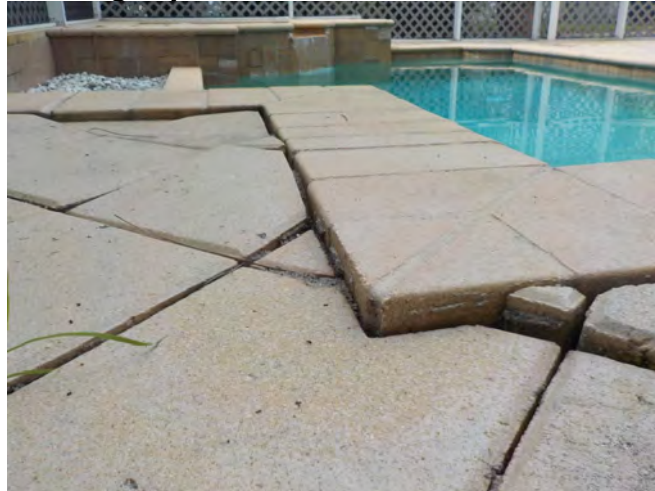
| 3002. | Decking | <b>Review; Pavers. Settlement noted at multiple areas of pavers causing trip hazard.</b> |

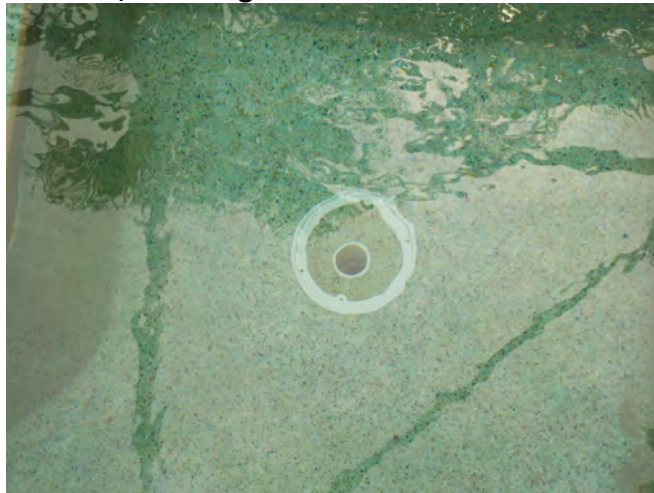
Review; Missing drain cover noted at hot tub.

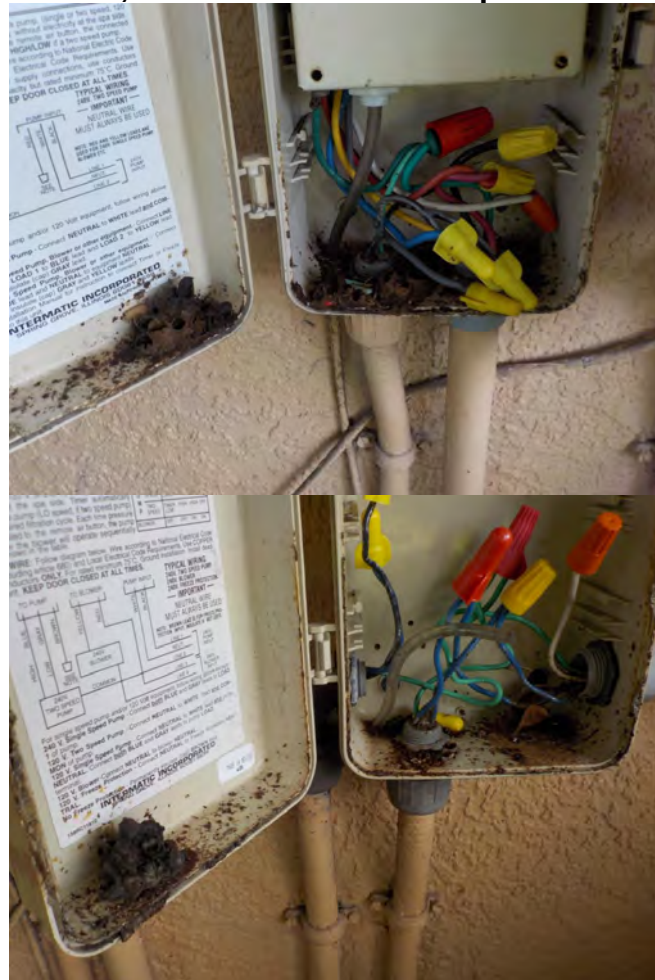
**Review; Insect debris noted at pool timer boxes.**
