## FULL PROPERTY INSPECTION REPORT

Doc #: 2507-029 Inspection Date: 7/28/2025

Dwelling Address: XX Henderson Drive, Naples, FL 34114

## HAZELBAKER INSPECTION SERVICES

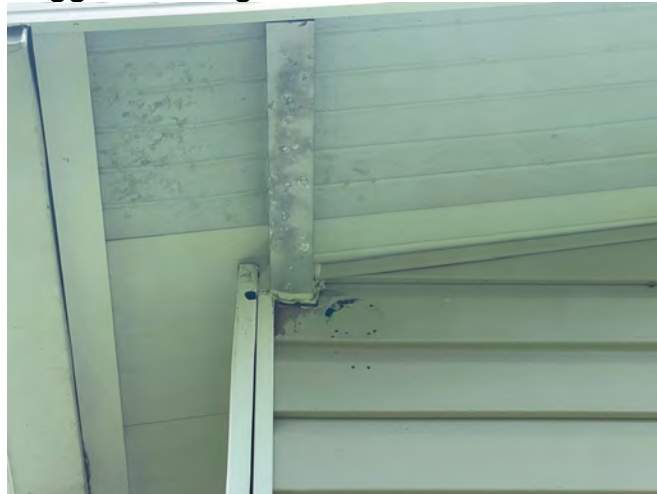
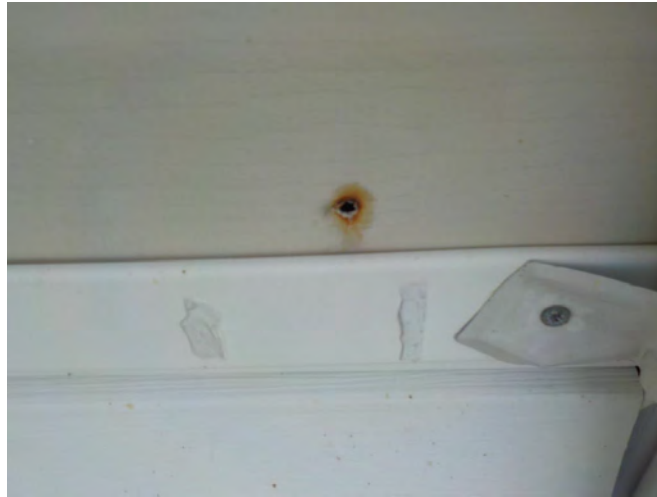
1104. Siding

**Review; Penetrations noted at some areas of vinyl siding. Suggest sealing.**

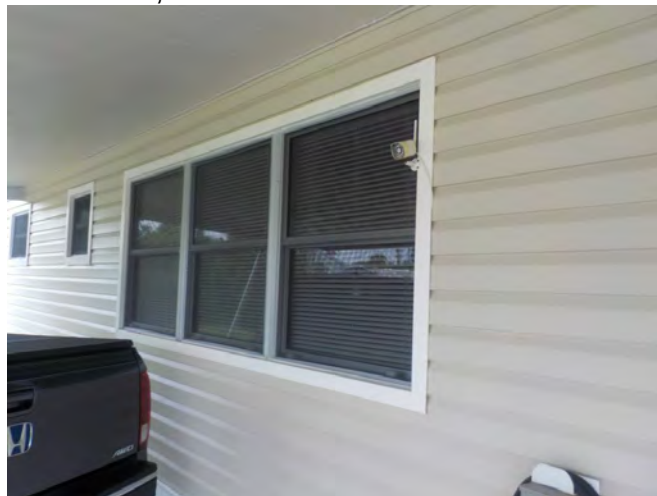
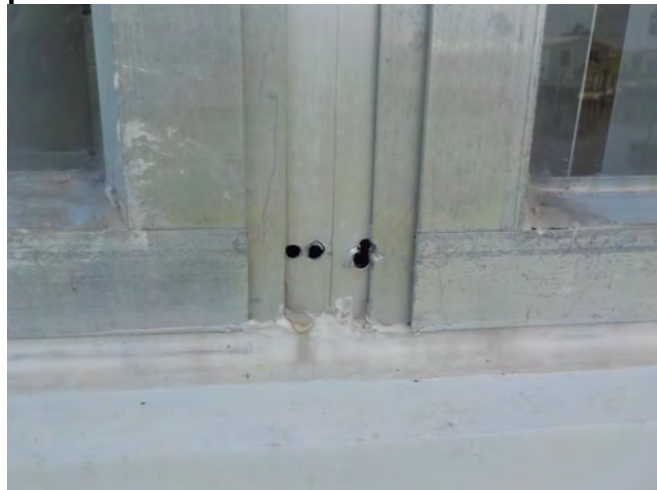
1106. Windows & Frames Functional; Metal.

**Review; Suggest sealing penetrations at some windows to prevent moisture and insect intrusion.**

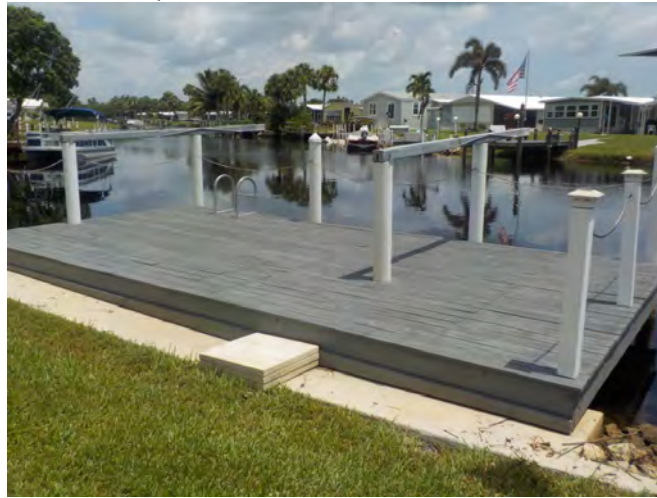
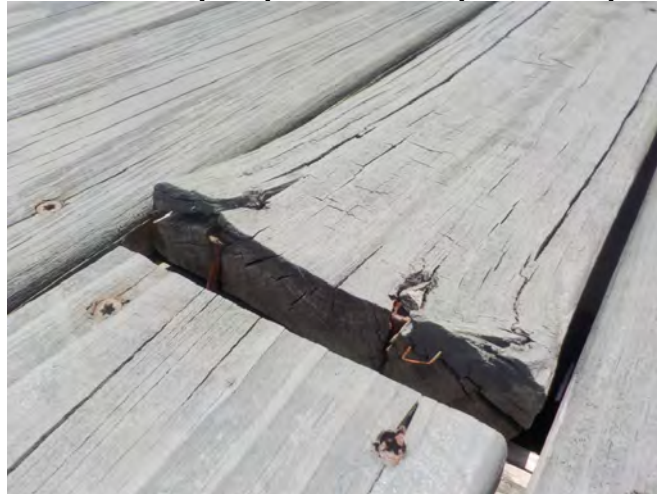
1118. Dock

**Review; Warped plank and exposed staples noted.**

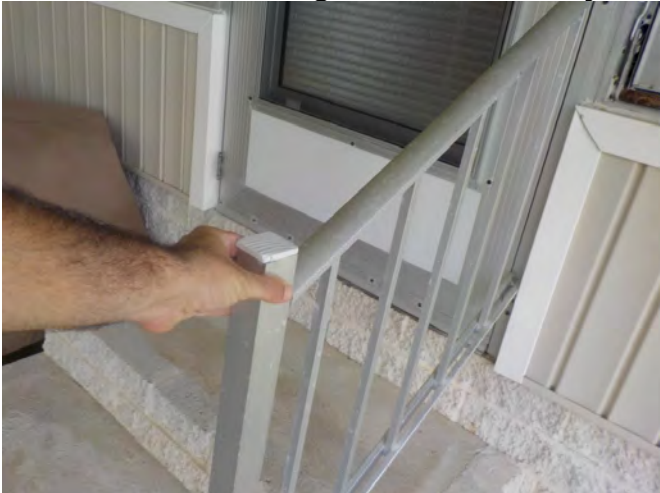
| Step # | Component | Comment |
|---|---|---|
| 1209. | Railing | <b>Review; Loose railing noted at stairway.</b><br> |

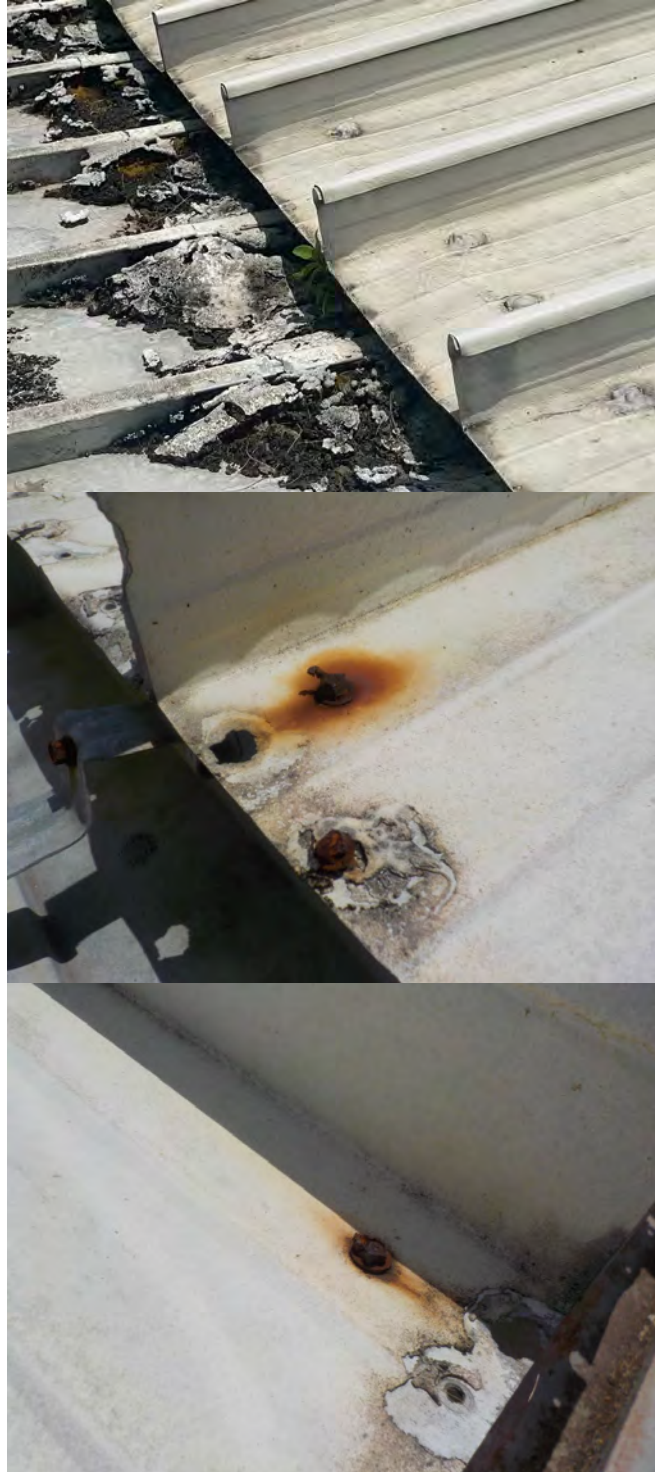
1304. Conditions

**Review; Roof is generally worn. Missing and rusted fasteners noted along front side of roof. Growth noted at insulation underneath sheathing. Suggest review by a qualified roofing contractor.**

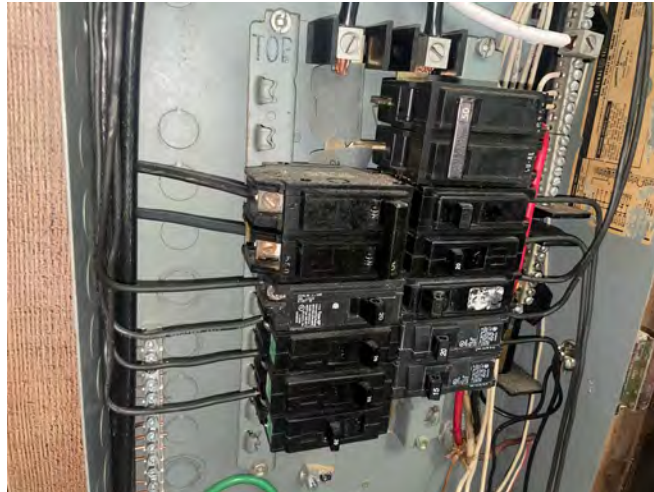
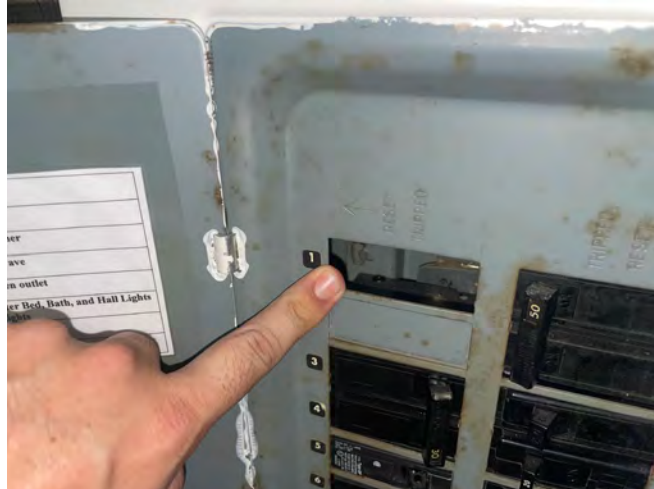
**Review; Missing knockout panel noted at master bedroom panel.**

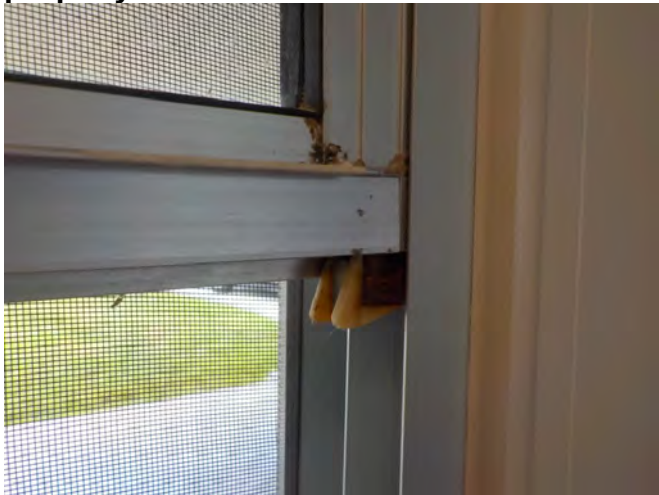
| Step # | Component | Comment |
|---|---|---|
| 2106. | Windows / Screens | <b>Review; Single hung. Loose sash spring noted at one kitchen window at front side of home. Window does not close and latch properly.</b><br> |

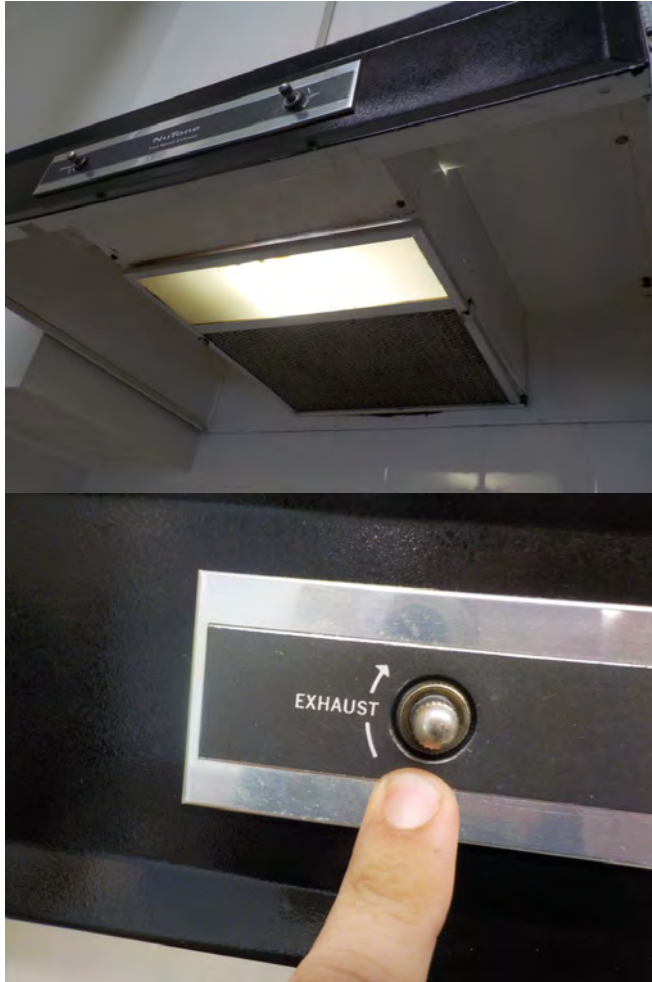
2117. Hood/Fan/Light

**Review; Exhaust fan at stove hood is not functional.**

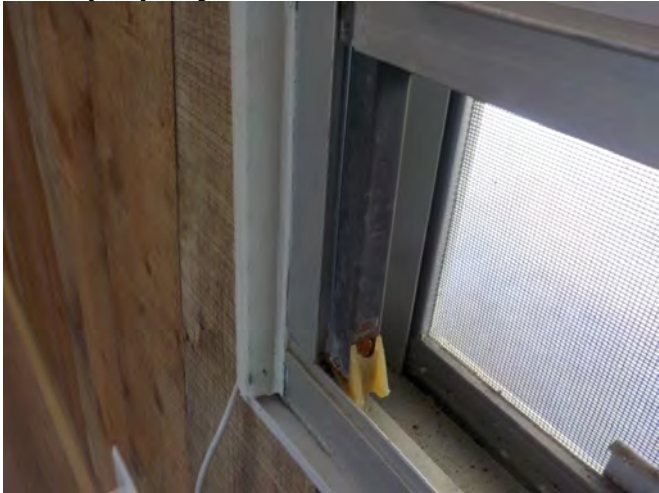
| Step # | Component | Comment |
|---|---|---|
| 2406. | Windows / Screens | <b>Review; Single hung. Loose sash spring noted at one dining room window at front side of home. Window does not close and latch properly.</b><br> |

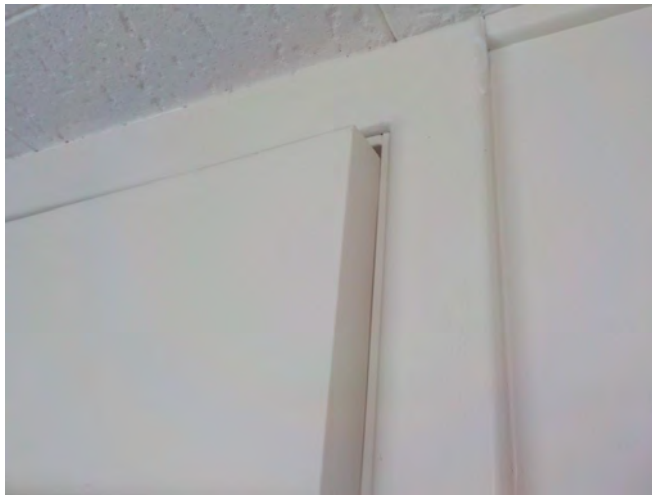
**Review; Master bedroom door is slightly binding at top of frame.**

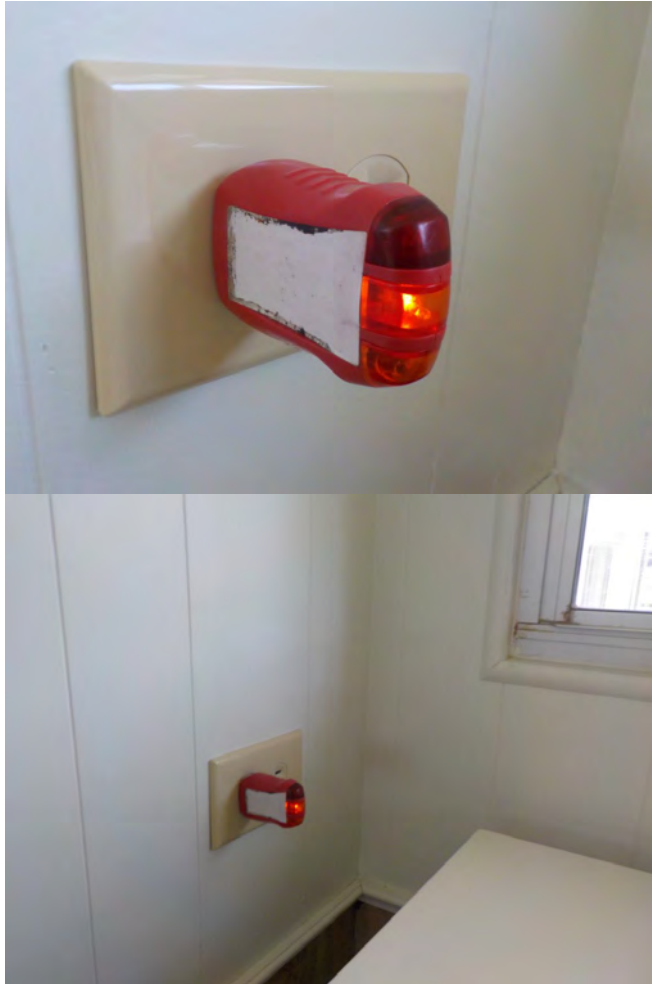
**Review; Improperly wired outlet (open ground) noted near rear side window.**

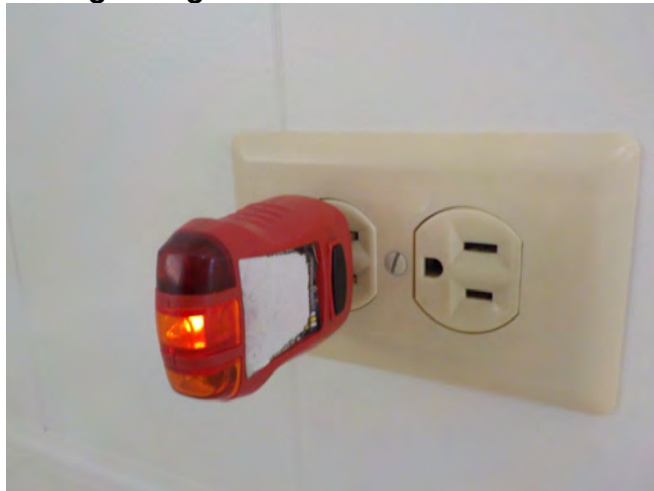
**Review; Improperly wired outlets (open ground) noted throughout guest bedroom.**
