## SUMMARY REPORT

Doc #: 2507-029 Inspection Date: 7/28/2025

Dwelling Address: XX Henderson Drive, Naples, FL 34114

## HAZELBAKER INSPECTION SERVICES

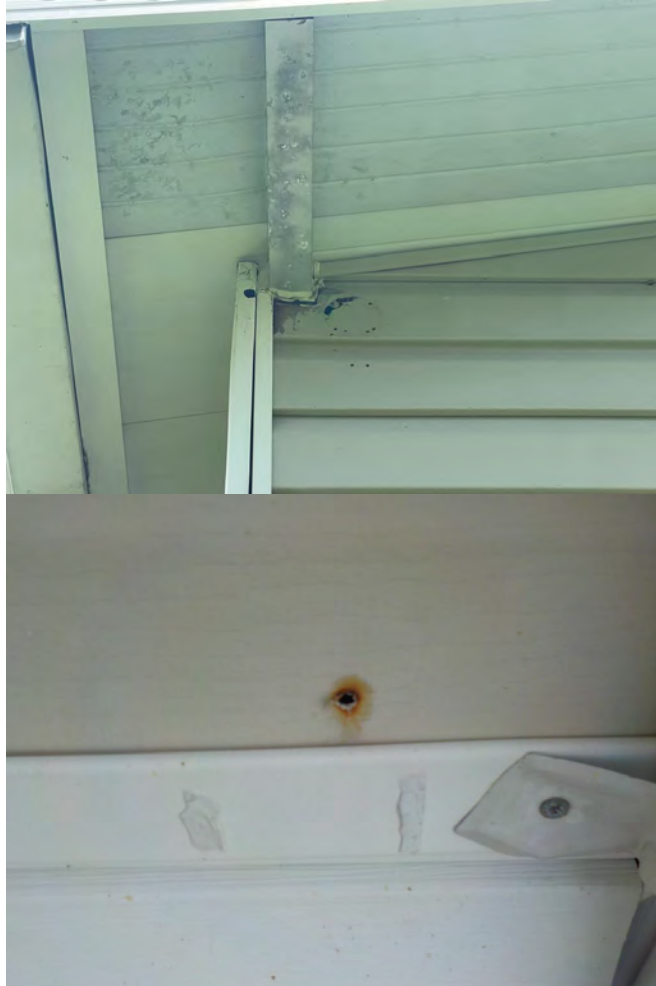
1104. Siding

**Review; Penetrations noted at some areas of vinyl siding. Suggest sealing.**

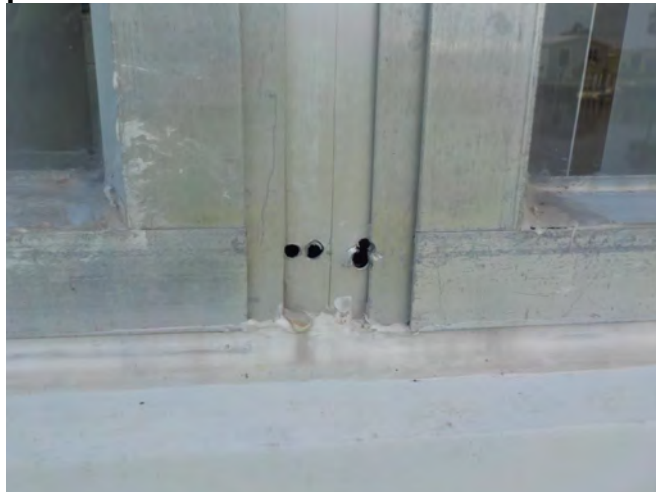
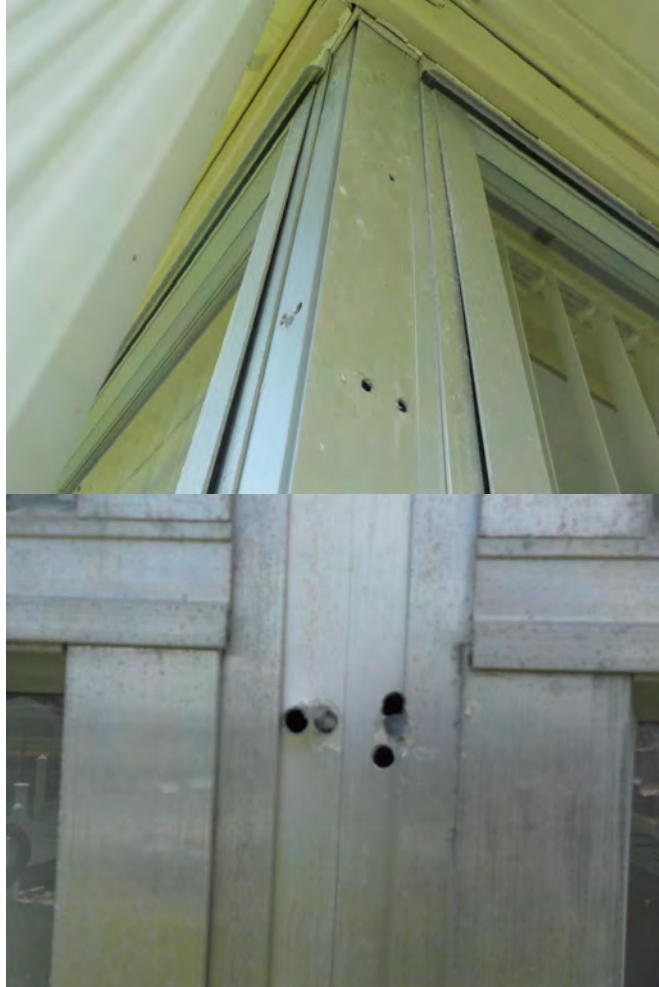
1106. Windows & Frames

**Review; Suggest sealing penetrations at some windows to prevent moisture and insect intrusion.**

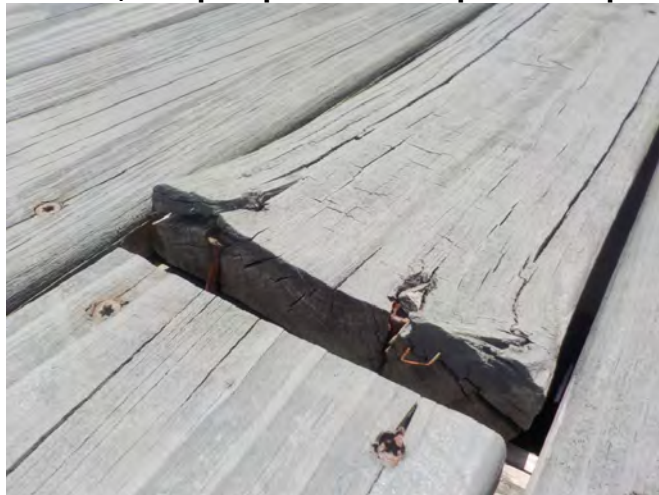
1118. Dock

**Review; Warped plank and exposed staples noted.**

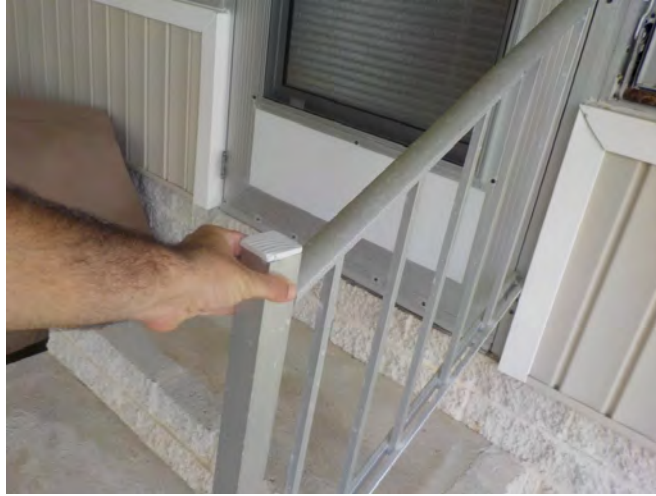
1209. Railing

**Review; Loose railing noted at stairway.**

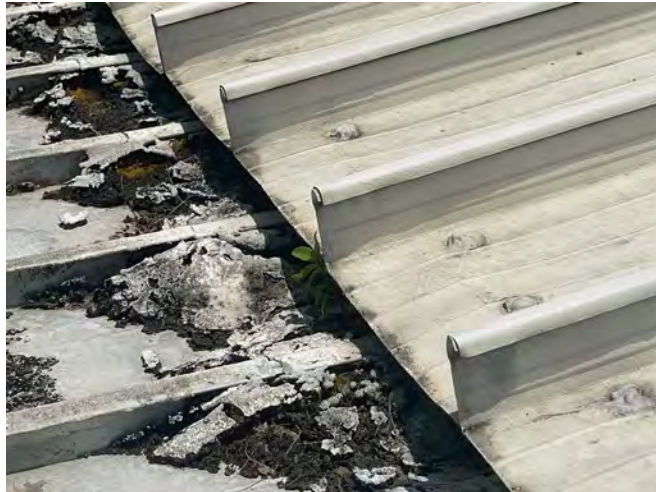
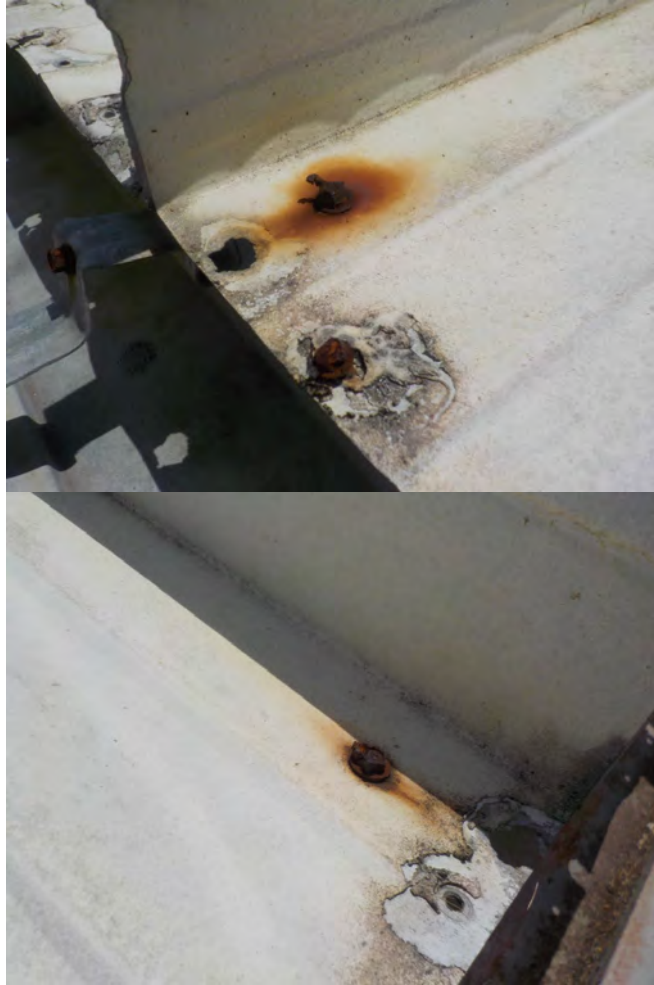
1304. Conditions

**Review; Roof is generally worn. Missing and rusted fasteners noted along front side of roof. Growth noted at insulation underneath sheathing. Suggest review by a qualified roofing contractor.**

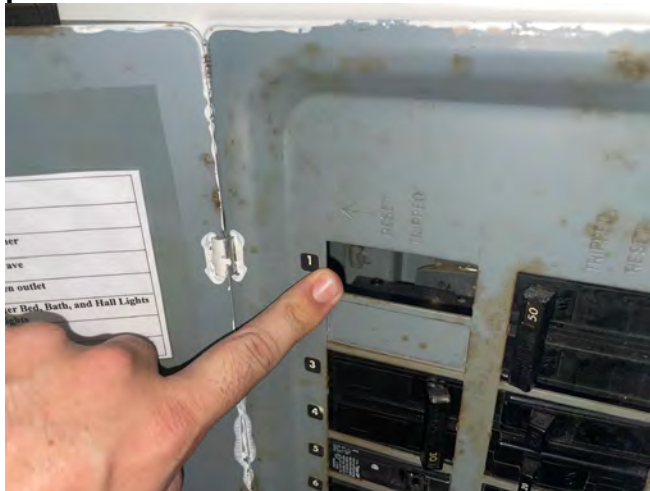
2002. Electrical Main  
Box Comments

**Review; Missing knockout panel noted at master bedroom panel.**

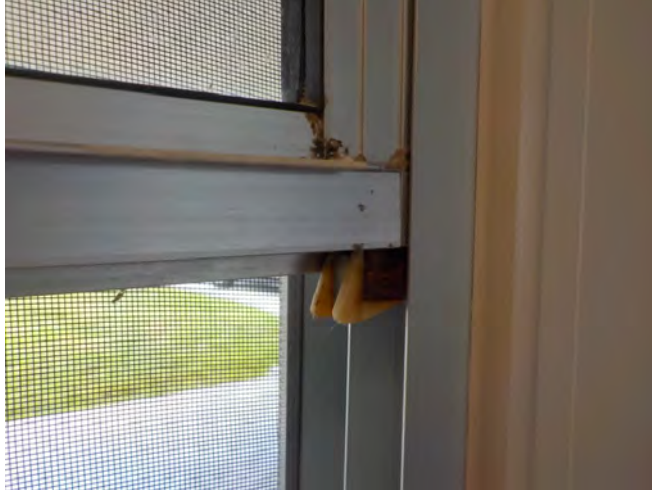
2106. Windows /  
Screens

**Review; Single hung. Loose sash spring noted at one kitchen window at front side of home. Window does not close and latch properly.**

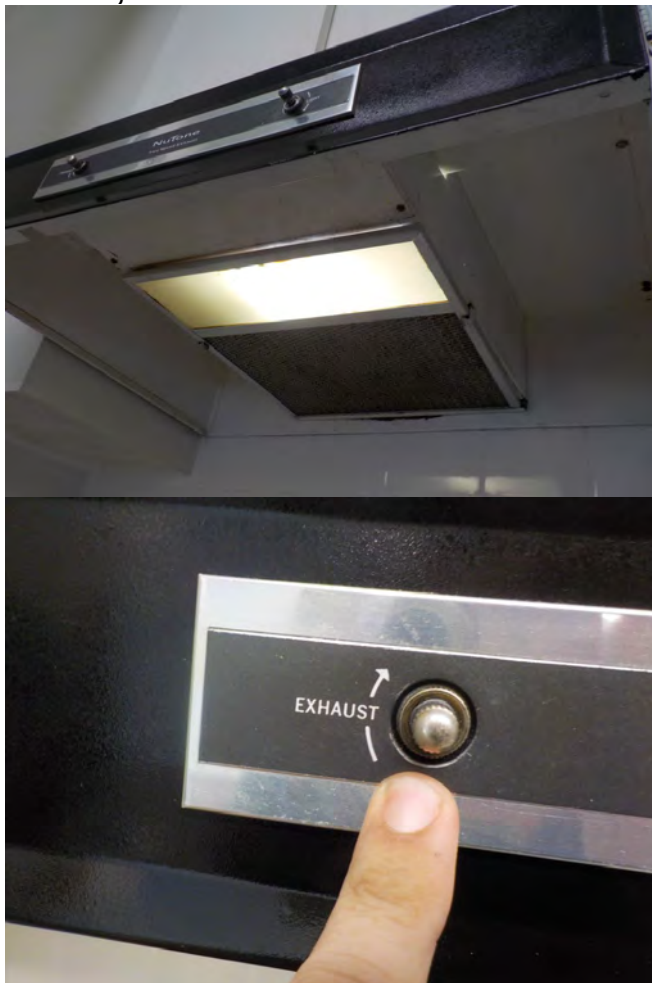
2117. Hood/Fan/Light

**Review; Exhaust fan at stove hood is not functional.**

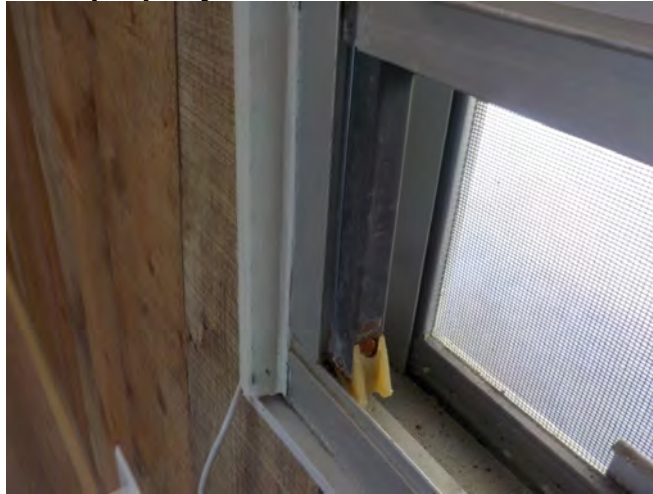
2406. Windows / Screens      **Review; Single hung. Loose sash spring noted at one dining room window at front side of home. Window does not close and latch properly.**

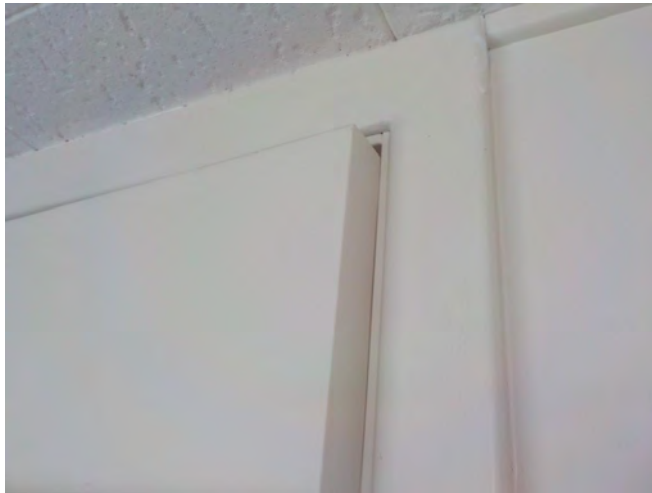
2904. Interior Doors      **Review; Master bedroom door is slightly binding at top of frame.**

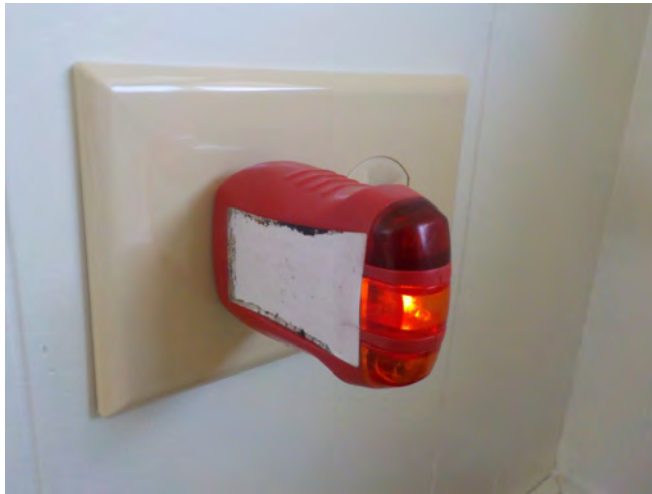
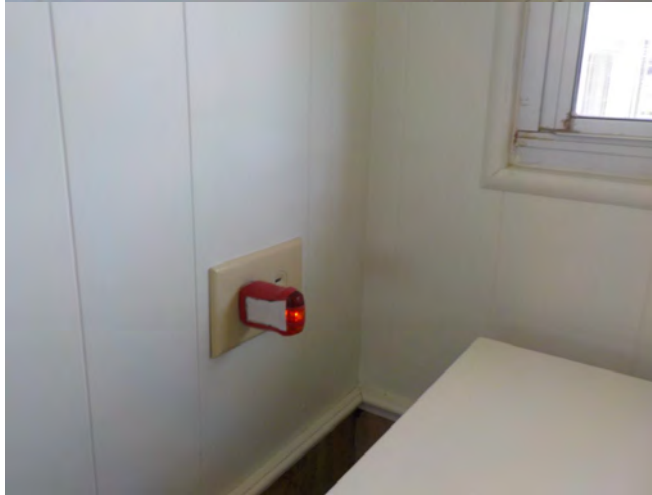
2907. Electrical

**Review; Improperly wired outlet (open ground) noted near rear side window.**

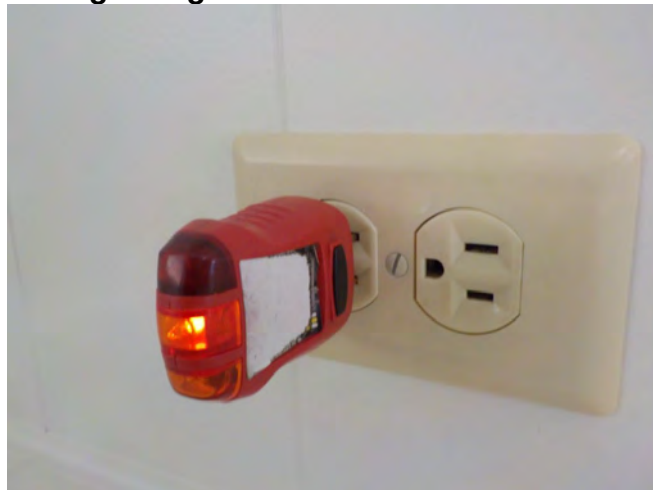
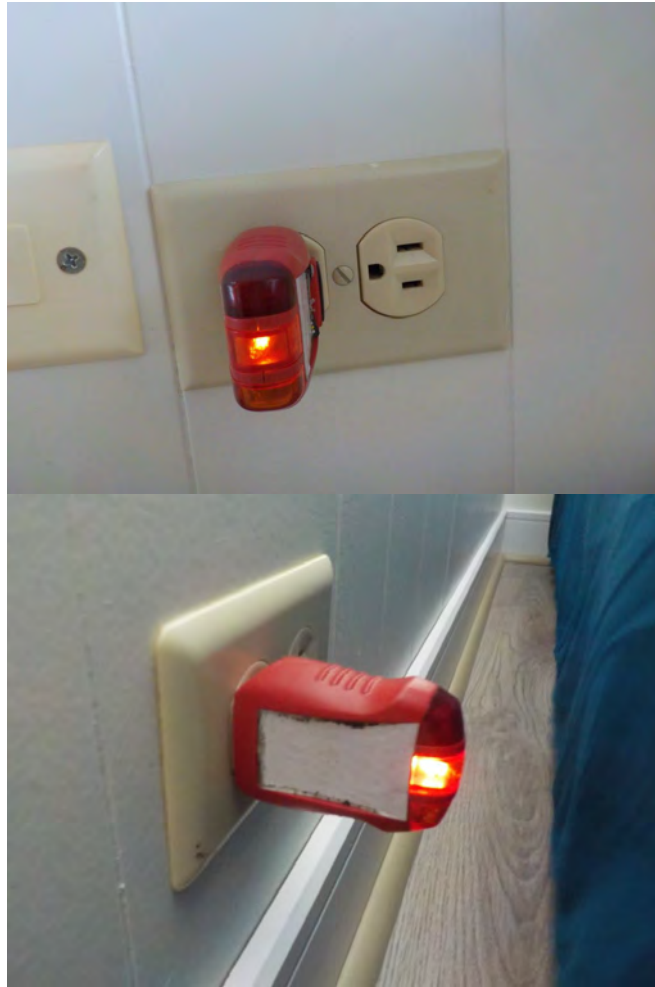
2907.2. Electrical

**Review; Improperly wired outlets (open ground) noted throughout guest bedroom.**
