## SUMMARY REPORT

Doc #: 2508-003 Inspection Date: 8/8/2025

Dwelling Address: XXXXX Vanderbilt Drive, Naples, FL 34108

## HAZELBAKER INSPECTION SERVICES

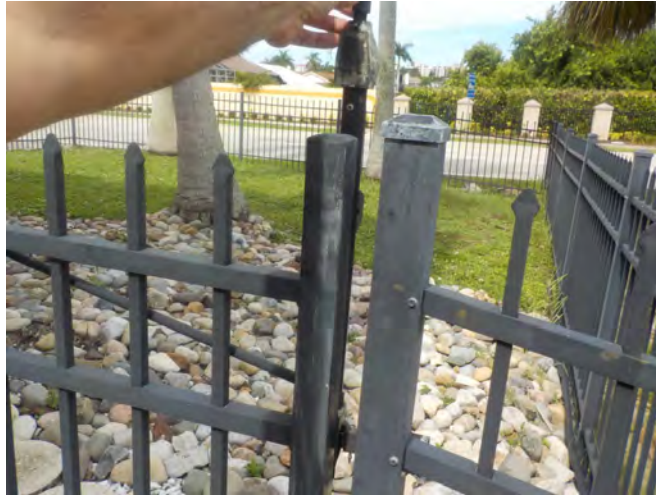
1103. Fences/Gates

**Review; Gate at left side of home does not latch.**

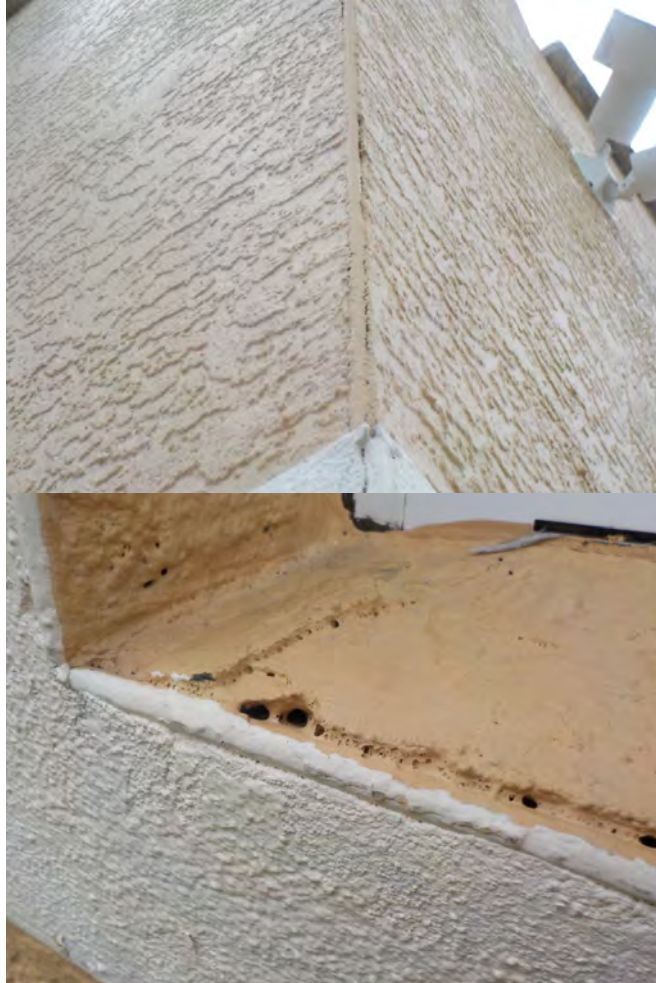
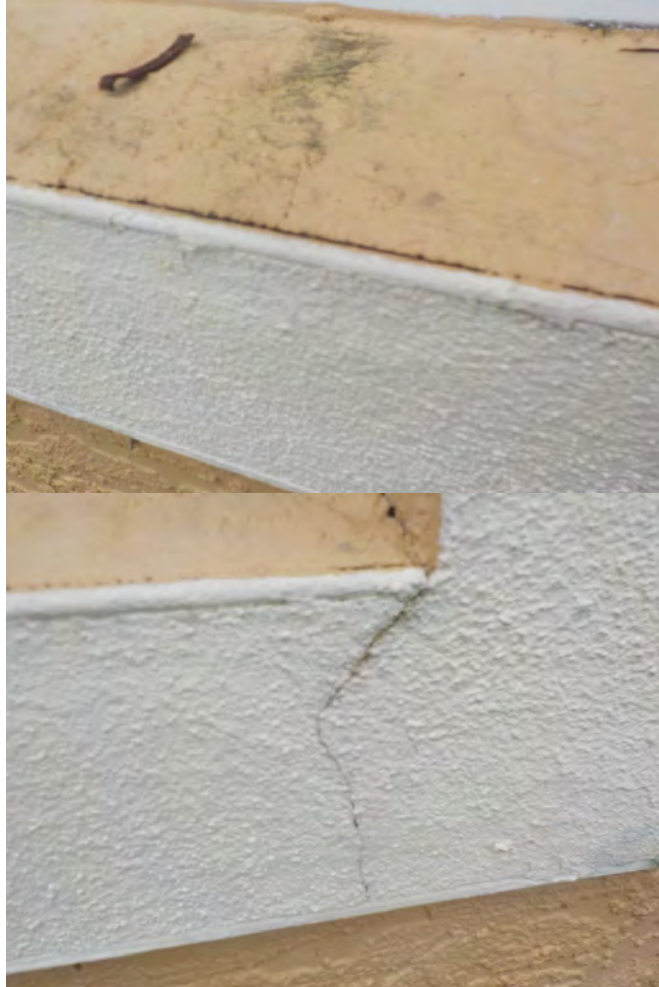
1104. Siding

**Review; Common cracking noted at stucco at multiple areas. Suggest sealing to prevent moisture and insect intrusion.**

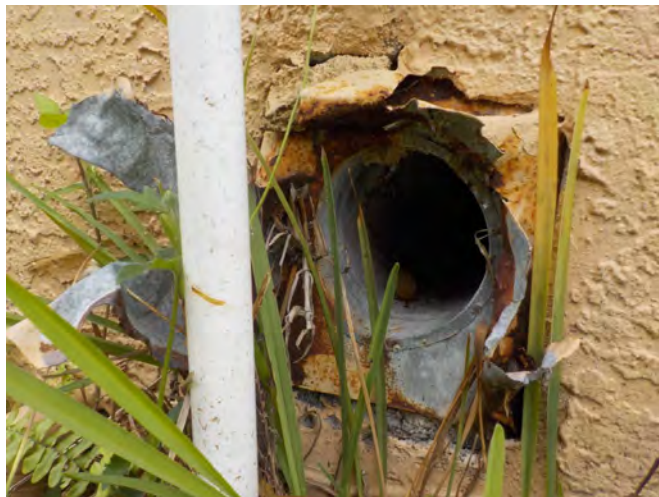
**Review; Missing cover noted at dryer vent termination at left side of home.**

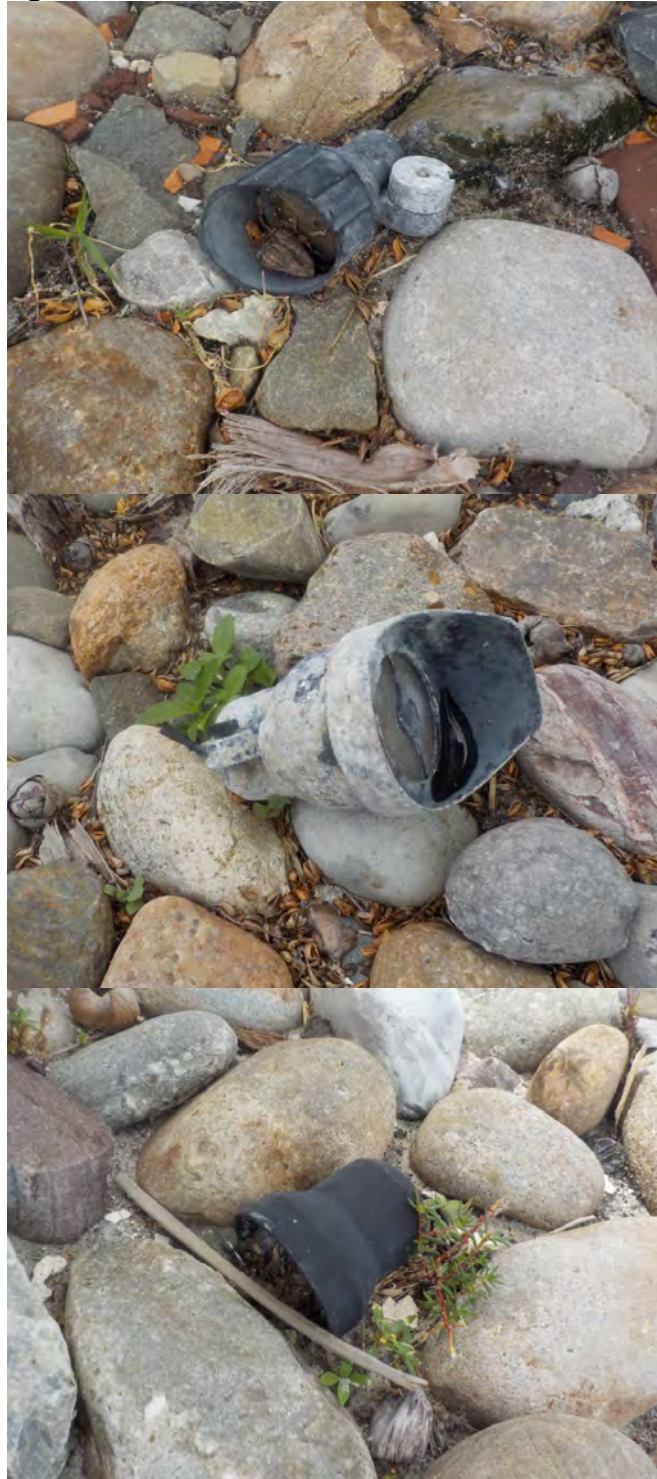
1107. Electrical

**Review; Landscape lighting system is not functional. Damaged lights noted.**

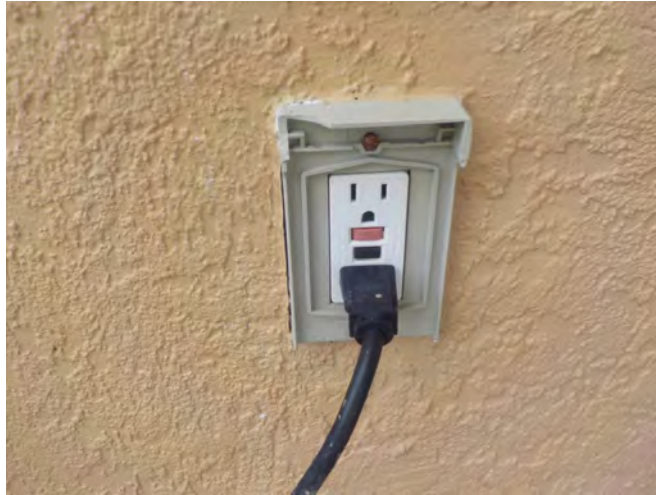
**Review; Missing weather cover noted at outlet at rear side of home.**

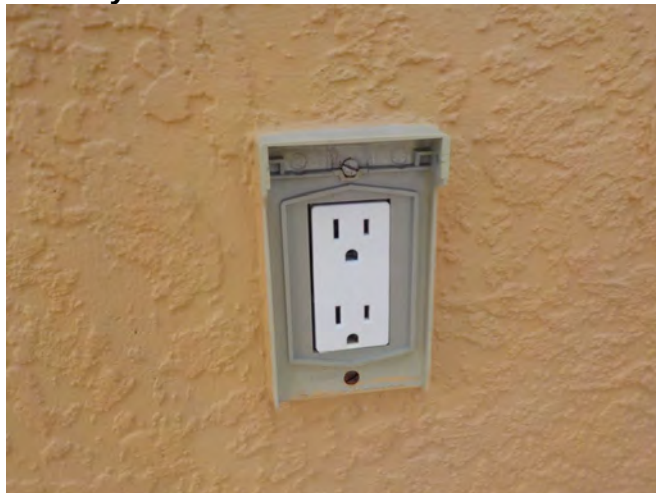
**Review; Missing weather cover noted at outlet at 2<sup>nd</sup> floor balcony area.**

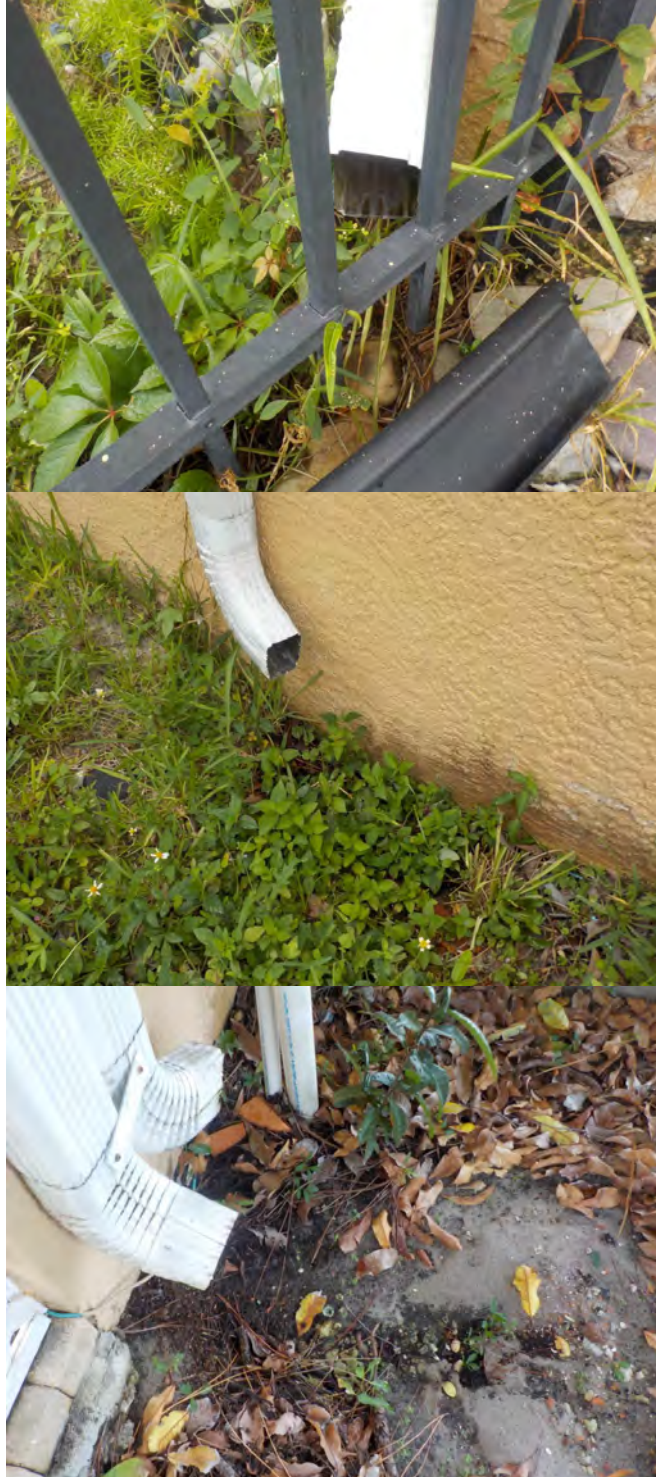
1108. Gutters & Downspouts

**Review; Missing splash blocks noted at multiple gutter downspouts. Erosion noted.**

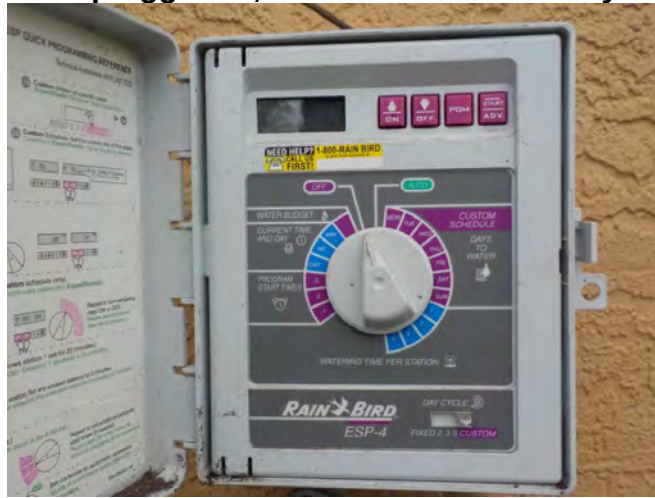
1110. Sprinkler System **Review; 4 Zones present. Irrigation system is not functional. System was unplugged at start of inspection. System had power once plugged in, but unable to manually start.**

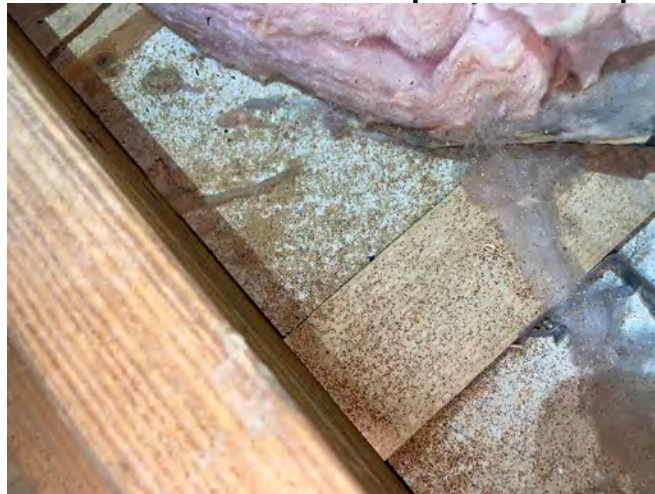
1120. Exterior Comments **Review; Signs of termite activity noted at upstairs attic area. Termite frass found near upstairs attic opening.**

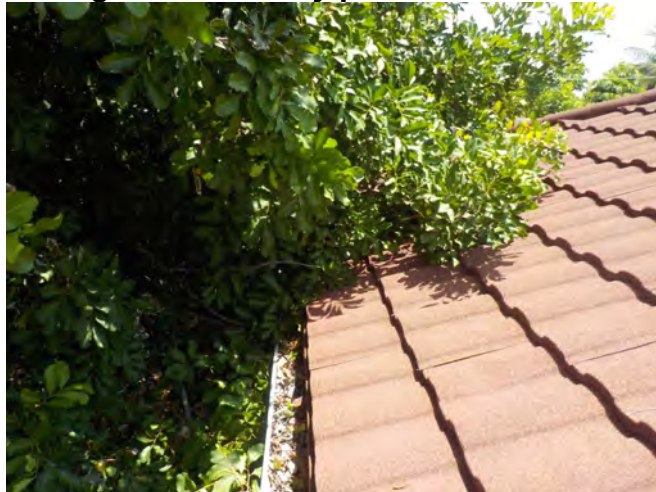
1308. Roof Comments

**Review; Suggest trimming or removing plantings to prevent damage or access by pests to roof area.**

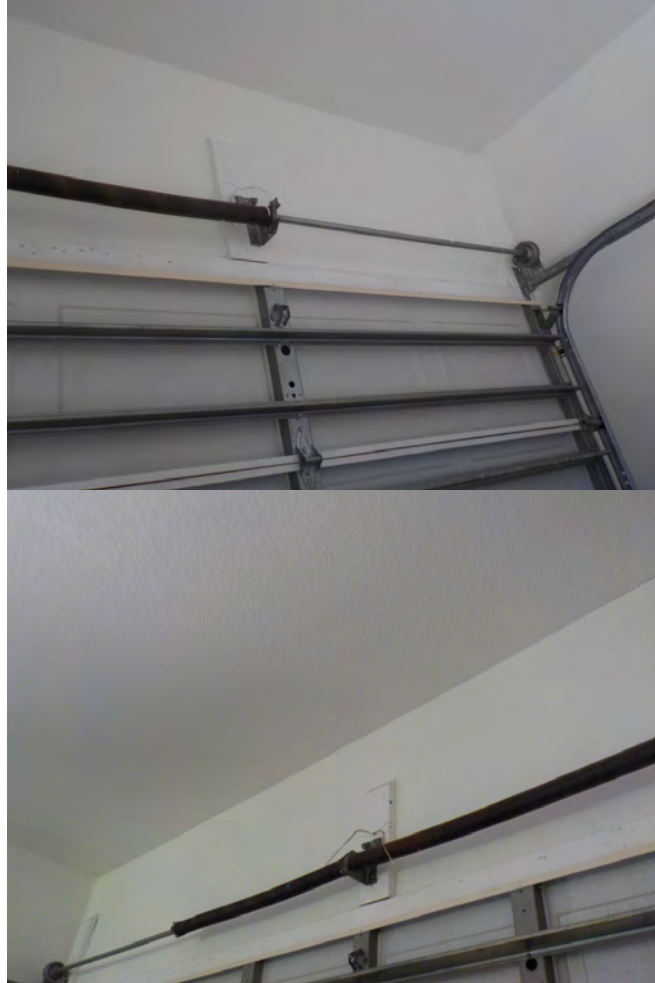
1505. Garage Door Opener

**Review; Garage doors inoperable. Garage door openers and tracks have been removed.**

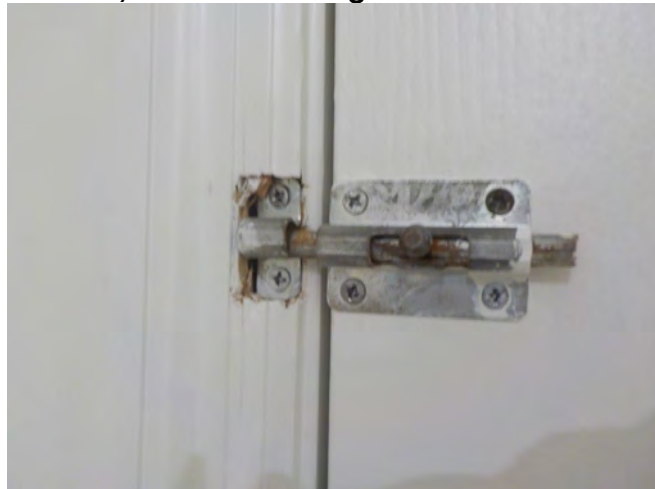
1508. Interior Door

**Review; Lock is misaligned.**

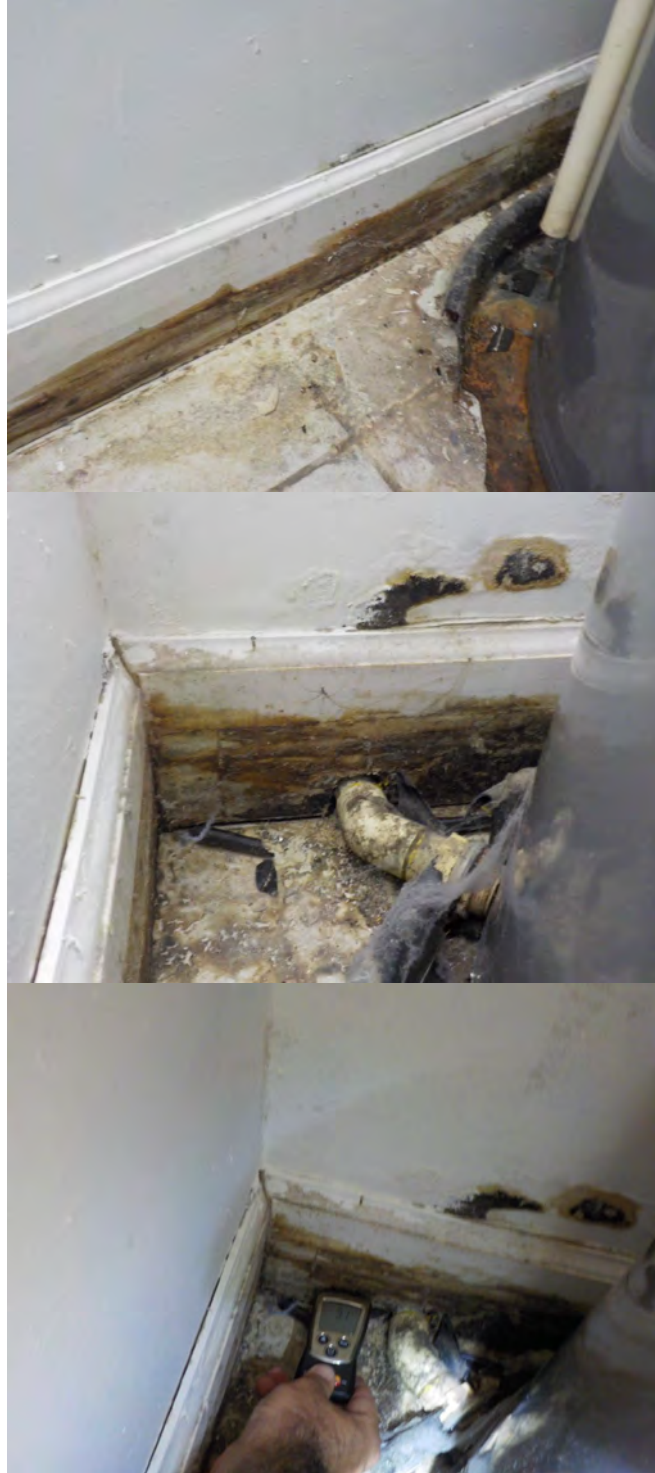
1602. Walls

**Review; Water damage noted at baseboard behind water heater/dryer. Area was dry at time of inspection. Suggest review by a water damage expert.**

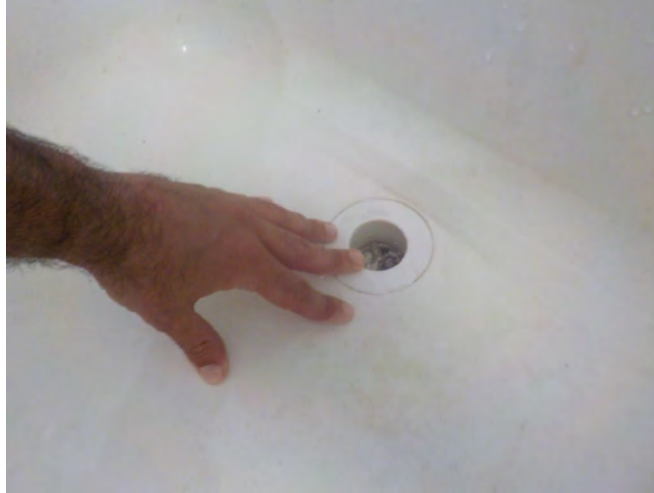
1608. Laundry  
Sink/Tub

**Review; Slow drain noted at laundry room sink.**

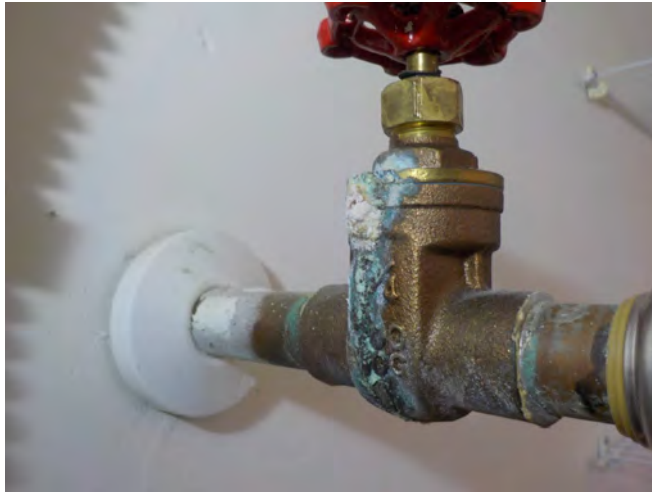
1903. Supply Pipes

**Review; Corrosion noted at shut off valve at upstairs water heater. No active leak at time of inspection.**

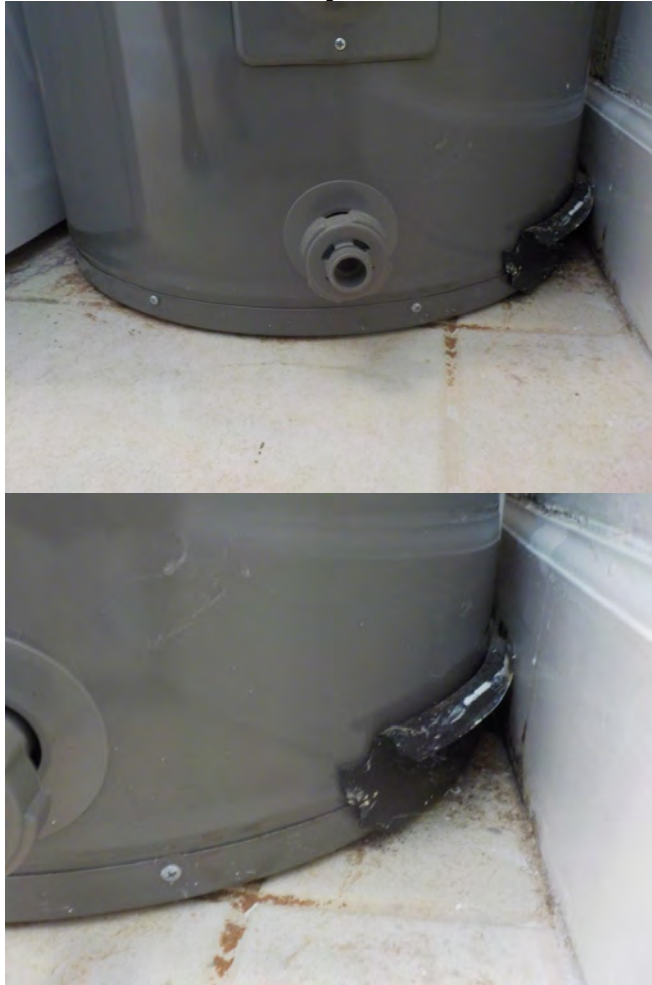
1908. Water Heater  
Manufacturer

**Review; Damaged/missing overflow pan noted at water heater located inside laundry room.**

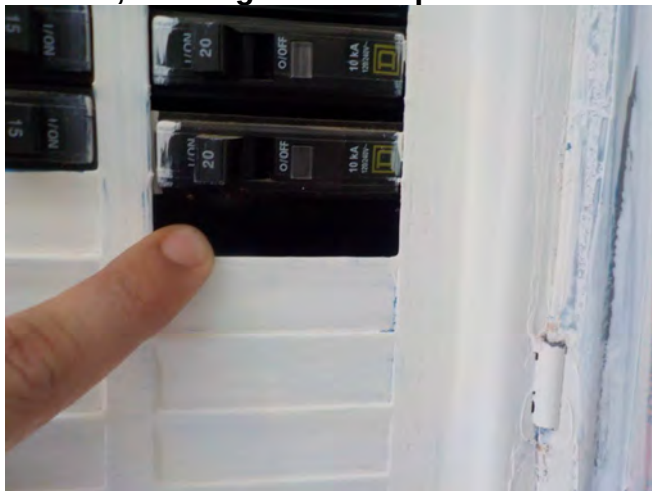
2002. Electrical Main  
Box Comments

**Review; Missing knockout panel noted at left side panel.**

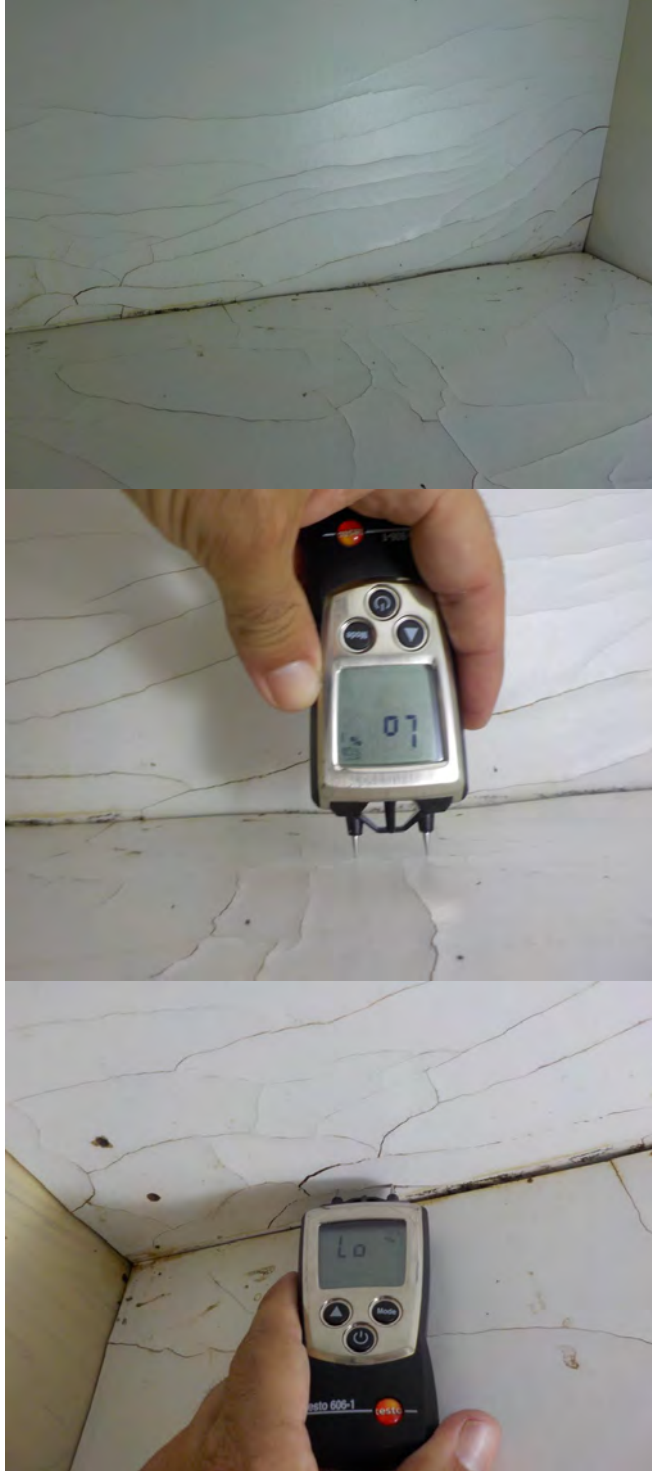
2107. Cabinets

**Review; Signs of water damage noted inside lower cabinet related to staining in laundry room on opposite side of wall. Area was dry at time of inspection.**

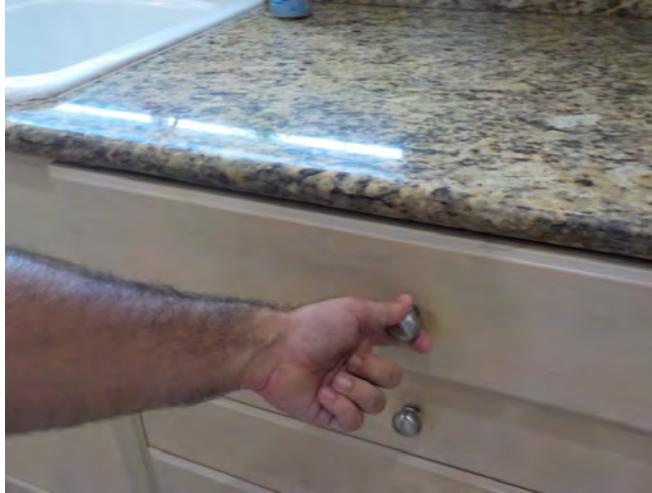
**Review; One cabinet drawer is not functional.**

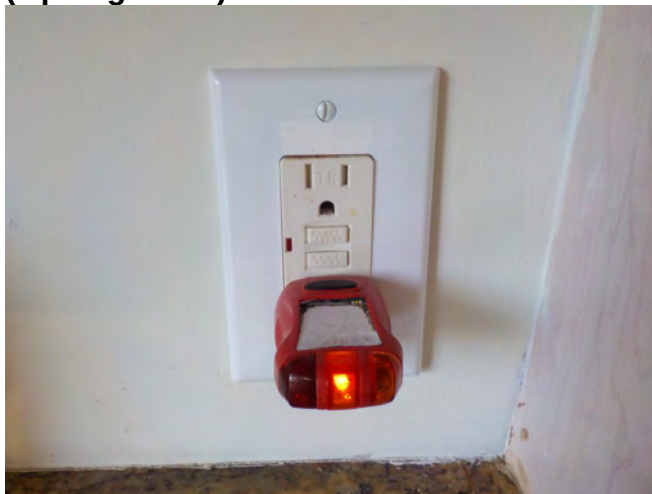
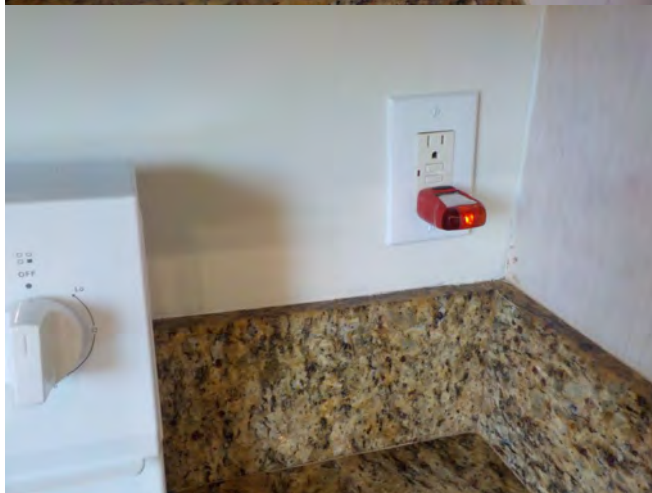
2109. Electrical

**Review; Improperly wired outlet noted at right side of stove. (Open ground).**

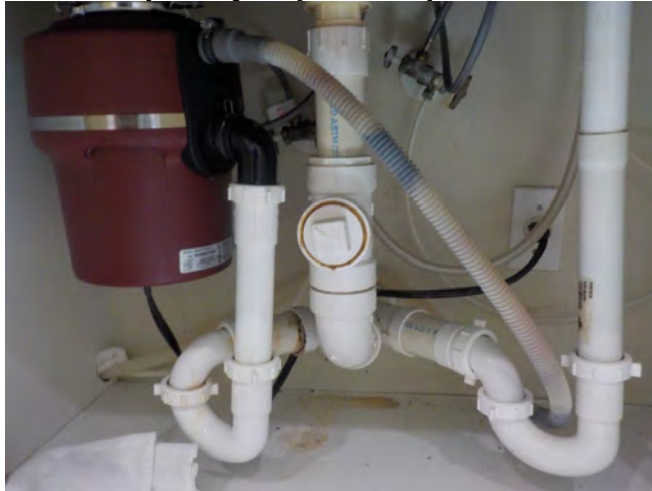
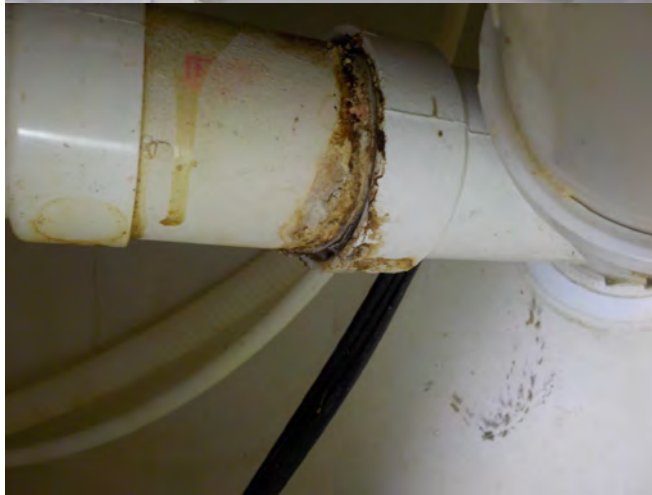
2112. Traps/Drain  
/Supply

**Review; Leak noted at drainpipe underneath sink. Suggest review/repair by a qualified plumber.**

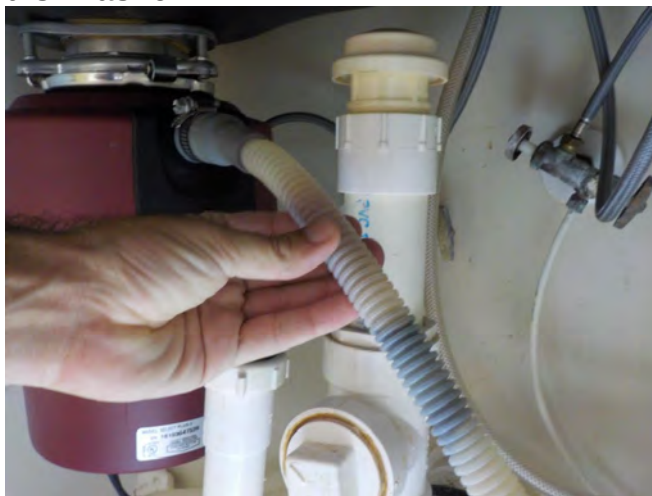
2114. Dishwasher

**Review; No loop in drain line at dishwasher. A loop in drain line is required to prevent dirty drain water from entering the dishwasher.**

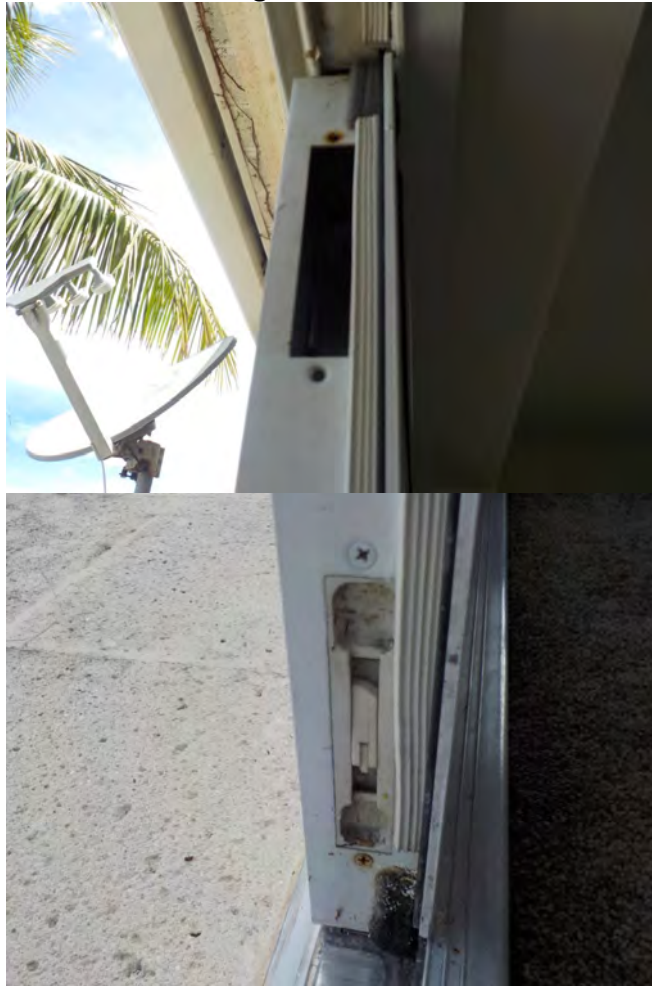
2305. Exterior Doors **Review; French Metal/Glass. Missing soffit strike noted at fixed side door. And damaged sill strike noted at fixed side door.**

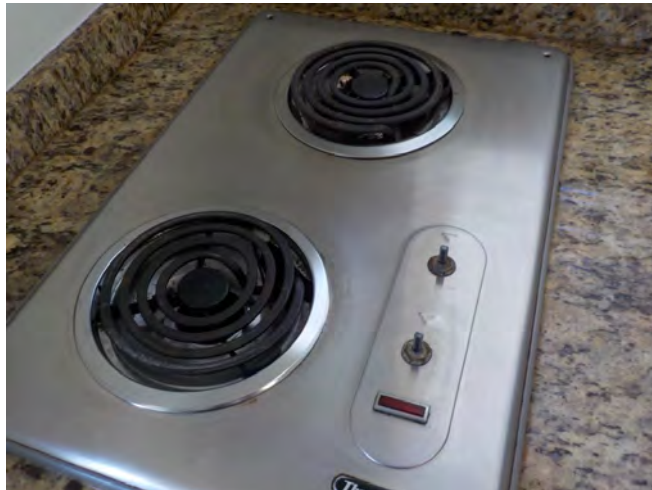
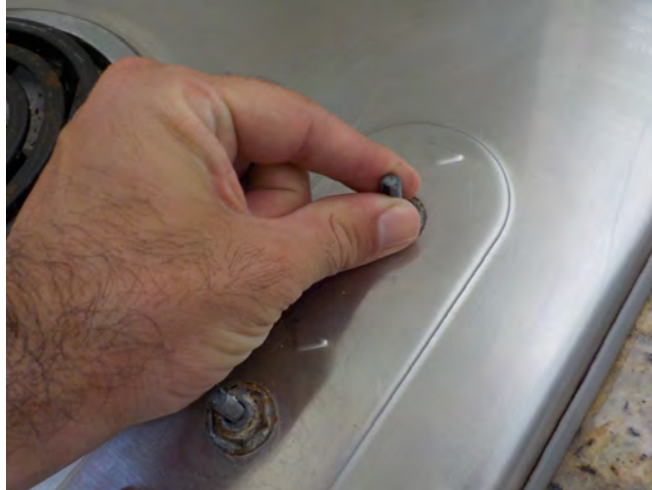
2310. Wet Bar **Review; Kitchenette stovetop is not functional. Missing knobs noted.**

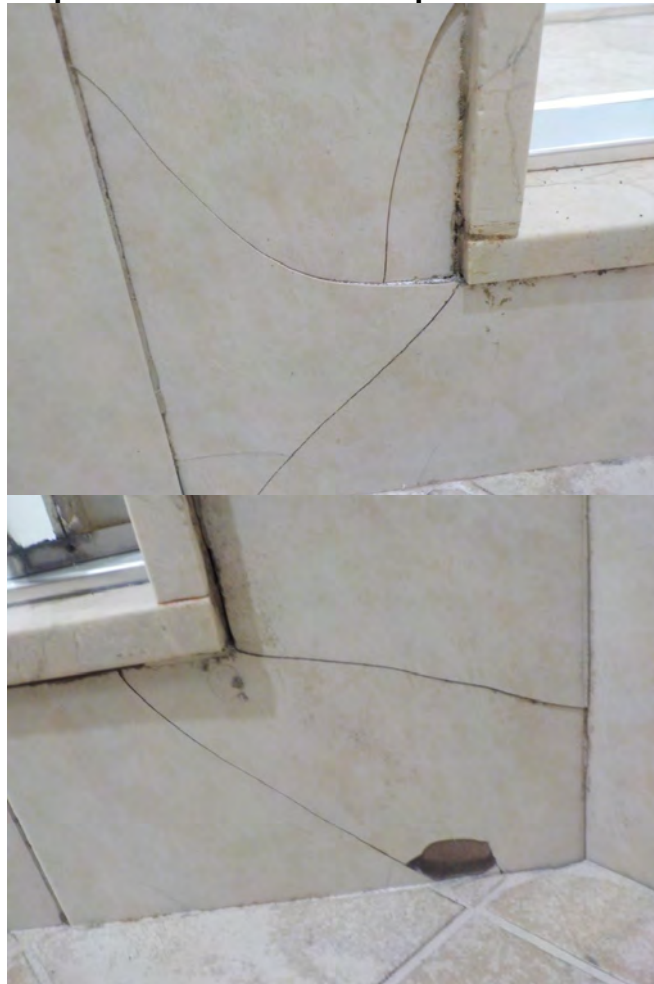
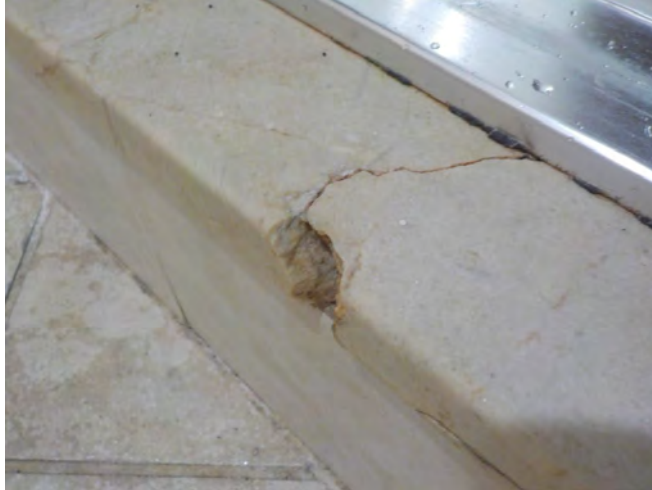
2713. Shower /  
Surround

**Review; Tile. Cracked tiles and open grout joints noted. Suggest replacing grout or caulking to prevent future/further moisture penetration and damage/deterioration to interior walls. This damage is not always visible or accessible to the inspector at the time of inspection.**

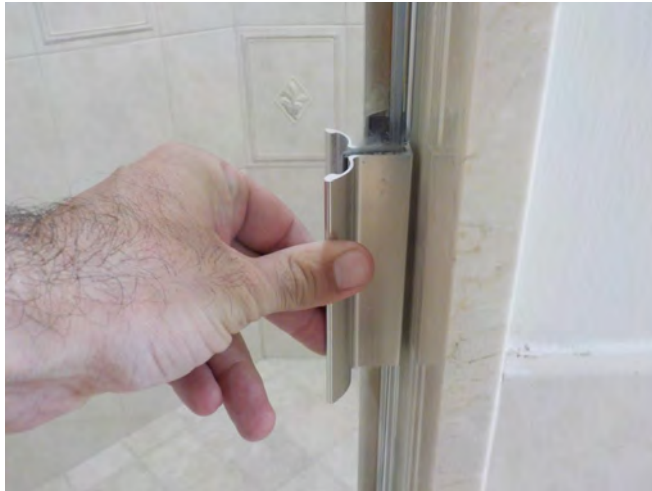
2715. Shower Door

**Review; Glass. Shower door is slightly binding on frame and difficult to latch.**

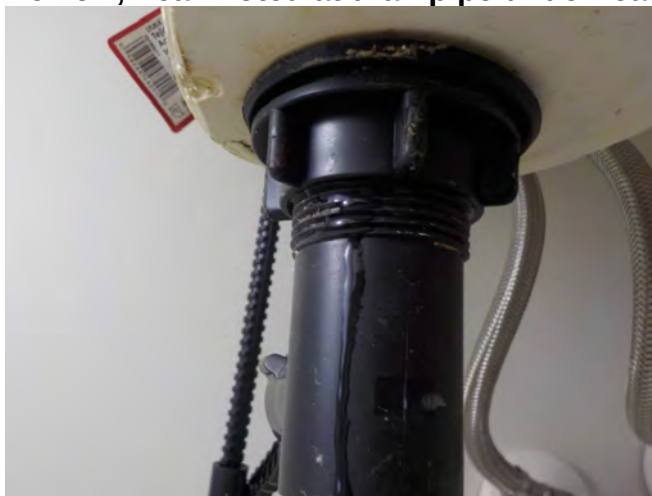
2719. Traps/Drain  
/Supply

**Review; Leak noted at drainpipe underneath left side sink.**

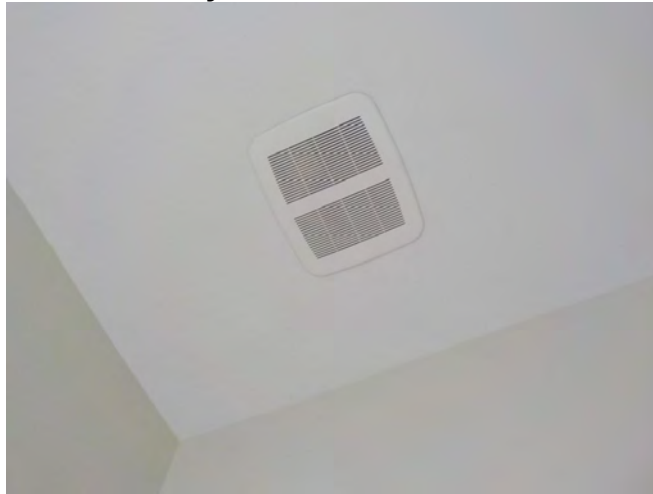
2808. Exhaust Fan **Review; Noisy exhaust fan noted.**

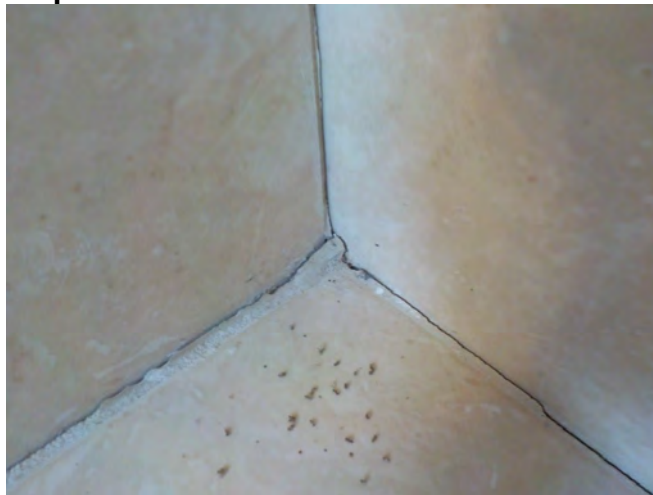
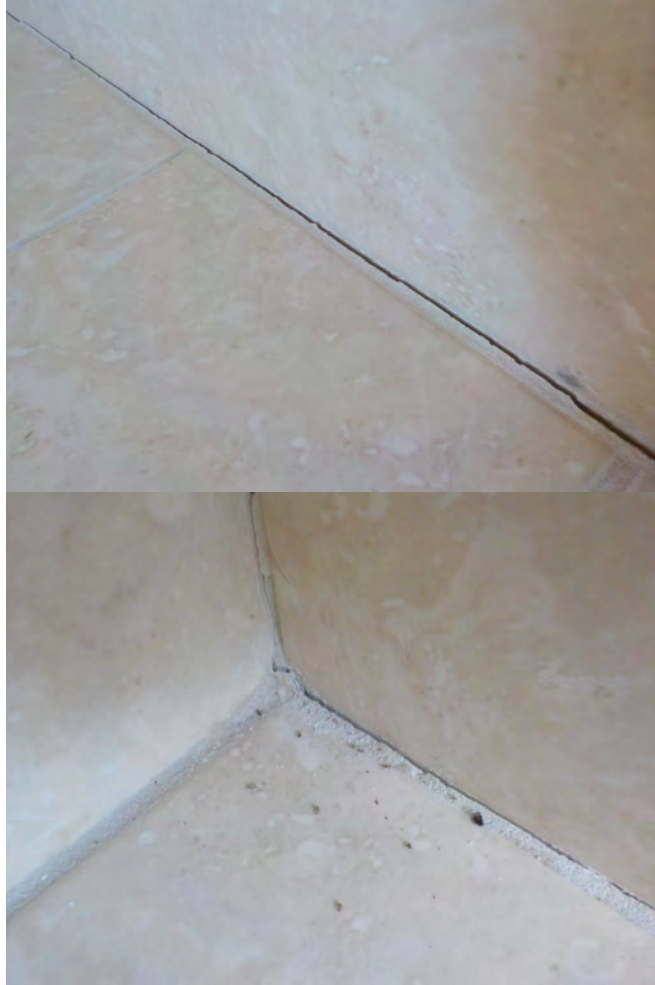
2814. Shower / Surround **Review; Tile. Open grout joints noted. Suggest replacing grout or caulking to prevent future/further moisture penetration and damage/deterioration to interior walls. This damage is not always visible or accessible to the inspector at the time of inspection.**

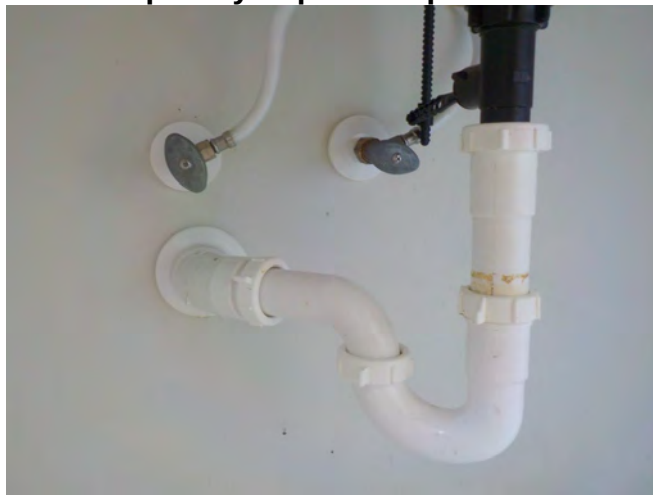
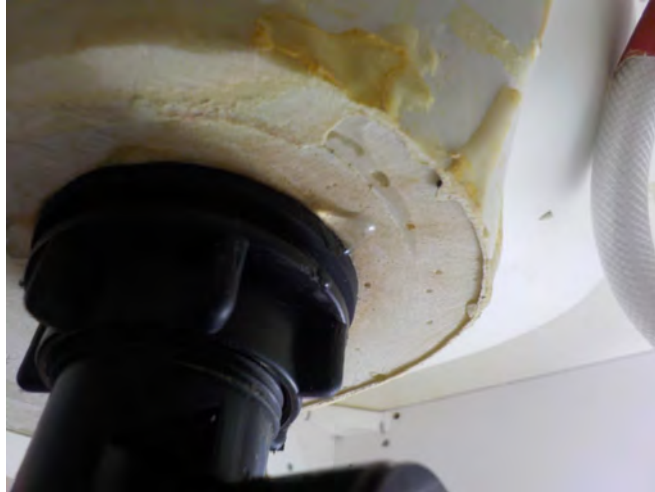
2819. Traps/Drain  
/Supply

**Review; Leak noted at drainpipe underneath sink. Suggest review/repair by a qualified plumber.**

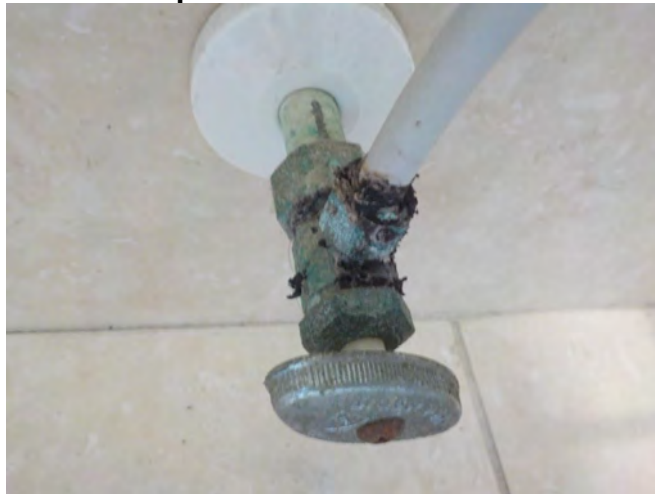
2820. Toilet

**Review; Corrosion noted at toilet supply valve. No leak noted at time of inspection.**

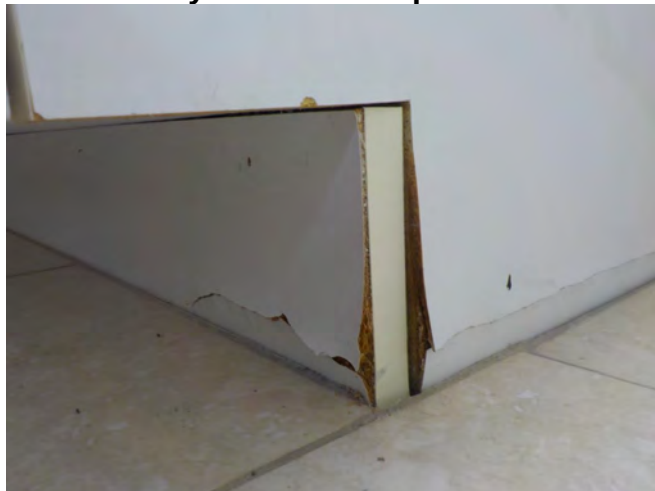
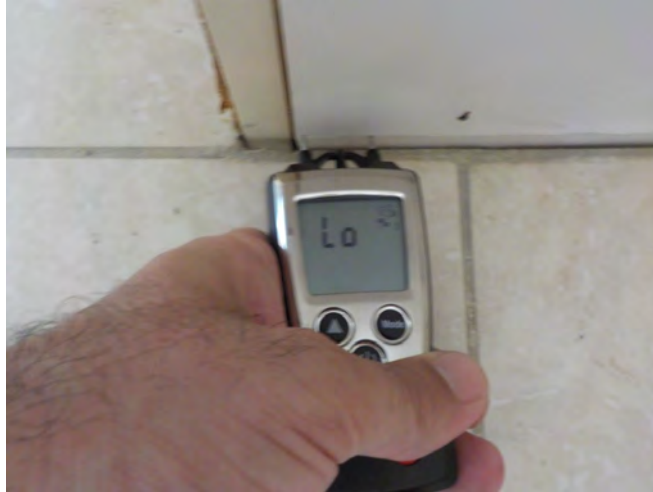
2822. Counter / Cabinets

**Review; Signs of water damage noted at vanity cabinet base. Area was dry at time of inspection.**

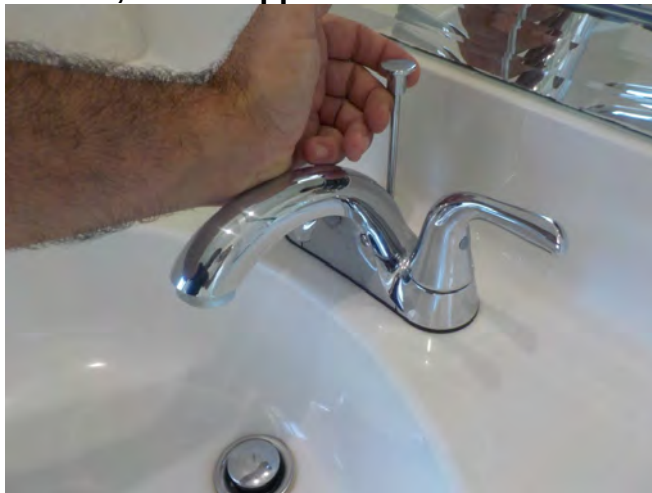
2818. 2. Sink Faucets

**Review; Sink stopper lever is detached.**

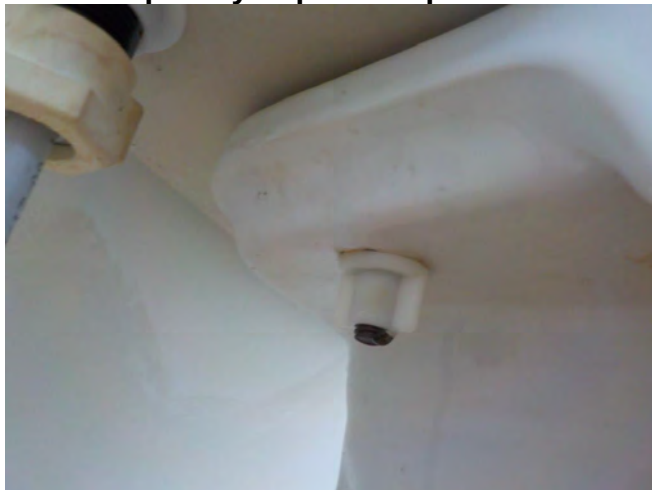
2820. 2. Toilet

**Review; Leak noted at tank while toilet is filling. Suggest review/repair by a qualified plumber.**

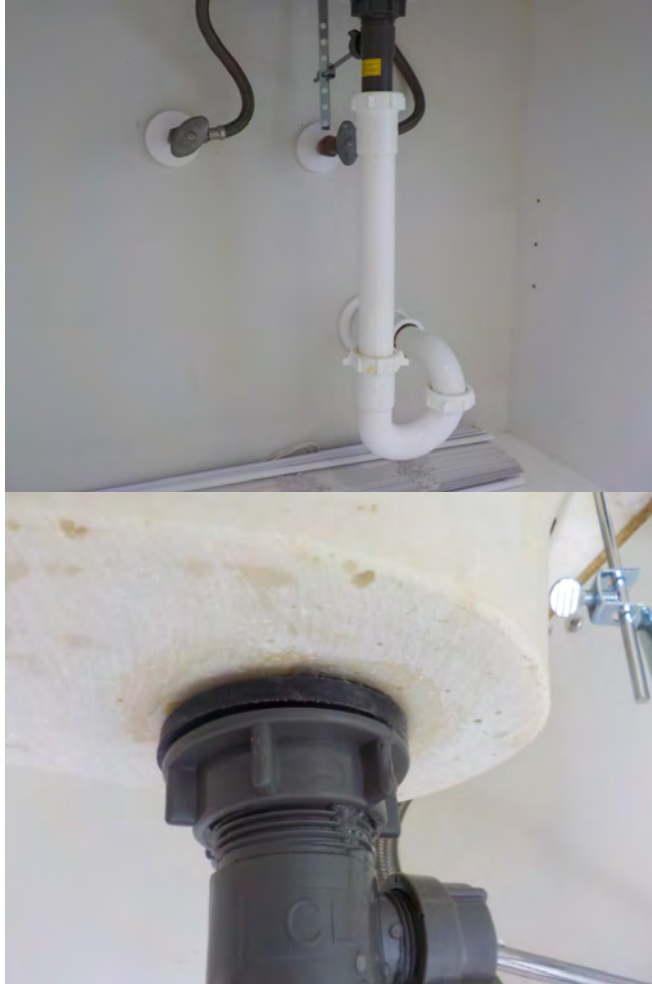
2819. 2. Traps/Drain  
/Supply

**Review; Leak noted at drainpipe underneath sink. Suggest review/repair by a qualified plumber.**

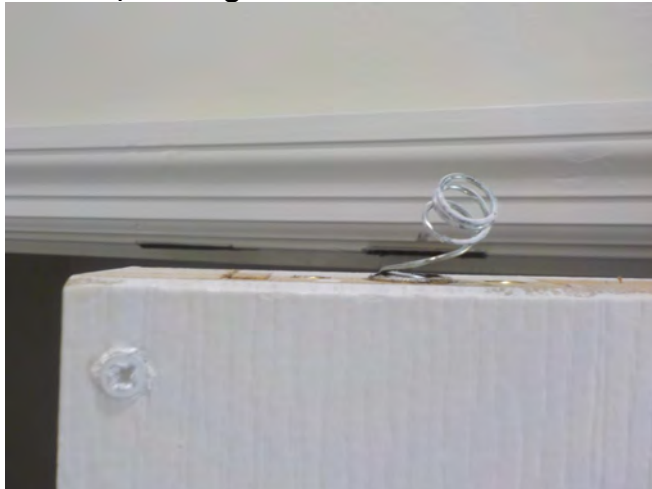
2823. 2. Closet

**Review; Damaged roller latch noted at one closet door.**

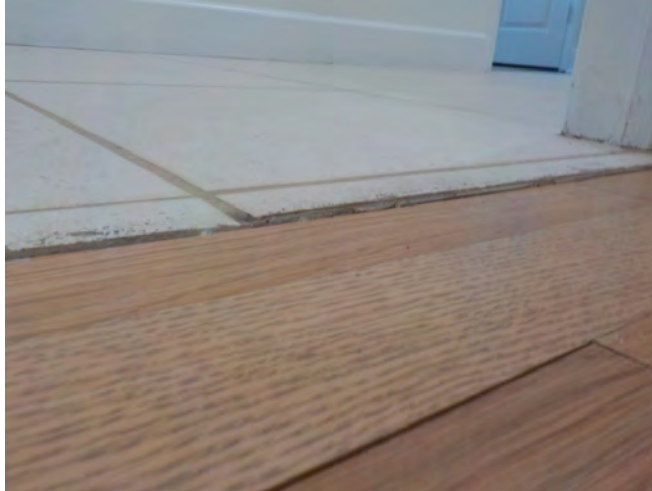
2901. Floor

**Review; Laminate. Missing threshold noted at bedroom entry area.**

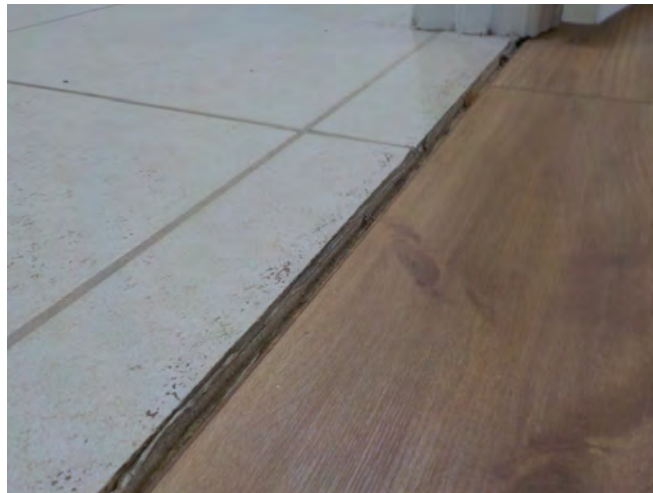
2901.2. Floor

**Review; Laminate. Missing threshold noted at bedroom entry area.**

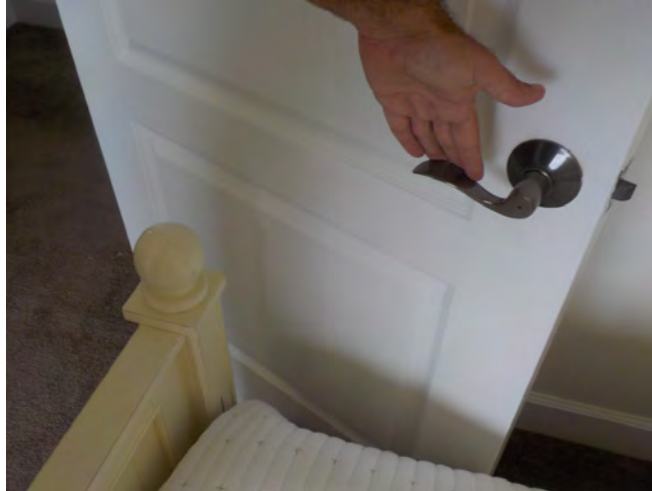
2904.3. Interior Doors

**Review; Wood. Door is obstructed by bed. Unable to test door latch.**

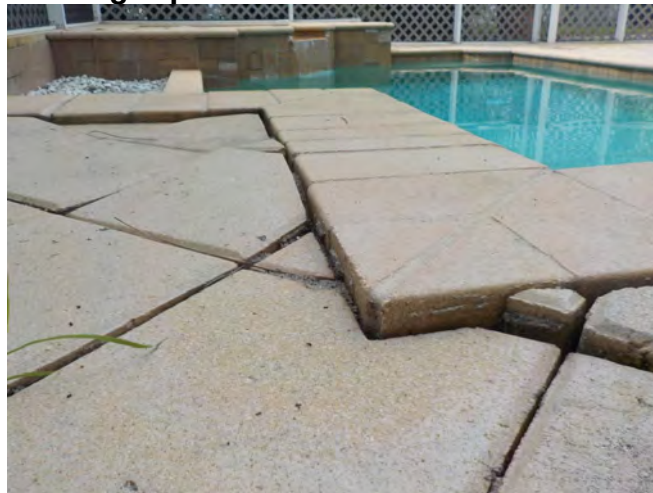
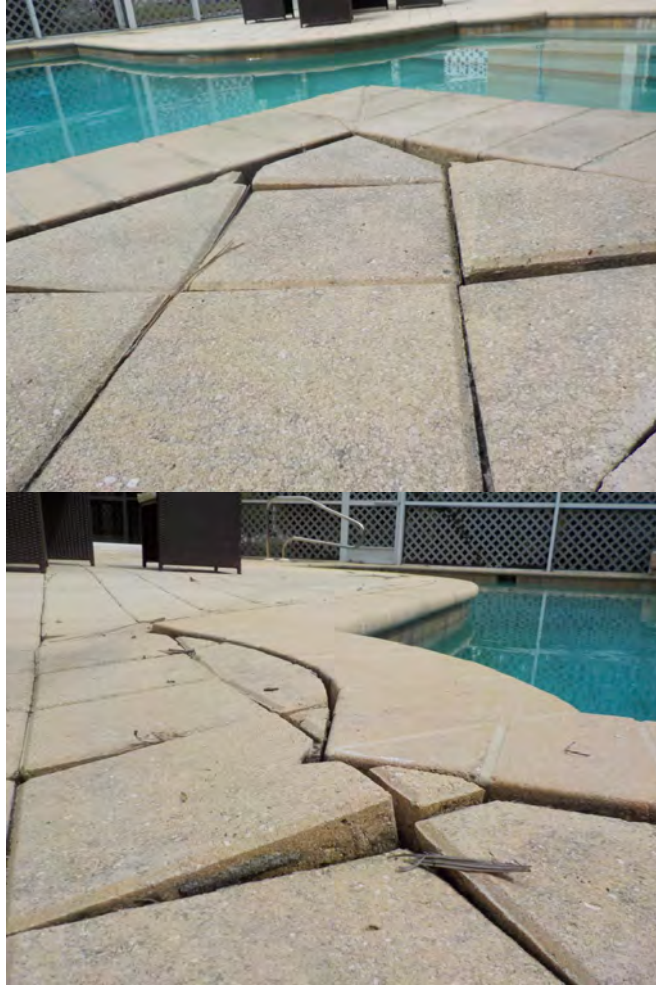
3002. Decking

**Review; Pavers. Settlement noted at multiple areas of pavers causing trip hazard.**

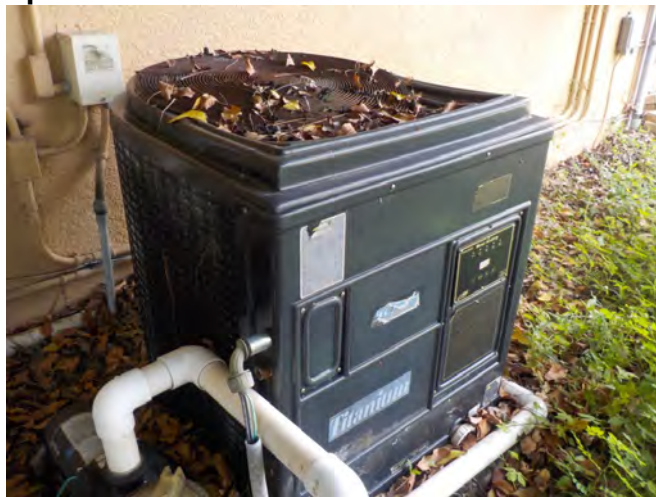
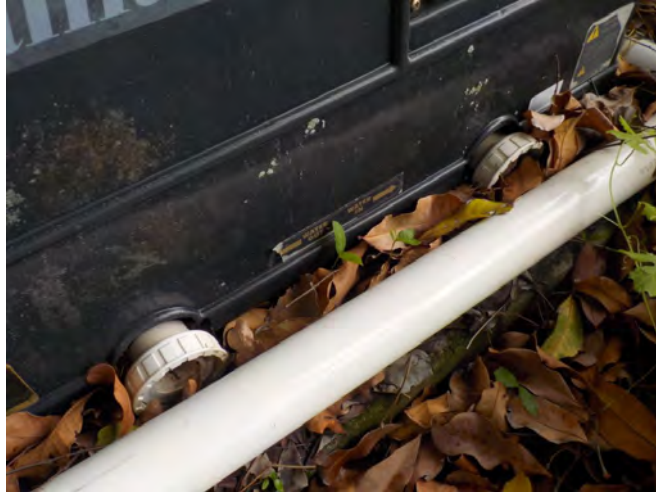
3010. Heater

**Review; Electric Heater present but disconnected. Unit is not operable.**
