## SUMMARY REPORT

Doc #: 2508-003 Inspection Date: 8/8/2025

Dwelling Address: XXXXX Vanderbilt Drive, Naples, FL 34108

## HAZELBAKER INSPECTION SERVICES

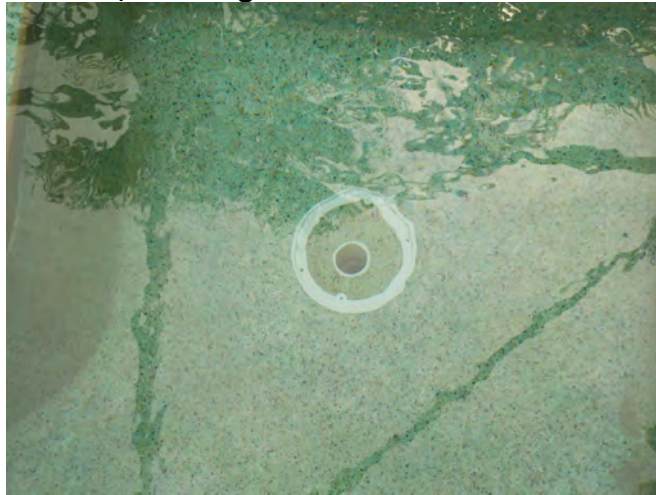
3013. Pump

**Review; Missing drain cover noted at hot tub.**

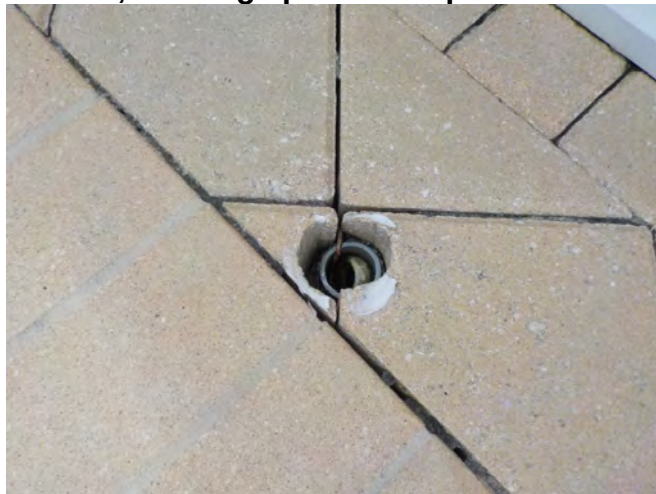
3015. Timer System

**Review; Missing spa control pad noted at hot tub.**

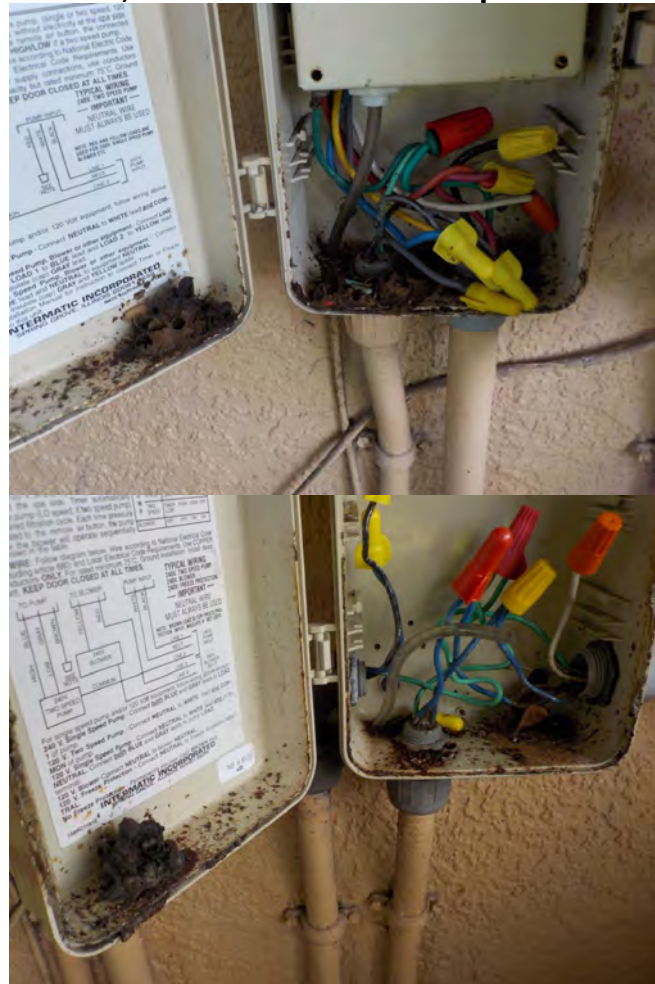
Review; Insect debris noted at pool timer boxes.
