HAZELBAKER CONSTRUCTION SERVICES
8965 QUARRY DRIVE
NAPLES, FLORIDA
(239)213-8046

Date: 12/23/2014

Dwelling Address: 123 Sunshine Way # 204, Estero, Florida 33928

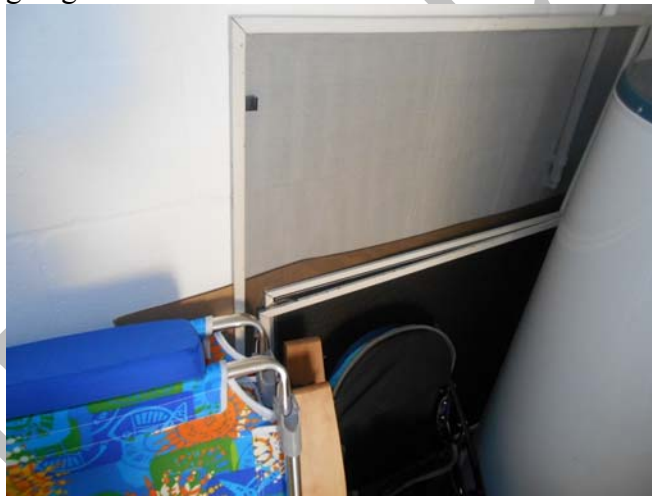
Step #	Component	Comment
1101.	Driveway	Functional; Brick.
1102.	Walkways	Functional; Brick.
1103.	Fences/Gates	None.
1104.	Siding	Functional; Stucco.
1105.	Trim	Functional; wood/metal.
1106.	Windows & Frames	Functional; Metal. Screens missing. Screens noted stored in garage.

Windows were difficult to operate. Possibly due to lack of use. All windows opened properly although unusual force was required in some cases.

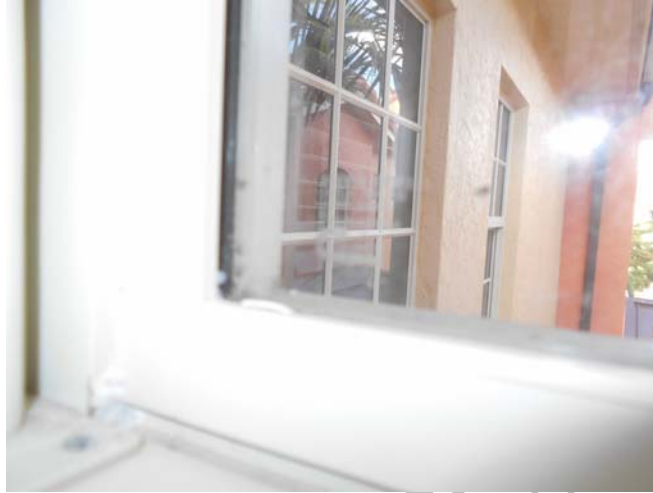
1114. Propane Tank/Gas Meter None.
1115. Exposed Foundation Functional; Slab.
1116. Shutters None. Impact glazing noted.

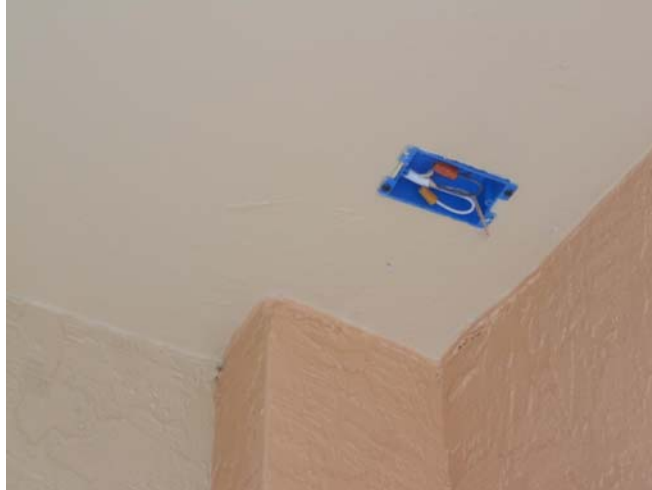
Step #	Component	Comment
1201.	Location	Rear.
1202.	Cover	Functional.
1203.	Enclosure	Functional; Aluminum and screen.
1204.	Electrical	Review: Open junction box noted, suggest installing device or cover for safety.

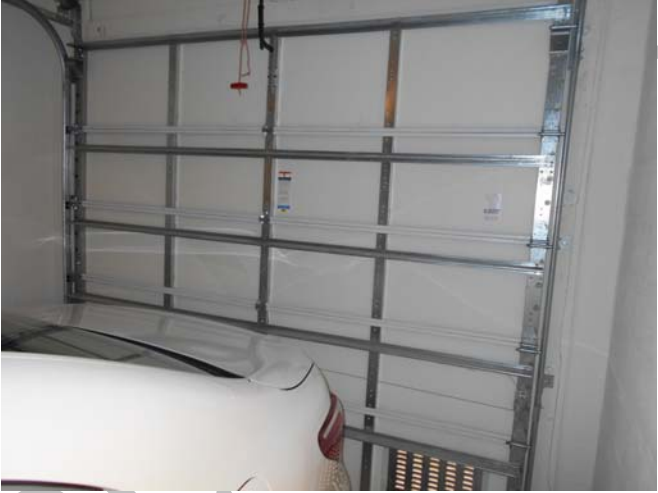
Step #	Component	Comment
1501.	Location	Attached.
1502.	Floor/Slab	Functional; Concrete. Common cracks noted.
1503.	Garage Door	Functional; Sectional; Metal.
1504.	Garage Door Hardware	Functional.
1505.	Garage Door Opener	Functional. This garage door is equipped with a mechanical safety reverse device, which operated when tested at the time of inspection. Suggest adjustments be checked as a maintenance item to assure safety. The U.S. Product Safety Commission recommends that these devices be checked monthly for proper operation and safety.

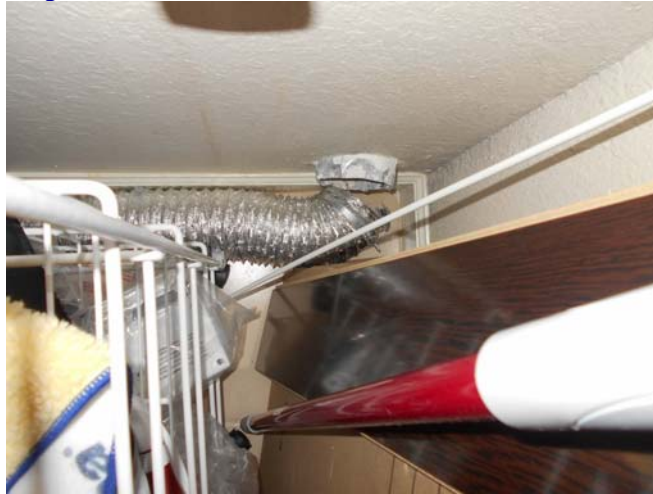
Review: Dryer vent was disconnected at the time of inspection.

1613. Dryer Manufacturer Suggest cleaning vent as part of normal home maintenance. Samsung.
1614. Heat/Cooling Source Forced air register.
1615. Closet None.
1616. Laundry Area None.
- Comments

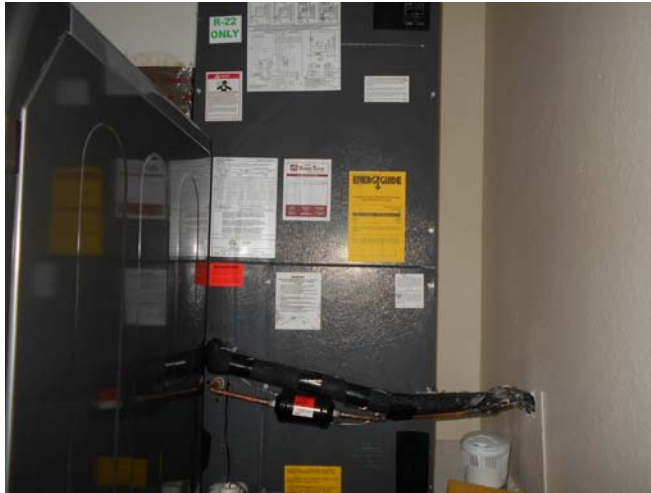
Step #	Component	Comment
1801.	Heating	Functional; Electric; Split system; Forced air. Unit is located at Hall closet.
1802.	Heating Conditions	Electrical heat current draw at time of inspection was 43 amps.
1803.	Heater Manufacturer	Goodman. Model#Aruf36421ba serial # 0605078666 Manufacture Date: 2006.

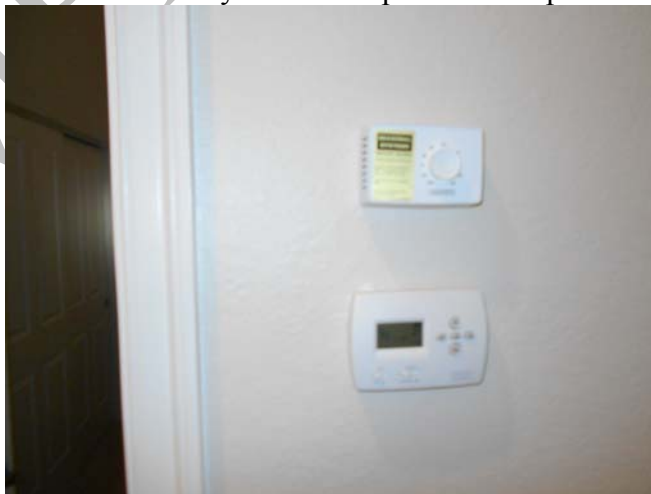
1804.	Exhaust Venting	Not Applicable.
1805.	Thermostat	Functional; Hallway. A humidistat is installed to control system operation during vacant periods. Testing of humidistats is beyond the scope of this inspection.

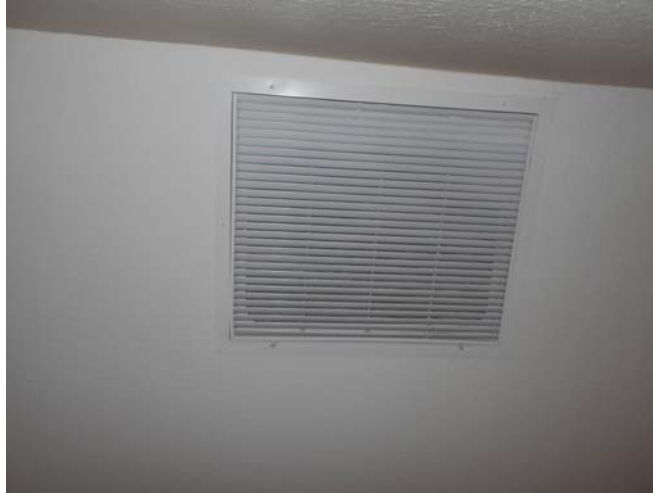
1806. Filter Hallway. Suggest replacing filter. Filter should be changed every thirty days for most efficient operation.

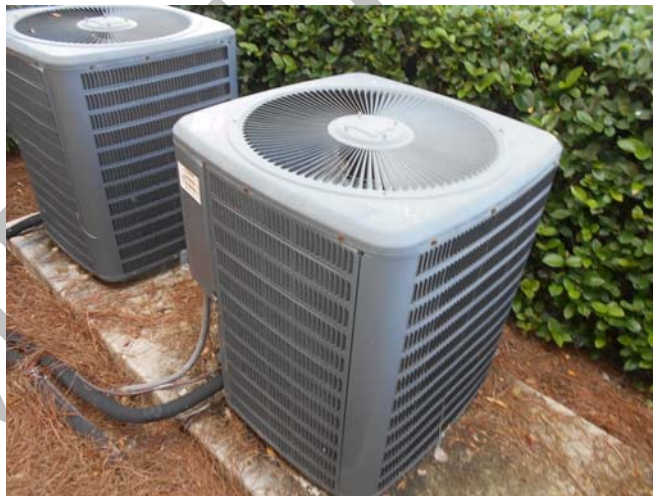
1807. Ducting Functional where visible.
 1808. Air Conditioning System Condenser is located at the front.
 1809. A/C Manufacturer Goodman.
 Model #gsci30361eb. Serial #0609678620
 Manufacture Date: 2006.

1810. A/C Temperature Differences Return air temperature at register was 71 degrees. Supply air temperature was 57 degrees. Difference in air temperature at time of inspection was 14 degrees.

Temperature difference was within the 14 to 22 degrees normal operating range at time of inspection. Unit functioned properly when tested. Appeared to be serviceable at time of inspection. As with all mechanical equipment, this unit may fail at any time without warning. Inspectors cannot determine future failures.

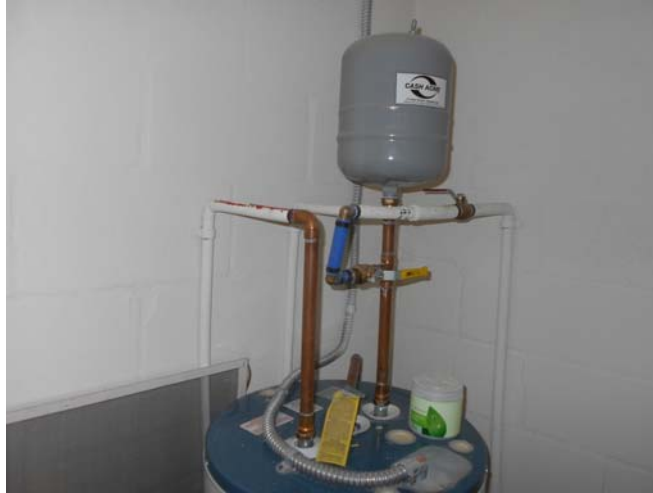
1906. Water Heater Electric; 40 Gallon. Temperature pressure relief valve and expansion tank installed as a safety feature.

1907. Water Heater Thermostat Settings Top and bottom elements are set at 125 degrees. Water temperature at time of inspection was 113 degrees.

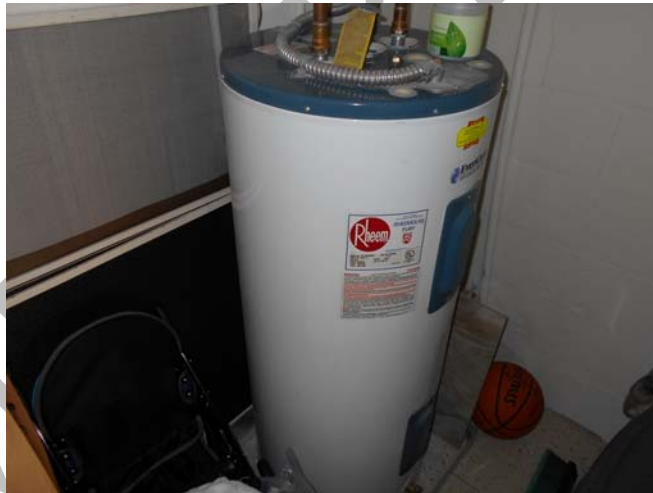
1908. Water Heater Manufacturer Rheem.
Model 82v40-2. Serial # 0806d06938.
Manufacture Date: 2006.
