HAZELBAKER CONSTRUCTION SERVICES
8965 QUARRY DRIVE
NAPLES, FLORIDA
(239)213-8046

Doc #: 1412-000 Inspector: Joel Hazelbaker

Date: 12/23/2014

Dwelling Address: 123 Sunshine Way # 204, Estero, Florida 33928

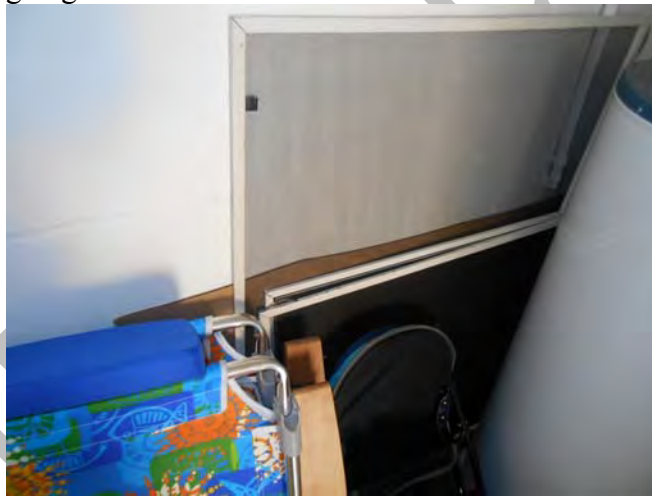
Step #	Component	Comment
1101.	Driveway	Functional; Brick.
1102.	Walkways	Functional; Brick.
1103.	Fences/Gates	None.
1104.	Siding	Functional; Stucco.
1105.	Trim	Functional; wood/metal.
1106.	Windows & Frames	Functional; Metal. Screens missing. Screens noted stored in garage.

Windows were difficult to operate. Possibly due to lack of use. All windows opened properly although unusual force was required in some cases.

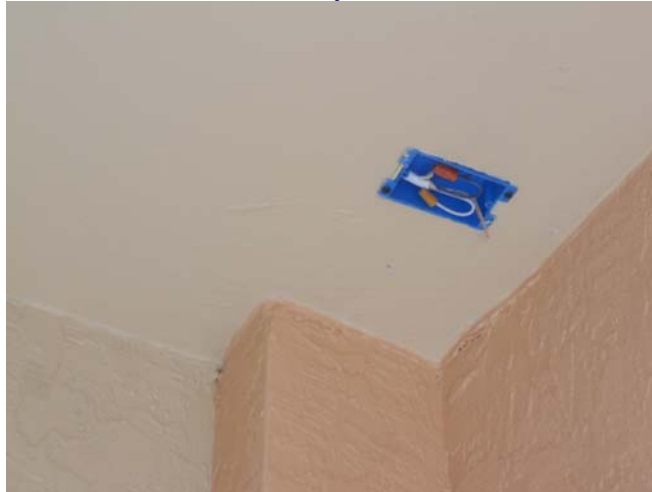
Step #	Component	Comment
1201.	Location	Rear.
1202.	Cover	Functional.
1203.	Enclosure	Functional; Aluminum and screen.
1204.	Electrical	Review: Open junction box noted, suggest installing device or cover for safety.

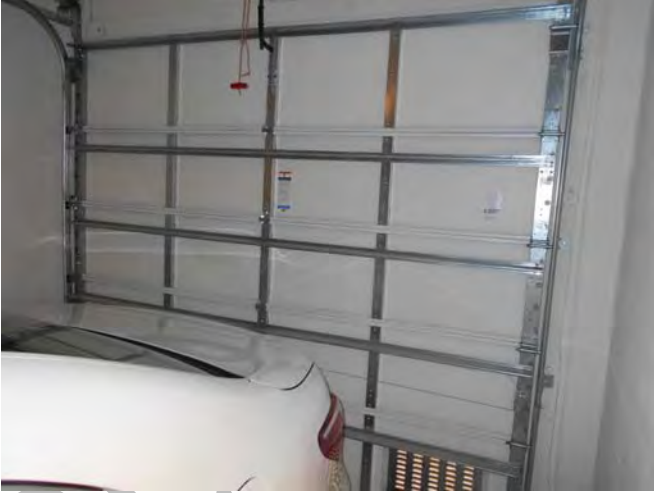
Step #	Component	Comment
1501.	Location	Attached.
1502.	Floor/Slab	Functional; Concrete. Common cracks noted.
1503.	Garage Door	Functional; Sectional; Metal.
1504.	Garage Door Hardware	Functional.
1505.	Garage Door Opener	Functional. This garage door is equipped with a mechanical safety reverse device, which operated when tested at the time of inspection. Suggest adjustments be checked as a maintenance item to assure safety. The U.S. Product Safety Commission recommends that these devices be checked monthly for proper operation and safety.

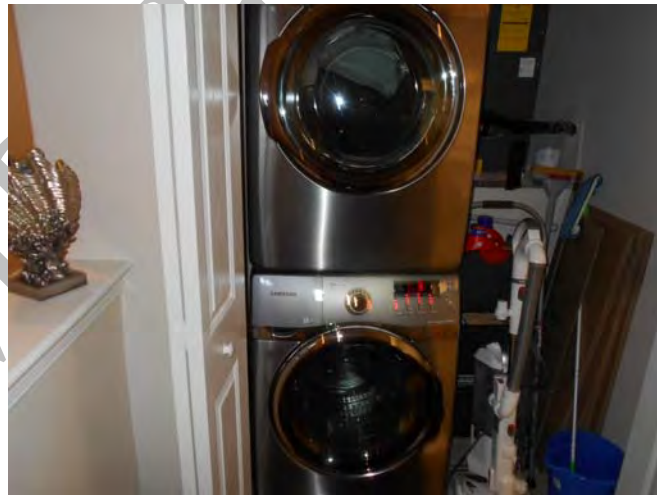
Step #	Component	Comment
1601.	Floor	Tile.
1602.	Walls	Functional.
1603.	Ceiling	Functional.
1604.	Interior Doors	Functional; Wood Bi-Fold.
1605.	Exterior Doors	None.
1606.	Windows / Screens	None.
1607.	Cabinets	None.
1608.	Laundry Sink/Tub	None.
1609.	Electrical	Functional.
1610.	Washer & Hook-ups	Washer was tested using normal operating controls and appeared to function properly at time of inspection. No warranty or guarantee is given as to the efficiency or functionality of this unit. As with all appliances, it may fail at any time without warning.

The supply hoses to the washer are not disconnected during the inspection, nor do we operate the valves. These can leak at any time and should be considered part of normal maintenance.

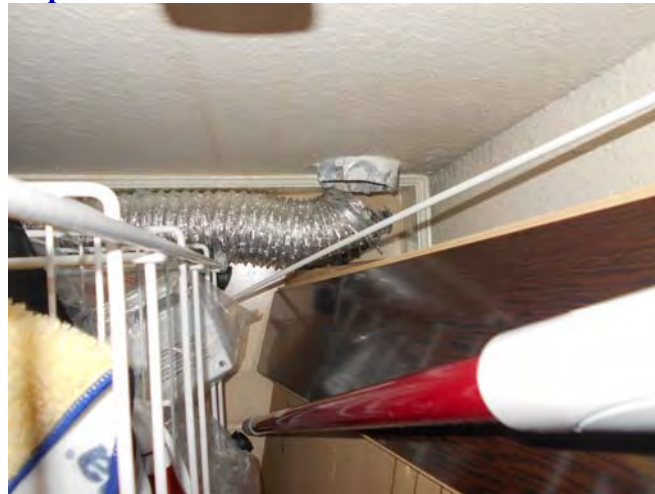
Review: Dryer vent was disconnected at the time of inspection.

1613. Dryer Manufacturer Suggest cleaning vent as part of normal home maintenance. Samsung.
1614. Heat/Cooling Source Forced air register.
1615. Closet None.
1616. Laundry Area None.
- Comments

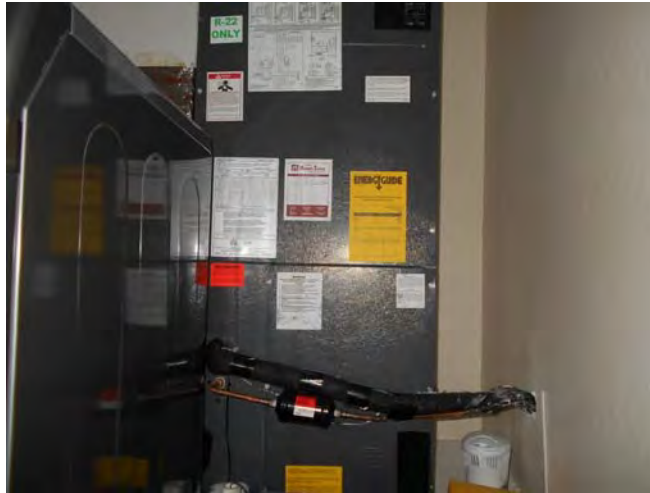
Step #	Component	Comment
1801.	Heating	Functional; Electric; Split system; Forced air. Unit is located at Hall closet.
1802.	Heating Conditions	Electrical heat current draw at time of inspection was 43 amps.
1803.	Heater Manufacturer	Goodman. Model#Aruf36421ba serial # 0605078666 Manufacture Date: 2006.

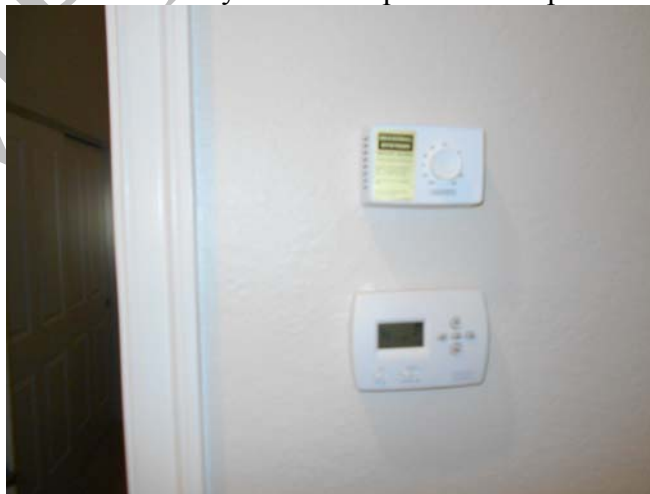
1804.	Exhaust Venting	Not Applicable.
1805.	Thermostat	Functional; Hallway. A humidistat is installed to control system operation during vacant periods. Testing of humidistats is beyond the scope of this inspection.

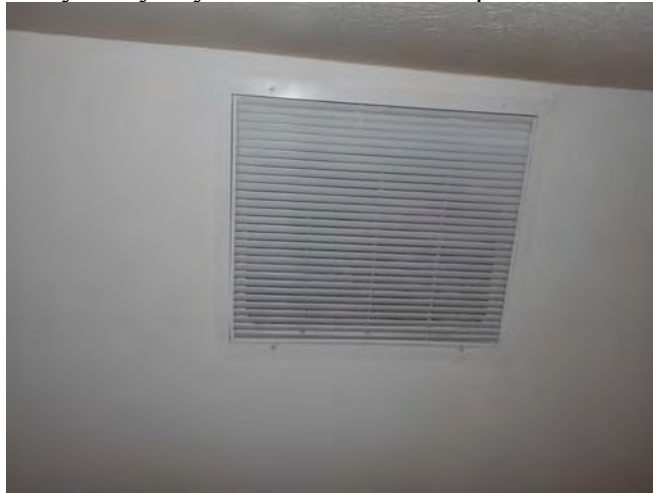
1806. Filter Hallway. Suggest replacing filter. Filter should be changed every thirty days for most efficient operation.

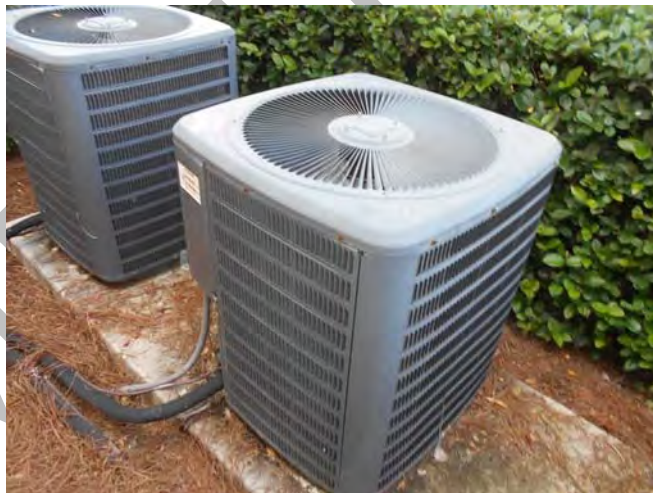
1807. Ducting Functional where visible.
 1808. Air Conditioning System Condenser is located at the front.
 1809. A/C Manufacturer Goodman.
 Model #gsci30361eb. Serial #0609678620
 Manufacture Date: 2006.

1810. A/C Temperature Differences Return air temperature at register was 71 degrees. Supply air temperature was 57 degrees. Difference in air temperature at time of inspection was 14 degrees.

Temperature difference was within the 14 to 22 degrees normal operating range at time of inspection. Unit functioned properly when tested. Appeared to be serviceable at time of inspection. As with all mechanical equipment, this unit may fail at any time without warning. Inspectors cannot determine future failures.

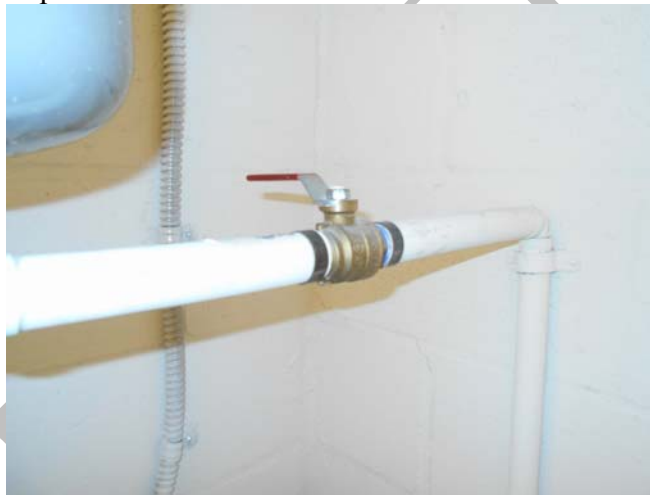
Step #	Component	Comment
1901.	Plumbing Supply System	Property has a public water supply. Main water shut off is located at garage. Water was left on at listing agents' request.

Water pressure at time of inspection was 60 psi. Pressure was within normal range of 35 to 80 psi.

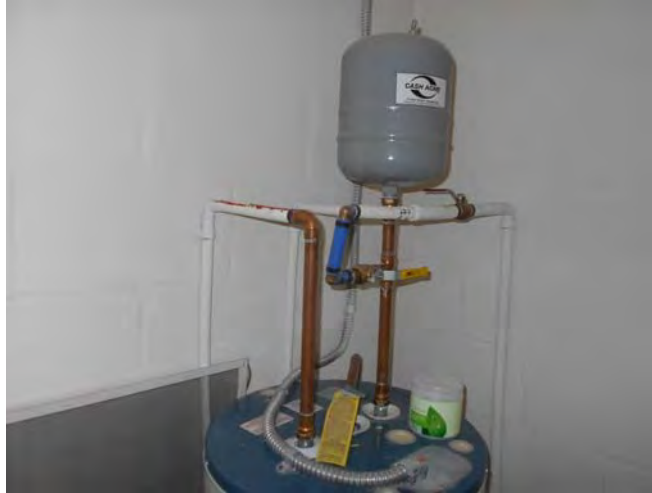
1906. Water Heater Electric; 40 Gallon. Temperature pressure relief valve and expansion tank installed as a safety feature.

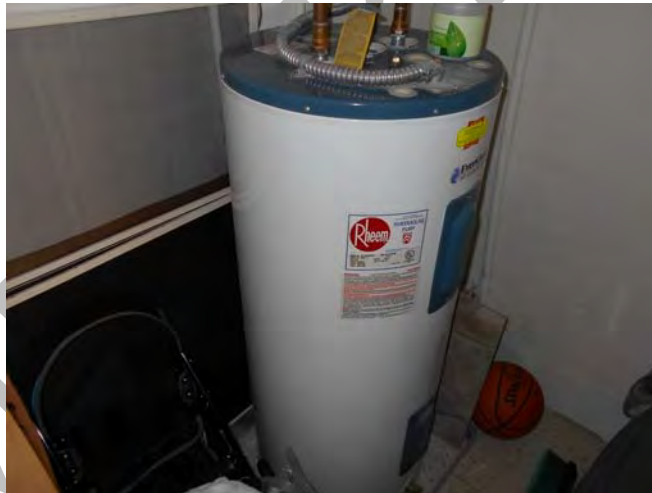
1907. Water Heater Thermostat Settings Top and bottom elements are set at 125 degrees. Water temperature at time of inspection was 113 degrees.
1908. Water Heater Manufacturer Rheem. Model 82v40-2. Serial # 0806d06938. Manufacture Date: 2006.
