## FULL PROPERTY INSPECTION REPORT

Doc #: 2509-003 Inspection Date: 9/9/2025

Dwelling Address: XXXX Cedar Hammock Circle #714, Naples, FL 34112

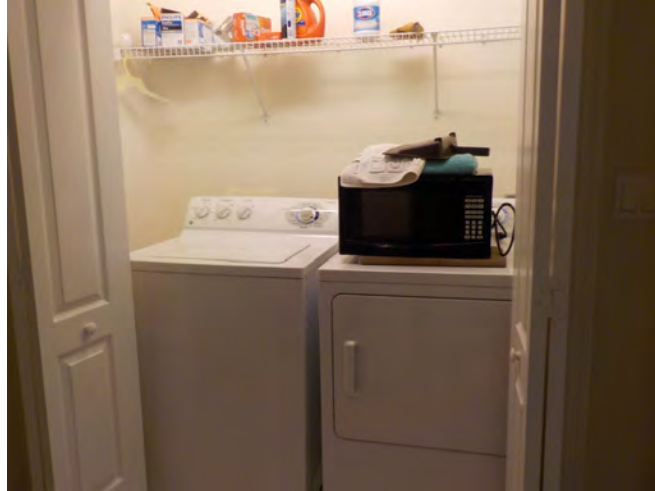
| 1602. | Walls | |

**Review; Staining consistent with possible mold growth noted at laundry room wall behind washing machine. Area was dry at time of inspection. Suggest review of mold air quality test performed on 9/9/2025.**

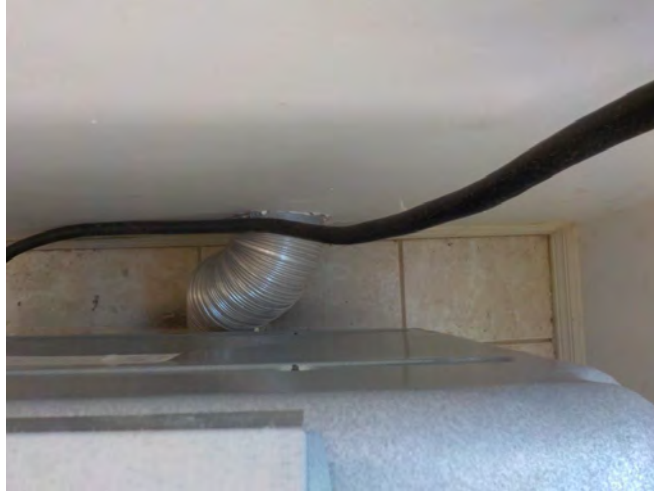
Suggest cleaning vent as part of normal home maintenance.

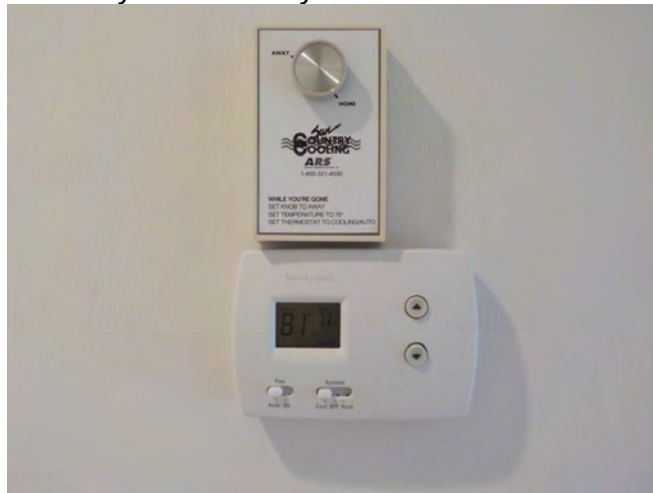
A humidistat is installed to control system operation during vacant periods. Testing of humidistats is beyond the scope of this inspection. A nonworking humidistat or improper use of a humidistat can cause substantial damage to a home. We suggest removal of the humidistat so that the thermostat can properly control the temperature and indirectly the humidity level in the home.

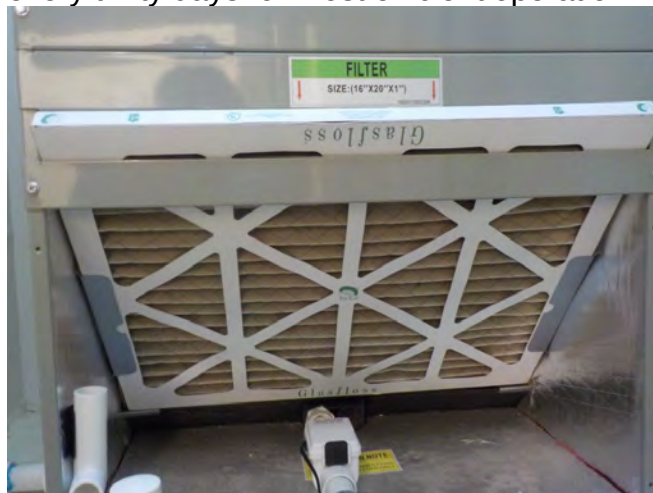
1806.     Filter                    Located at the unit. Suggest replacing filter. Filter should be changed every thirty days for most efficient operation.

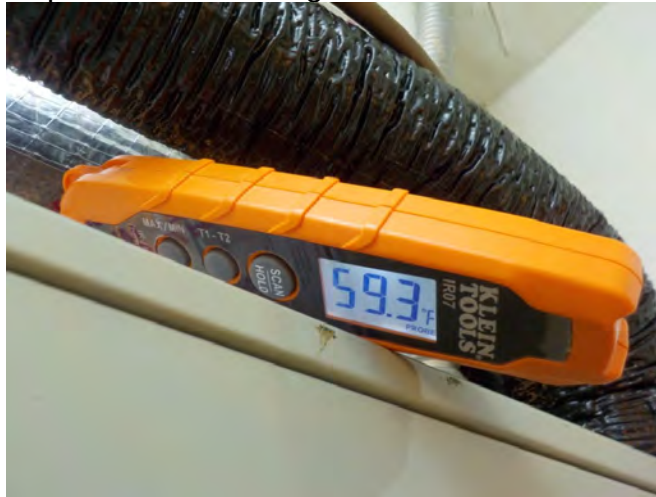
1810.     A/C Temperature Differences     Return air temperature at register was 78 degrees. Supply air temperature was 59 degrees. Difference in air temperature at time of inspection was 19 degrees.

Temperature difference was within the 16 to 22 degrees normal operating range at time of inspection. Unit functioned properly when tested. Appeared to be serviceable at time of inspection. As with all mechanical equipment, this unit may fail at any time without warning. Inspectors cannot determine future failures.

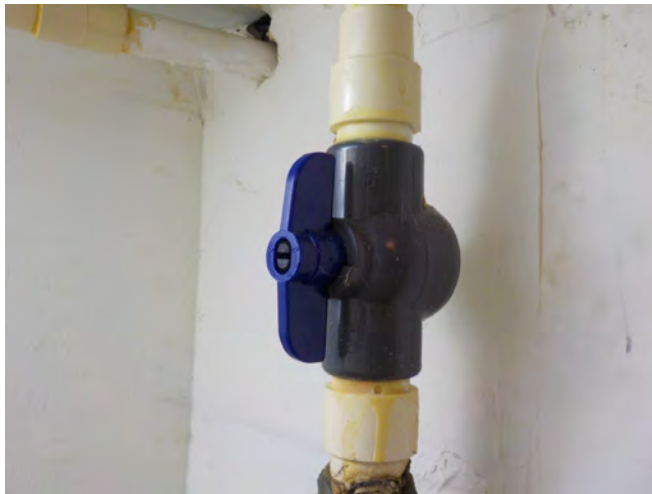
| Step # | Component | Comment |
|---|---|---|
| 1901. | Plumbing Supply System | Property has a public water supply. Main water shut off is located at water heater. |

Water pressure at time of inspection was 60 psi. Pressure was within normal range of 35 to 80 psi.

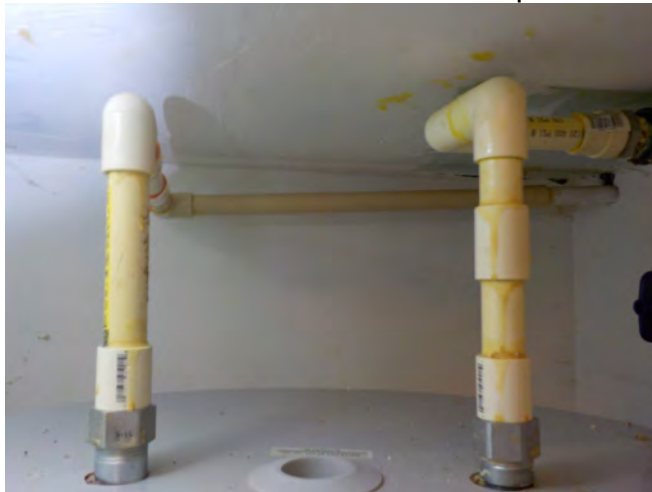
1903. Supply Pipes      CPVC. No leaks noted at time of inspection.

Review; Leak noted at supply connection at main water shut off. Suggest review/repair by a qualified plumber.

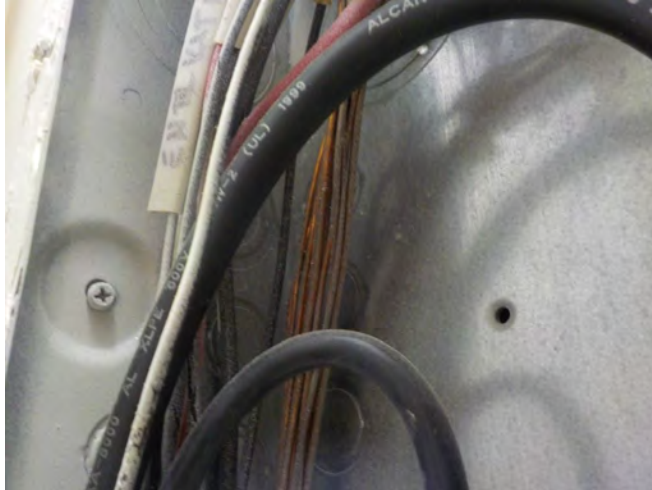
No surge protector present. Additional protection may be required to adequately protect the home and appliances.

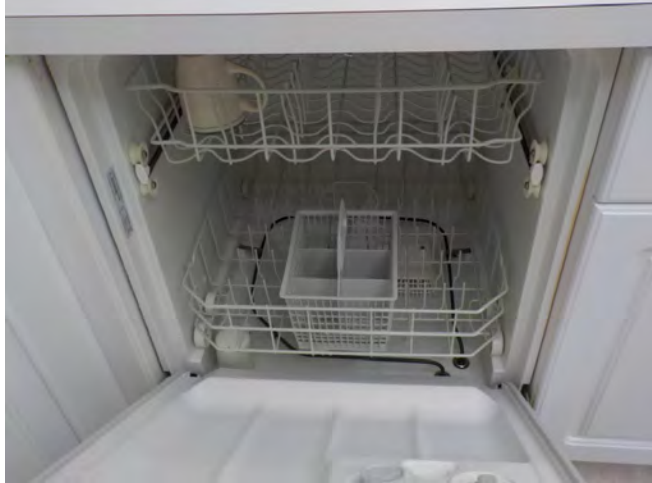
2114. Dishwasher

**Review; No loop in drain line at dishwasher. A loop in drain line is required to prevent dirty drain water from entering the dishwasher.**

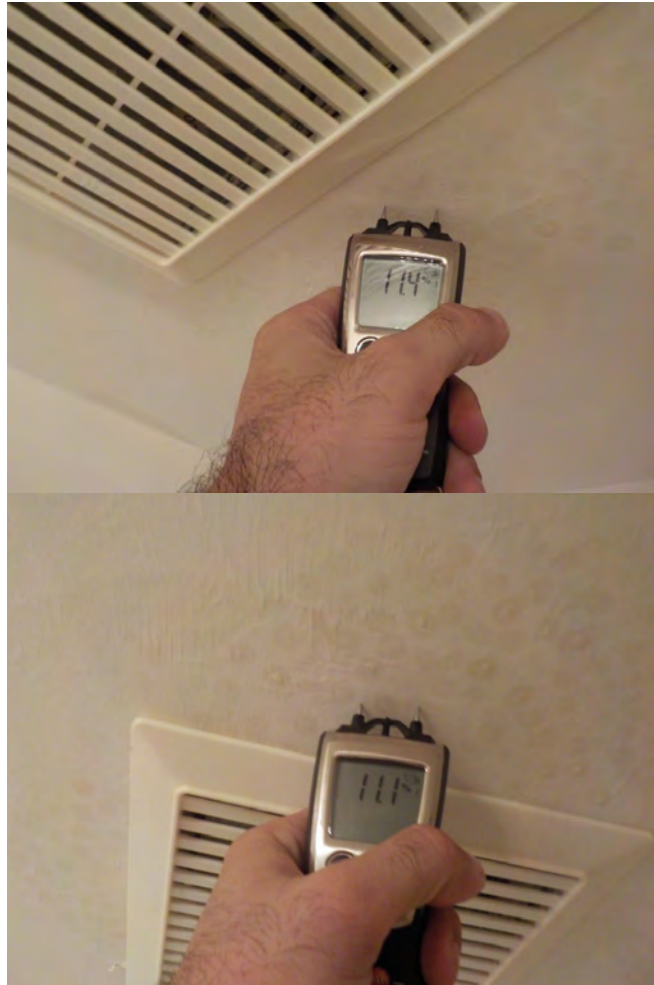
| Step # | Component | Comment |
|---|---|---|
| 2703. | Ceiling | <b>Review; Stain noted at master bathroom exhaust vent. Origin of staining unknown. Area was dry at time of inspection. Suggest monitoring.</b> |

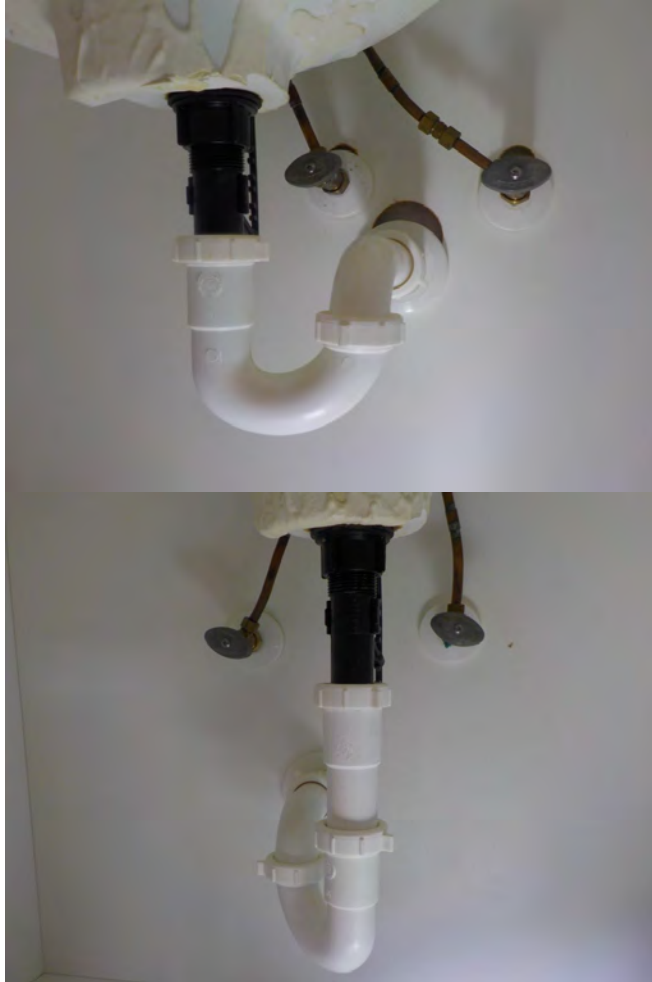
2719. Traps/Drain  
/Supply

**Review; Leak noted at top of drainpipe underneath right side sink. Suggest review/repair by a qualified plumber.**
