HAZELBAKER CONSTRUCTION SERVICES
14501 MARSALA WAY
NAPLES, FLORIDA 34109
(239) 213-8015

Doc #: 2112-030 Inspector: John "Jack" Defossez

Date: 12/22/2021

Dwelling Address: 123 Sunshine Way, Bonita Springs, Florida 34134

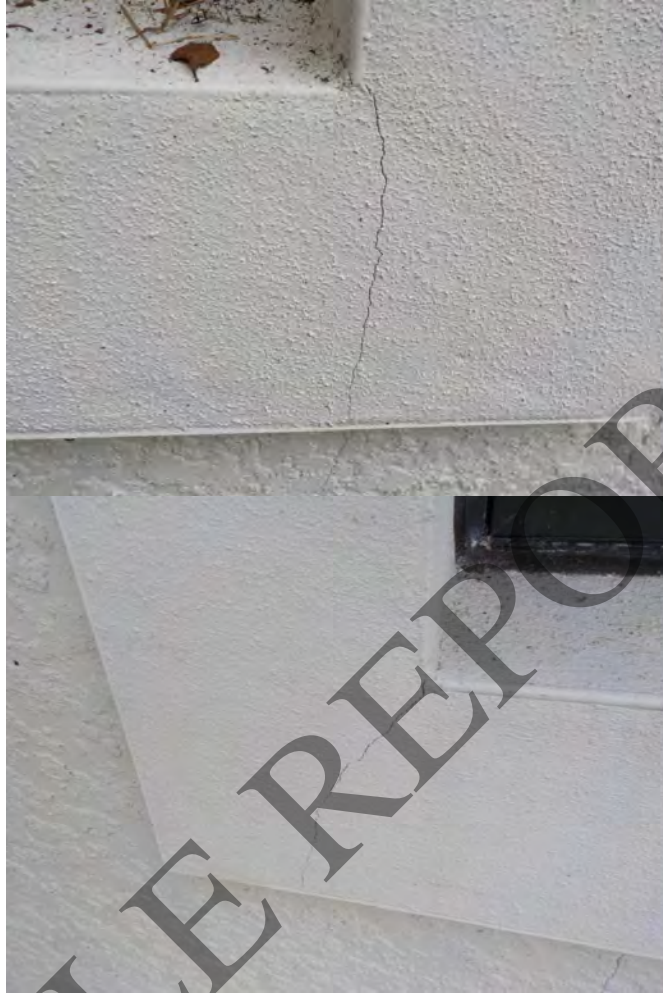
1104.	Siding	Review; Stucco. Cracks present at several locations. Cracks should be properly sealed to prevent insect and moisture intrusion. Damage/deterioration to interior walls may be present.
-------	--------	---

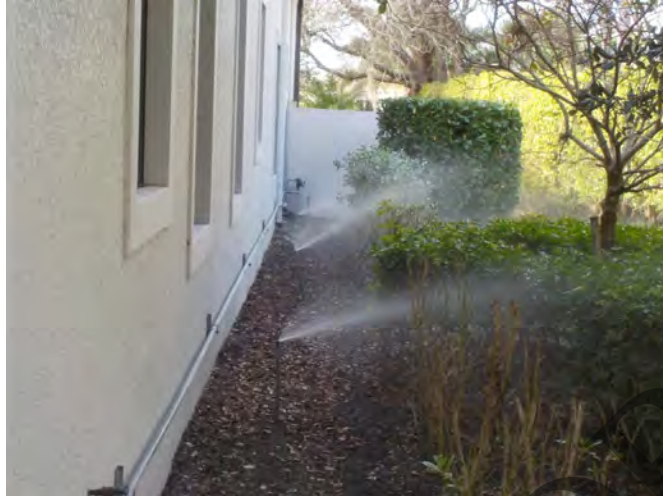
Review; Broken head noted at front side of home.

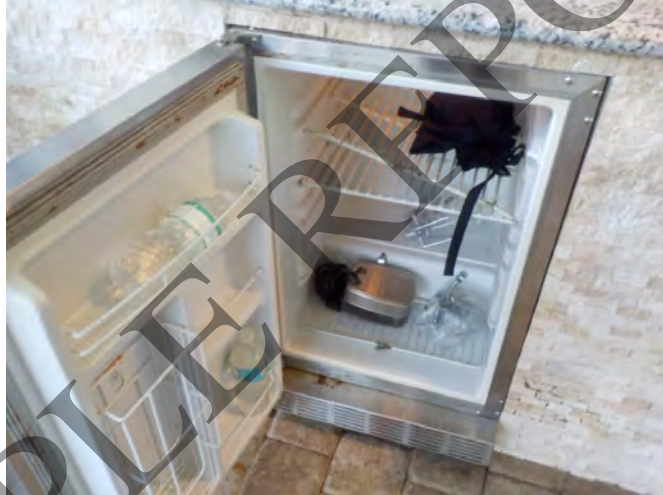
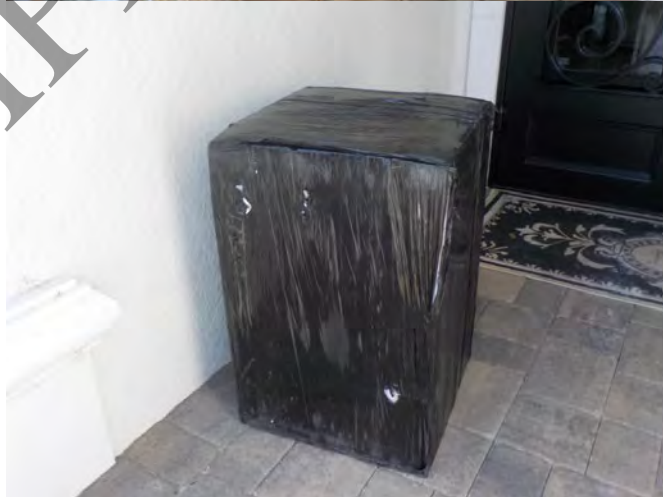
1212. Refrigerator

Review; Fridge is not functional. New fridge to be installed.

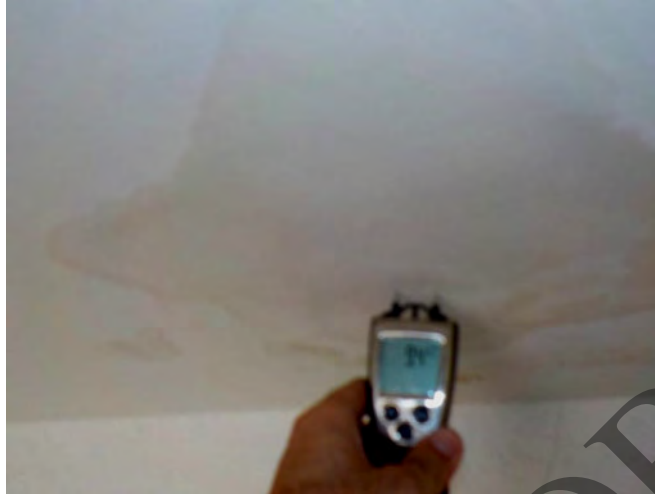
Review; Staining noted on ceiling in two areas on right-side garage. Areas were dry at time of inspection. Suggest review by a water damage expert.

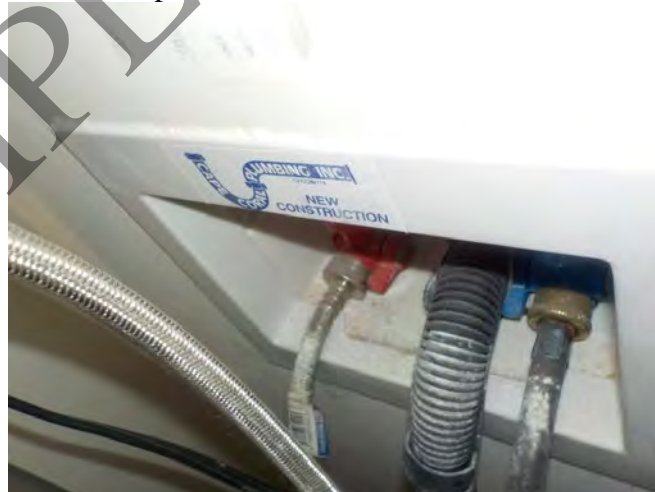
1611. Washer
Manufacturer Maytag.

Review; Rust noted at washing machine.

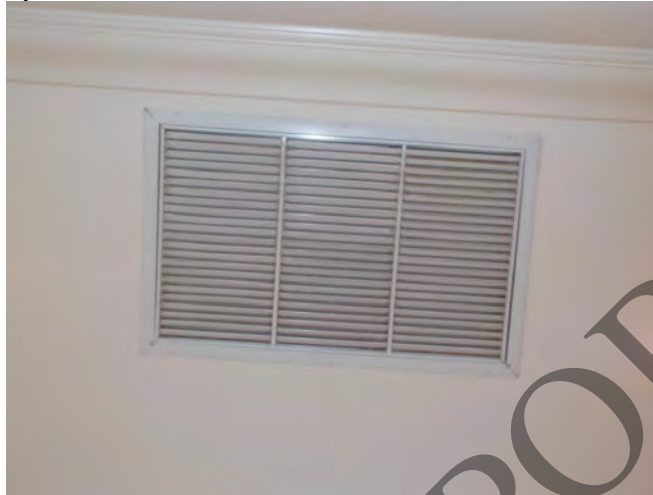
1806. Filter Located at the return air registers throughout home. Suggest replacing filter. Filter should be changed every thirty days for most efficient operation.

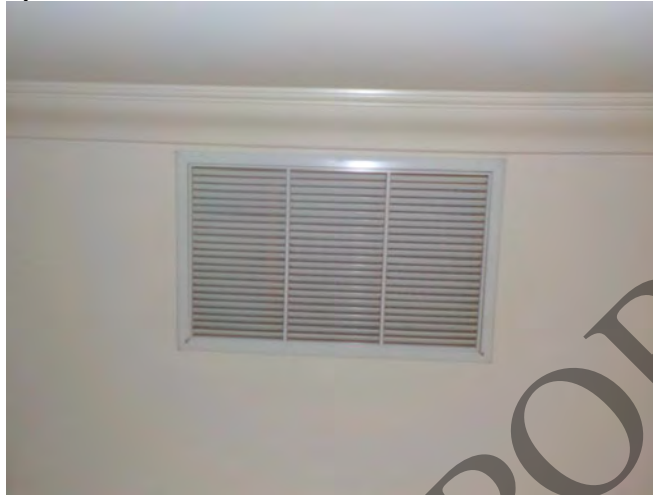
1806. Filter Located at the return air registers throughout home. Suggest replacing filter. Filter should be changed every thirty days for most efficient operation.

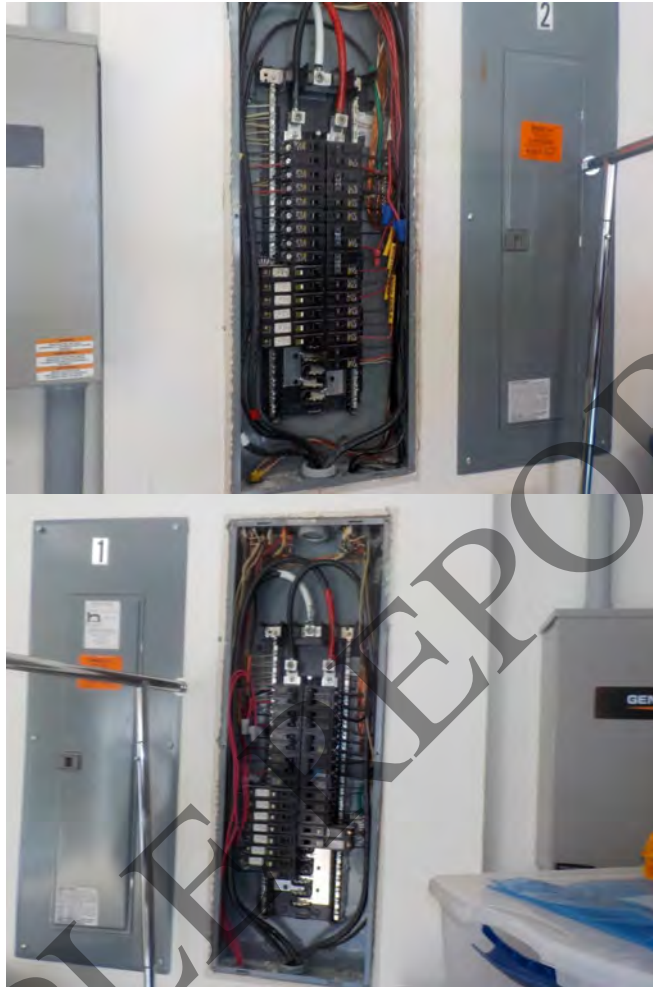
2002. Electrical Main Functional.
Box Comments

No surge protector present. Additional protection may be required to adequately protect the home and appliances.

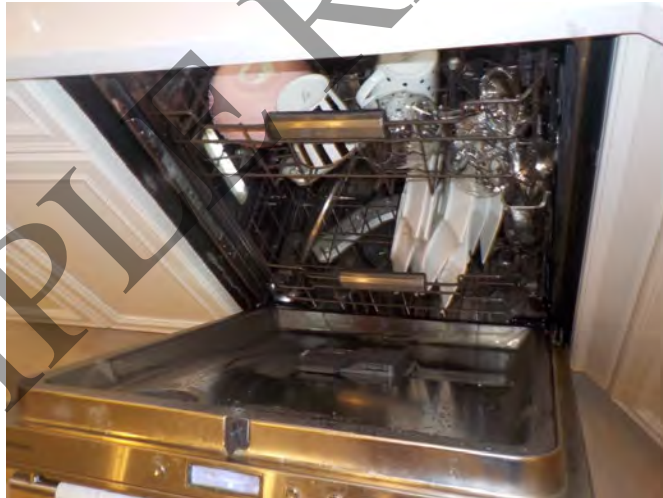
2114. Dishwasher

Review; No loop in drain line. A loop in drain line is required to prevent dirty drain water from entering the dishwasher.

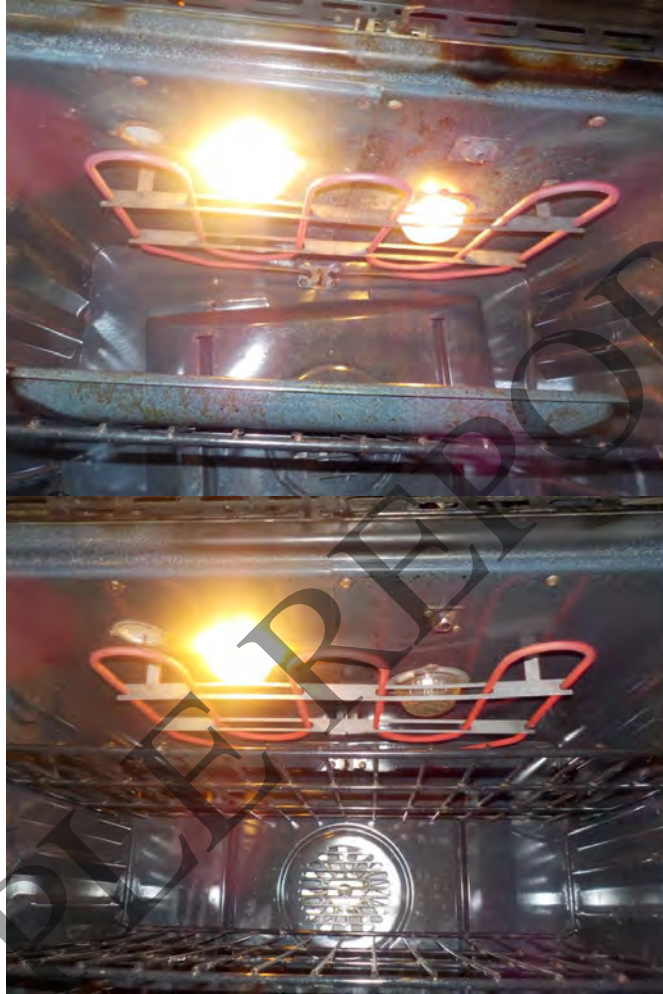
2116. Oven

Review; Loose handle noted at lower oven door. Cracked glazing noted at window.

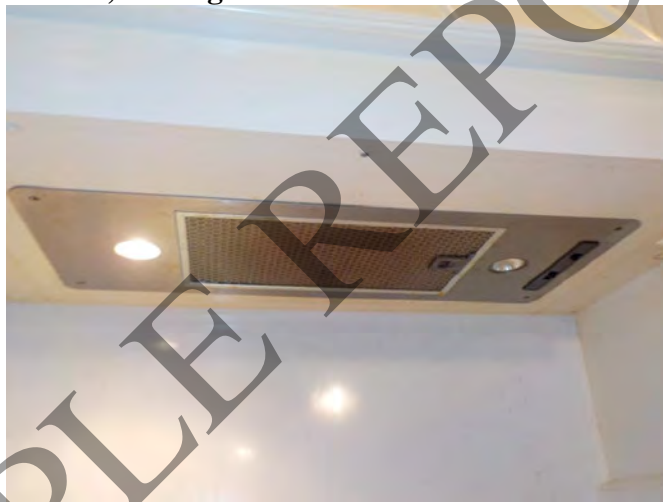
2117. Hood/Fan/Light **Review; One light not functional at hood. Possible bad bulb.**

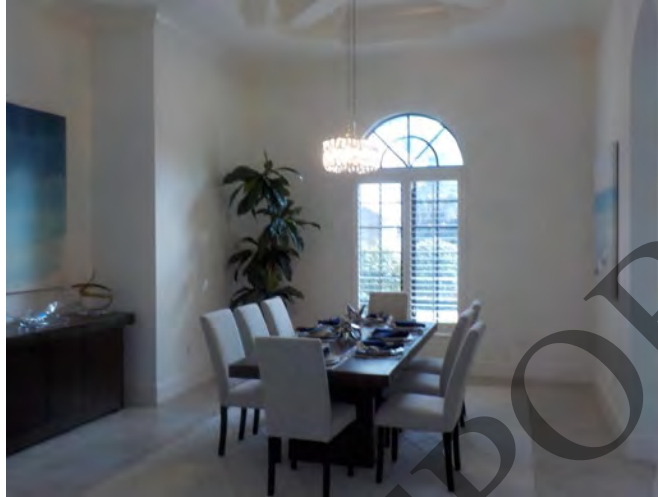
2402.	Walls	Functional. Patching noted at wall/baseboard near window.
2403.	Ceiling	Functional.
2404.	Interior Doors	None.
2405.	Exterior Doors	None.
2406.	Windows / Screens	Functional; Casement/Fixed.
2407.	Electrical	Functional.
2408.	Heat/Cooling Source	Forced air register.
2409.	Ceiling Fan	None.
2410.	Wet Bar	None.
2411.	Closet	None.
2412.	Comments	None.

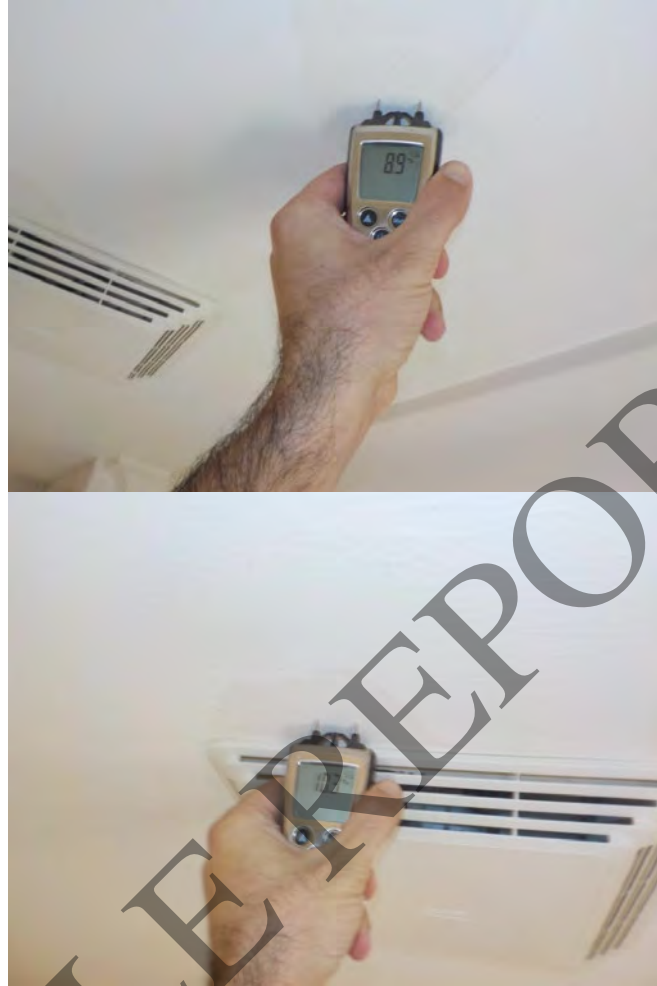
2803. 2.	Ceiling	Review; Staining noted at ceiling. Areas were dry at time of inspection. Suggest review by a water damage expert.
----------	---------	---

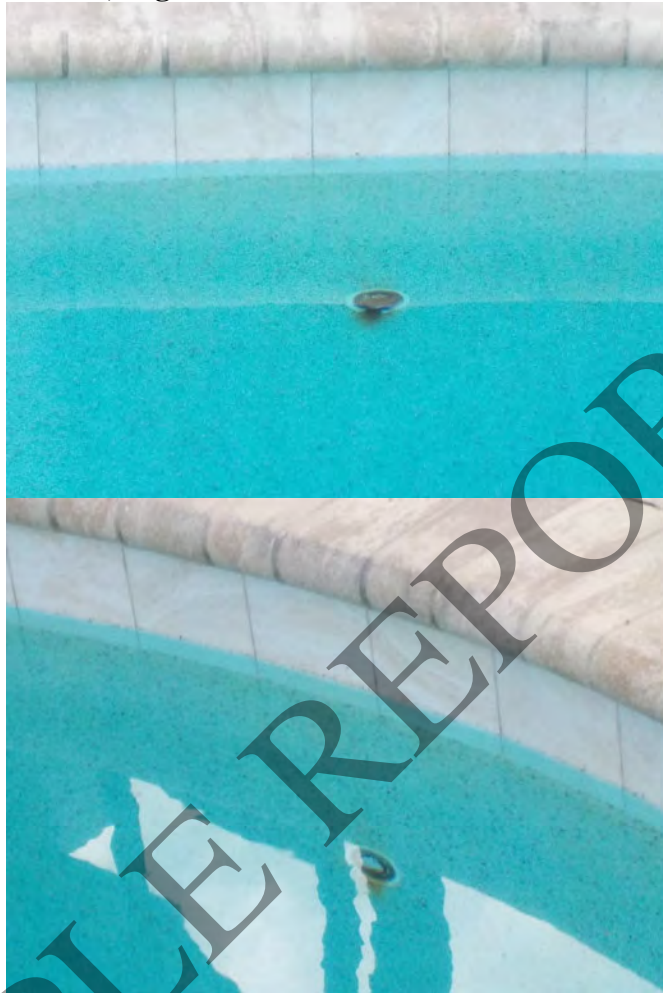
3008. Lights

Review; Lights are not functional.

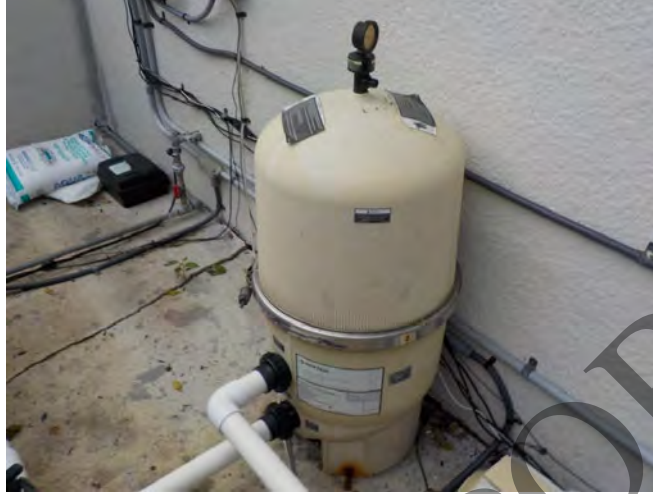
3011. Filter System Filter is the cartridge type. Filter was not accessed for inspection. Periodic cleaning/replacing of filter cartridge is required. Suggest replacing filter.

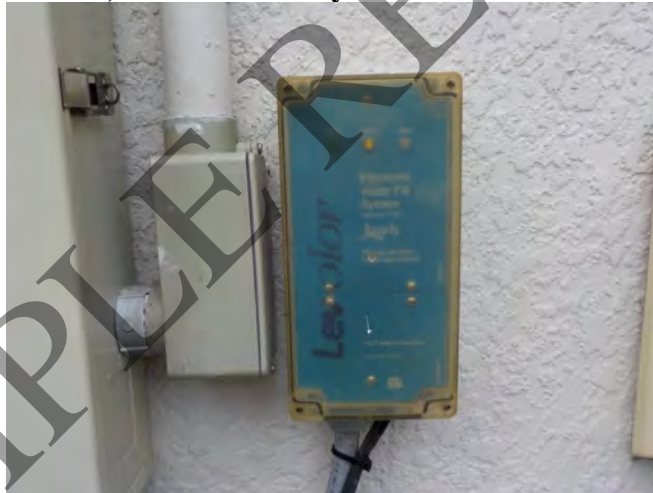
Review; Auto-level/fill system is not functional.

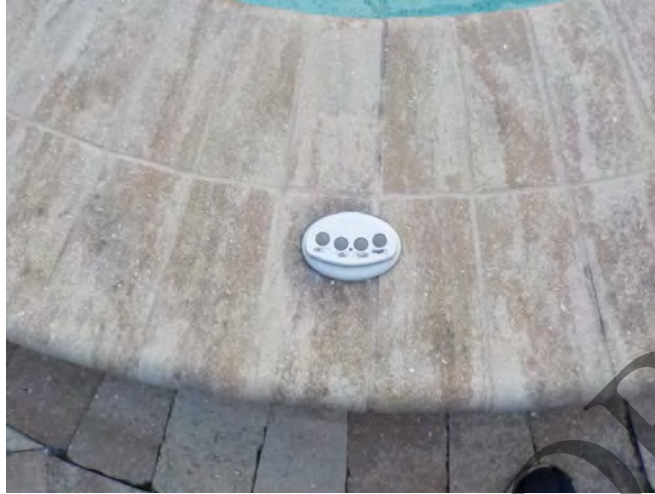
Review; Spa control pad is not functional.
