**HAZELBAKER CONSTRUCTION SERVICES**  
**8965 QUARRY DRIVE**  
**NAPLES, FLORIDA**  
**(239)213-8046**

Doc #: 1412-000 Inspector: Joel Hazelbaker  
Date: 12/13/2016  
Dwelling Address: 123 Sunshine Way # 204, Estero, Florida 33928  
Client Name: John Doe

**GENERAL CONDITIONS**

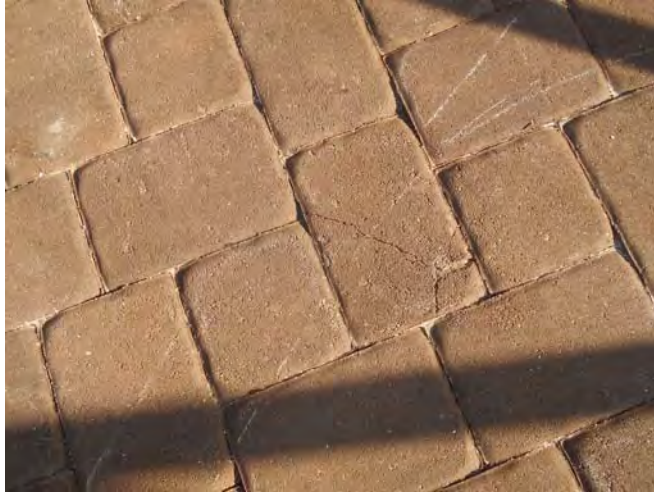
1102. Walkways

**Review; Brick. Brick requires cleaning of construction debris and paint at all locations.**

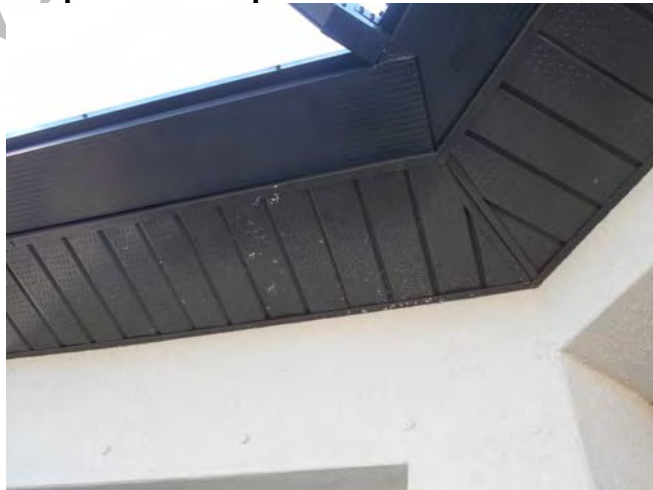
1105. Trim

**Review; Wood/Metal. Paint overspray present. Paint and construction debris should be cleaned off exterior trim and other building components as required.**

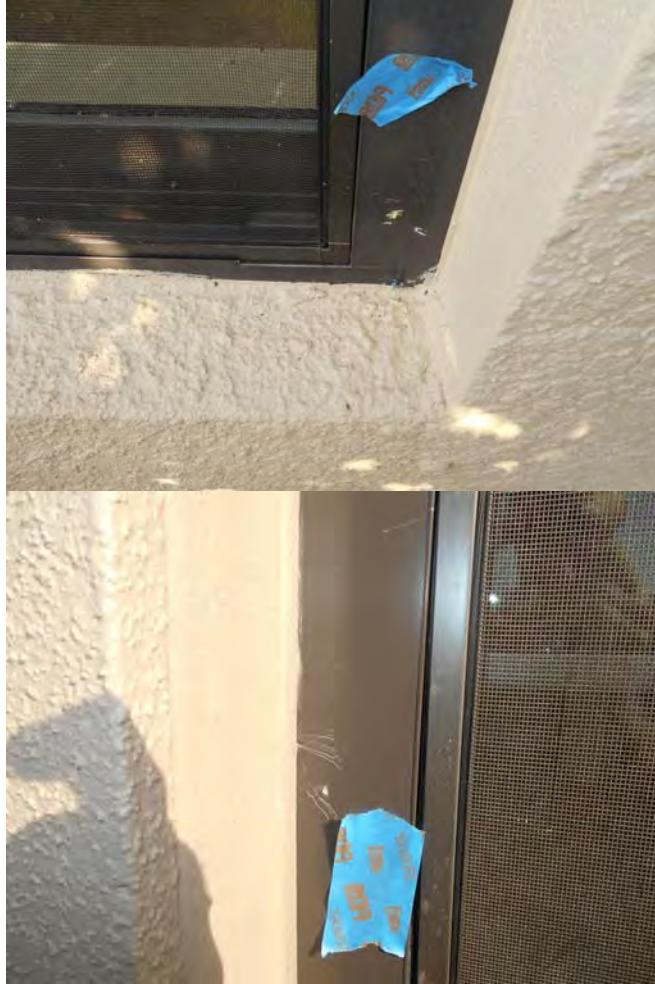
**Cleaning of glazing and frames required at all locations both inside and out.**

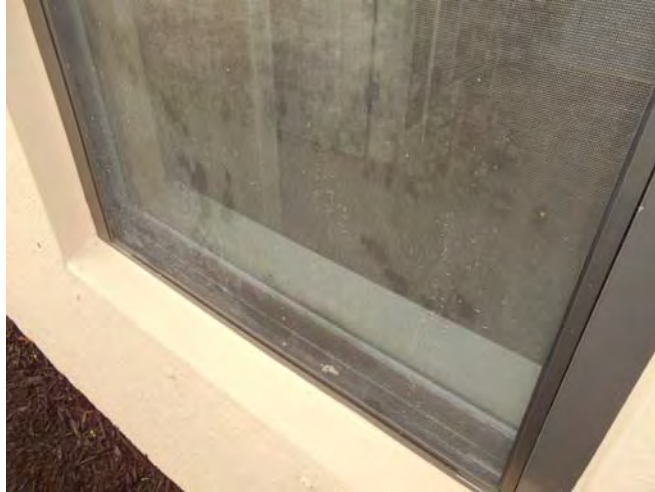
**Frames/Tracks and thresholds should be thoroughly cleaned of construction debris.**

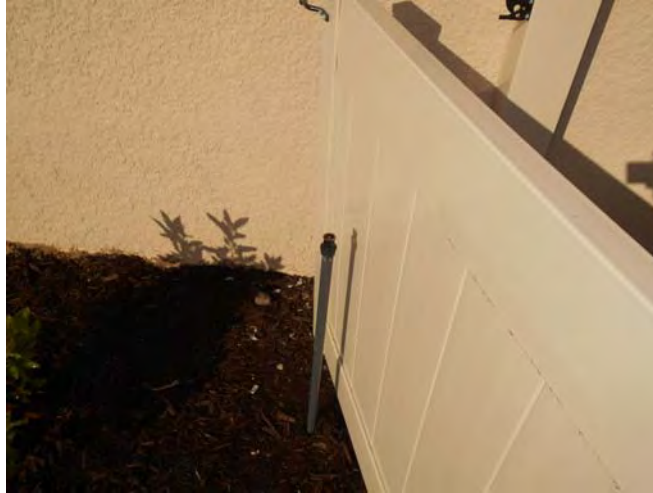
**Review; Sprinkler head conflicts with gate at right side; suggest relocating head.**

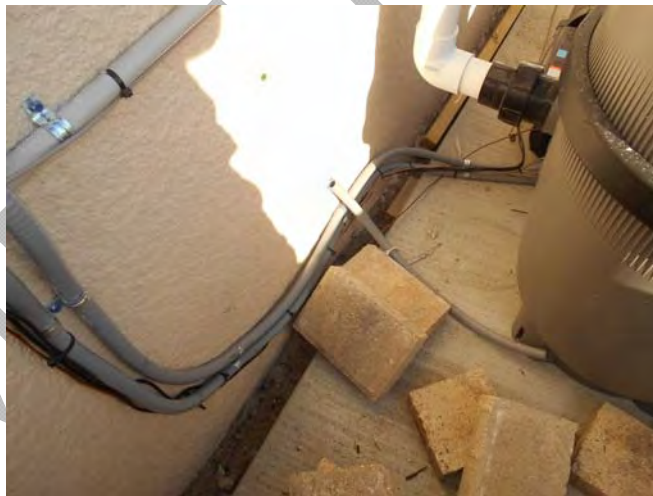
**Review; Construction debris present around the site that should be removed.**

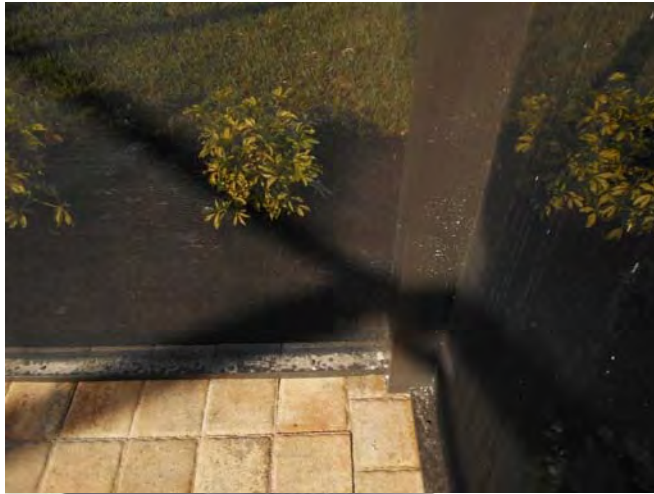
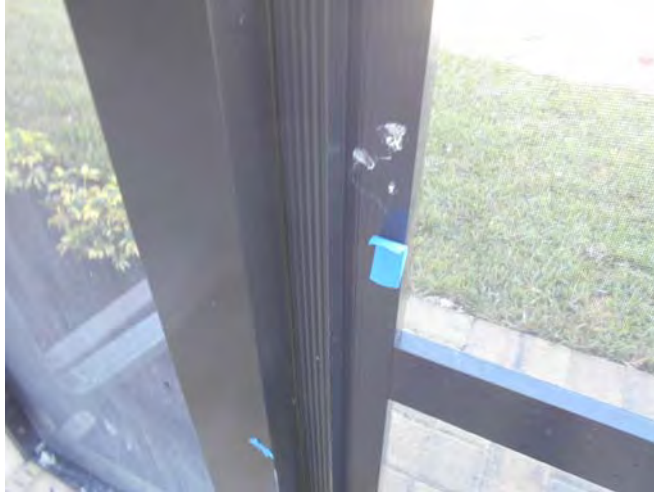
**Paint should be cleaned from frames/screens.**

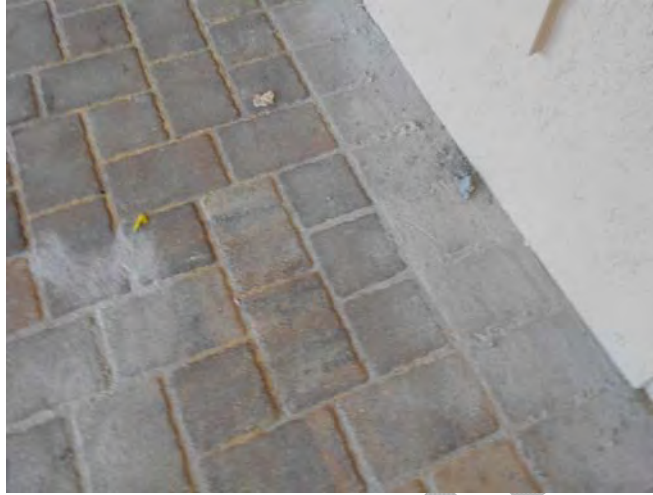
1207. Deck **Review; Brick. Decking requires cleaning of debris /paint and construction material.**

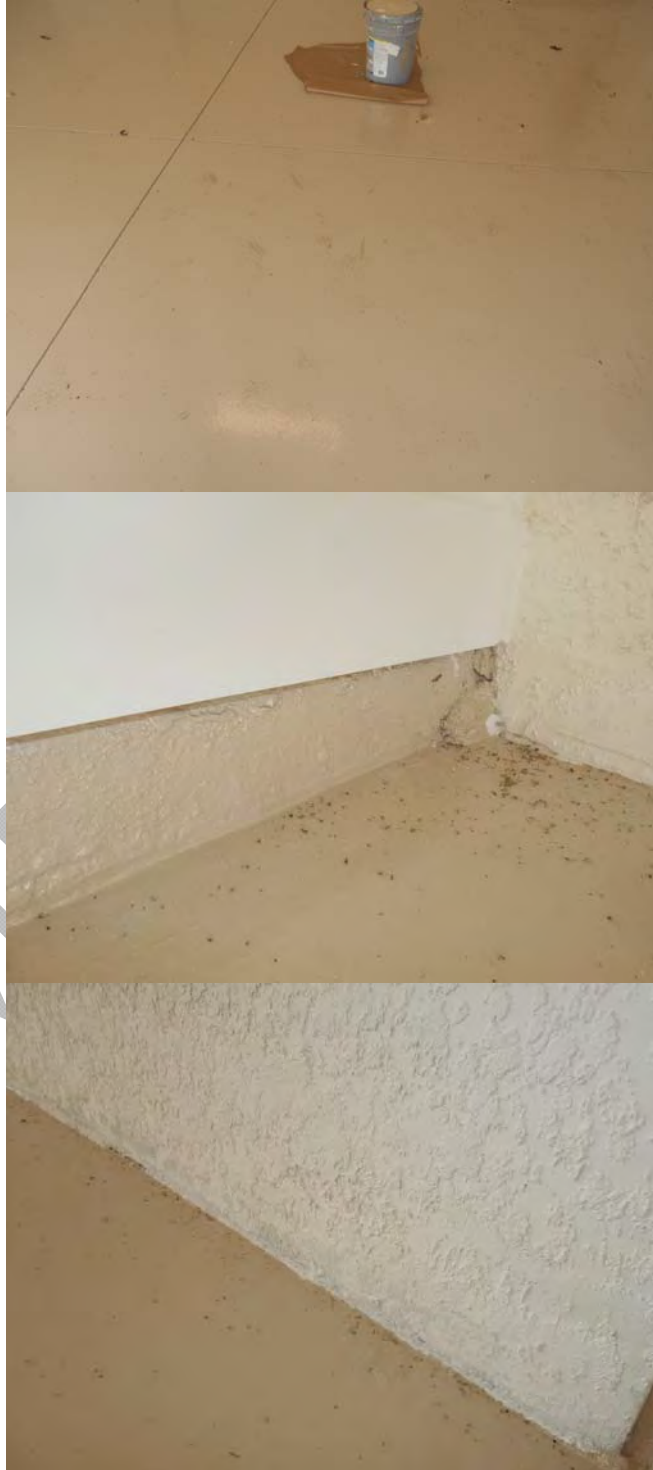
<b>Step #</b>	<b>Component</b>	<b>Comment</b>
1501.	Location	Attached.
1502.	Floor/Slab	<b>Review; Concrete. Floor and walls need cleaned of construction debris and patched as required.</b>

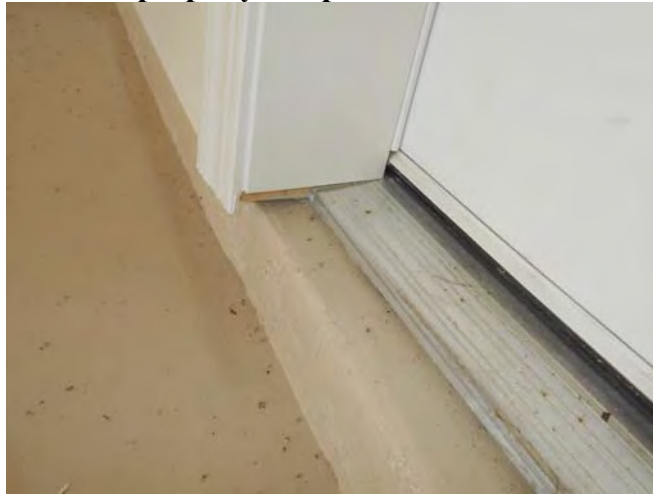
**Trim not properly completed.**

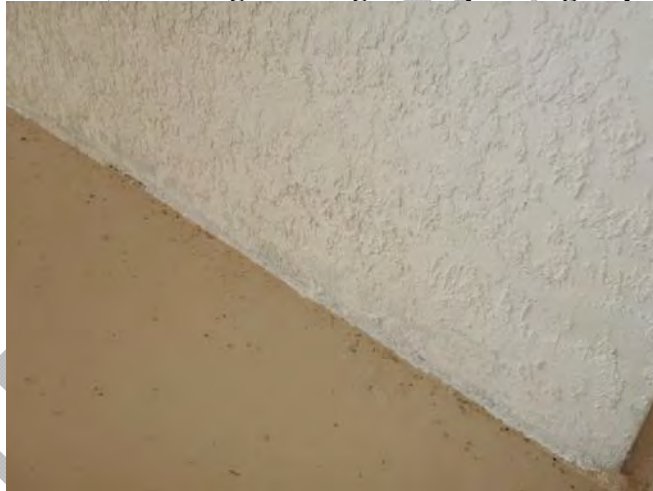
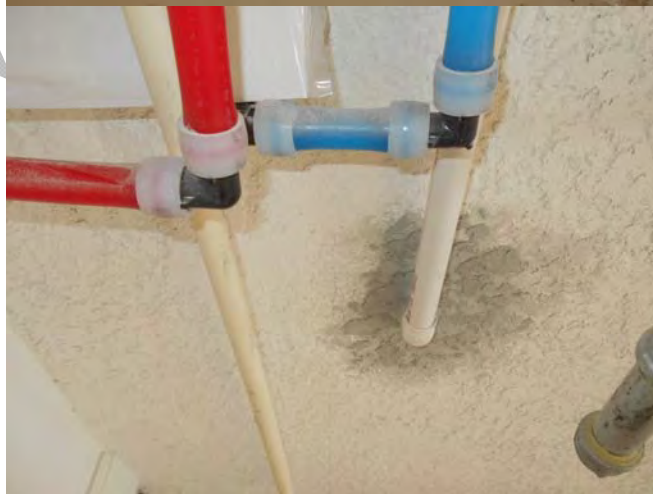
1511. Walls

**Review; Patching/cleaning and repainting required throughout.**

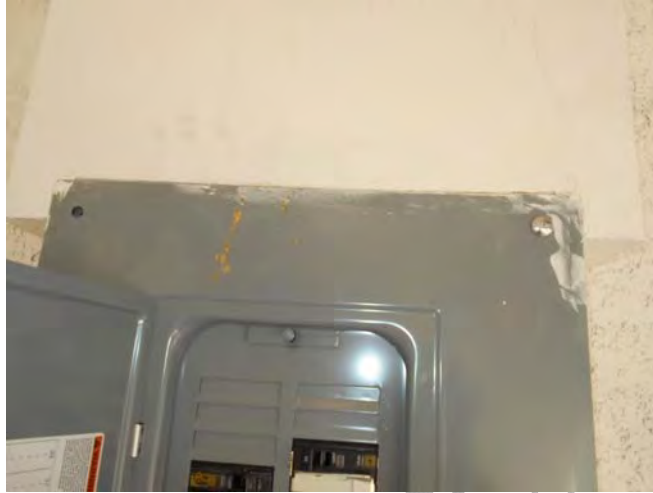
1512.	Ceiling	Functional.
1513.	Ceiling Fan	None.
1514.	Electrical	Functional.
1515.	Laundry Tub	None.
1516.	Garage Comments	<b>Review; Cleaning of electrical panel and devices required.</b>

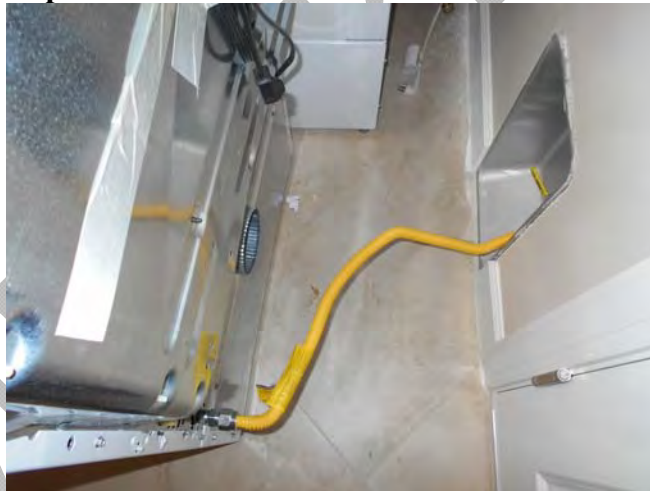
1612. Dryer & Hook-ups      **Review; Gas; 110 volt. Dryer was not connected at the time of inspection and could not be tested.**

**Suggest cleaning vent as part of normal home maintenance.**

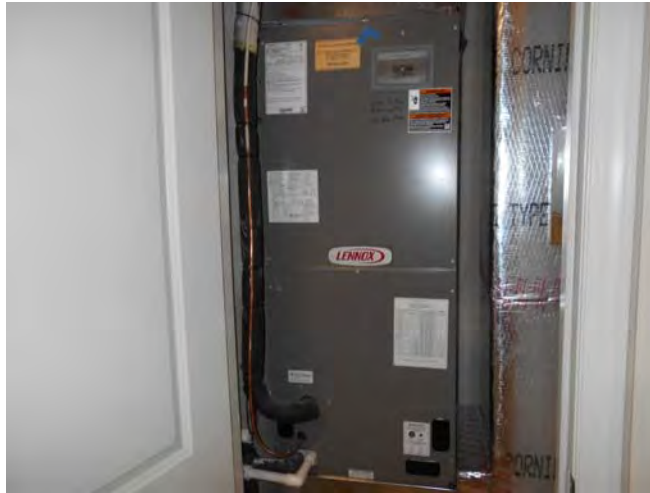
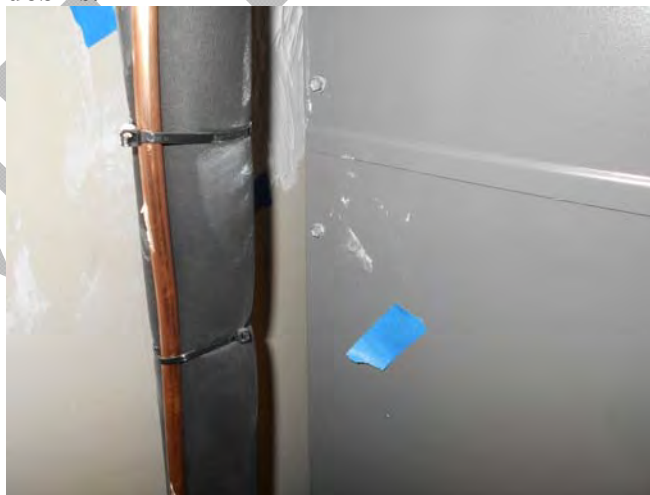
**Review; Unit and components should be cleaned of paint and other debris.**

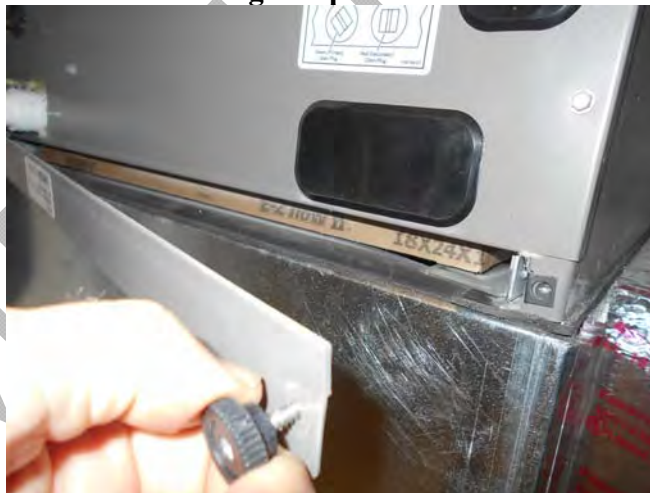
1806.      Filter      **Review; Located at the unit. Home was not even broom clean at the time of inspection and construction dust/debris not protected from return air locations. Ductwork should be cleaned and filter replaced after final cleaning completed.**

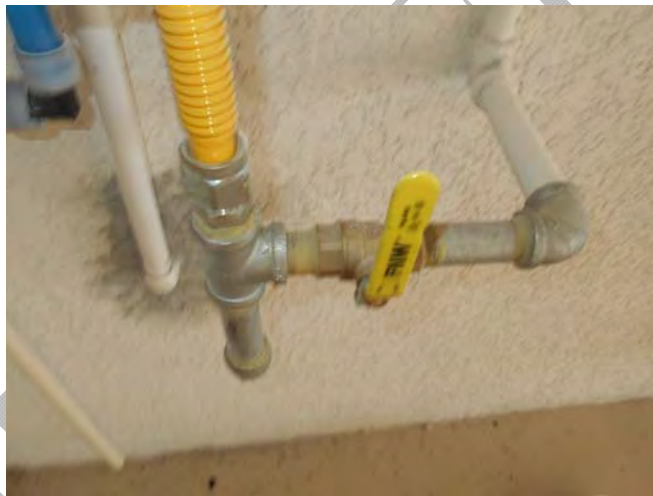
1907.      Water Heater  
Thermostat  
Settings      **Review; Gas was off to this unit. Hot water unit and fixtures could not be tested.**

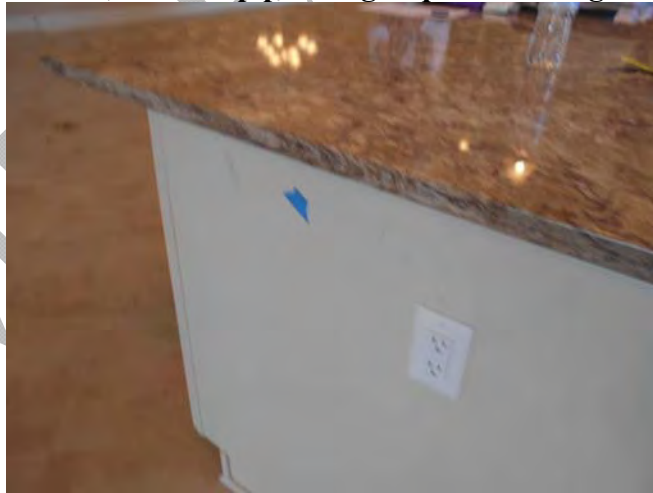
**Review; Touch up painting required throughout.**

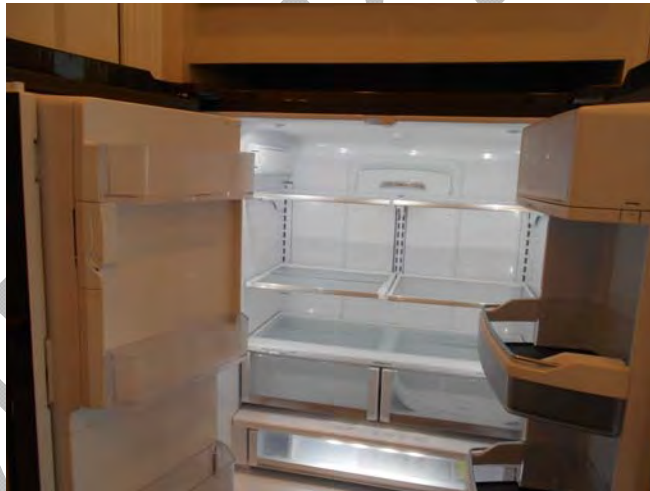
**Review; Water dispenser inoperable at the time of inspection.**

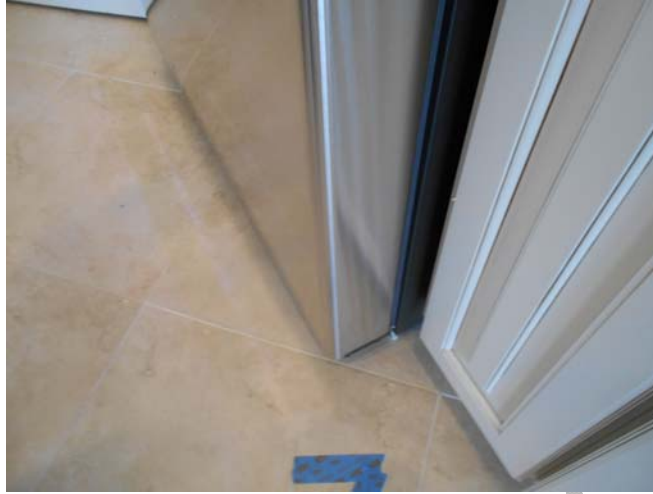
Refrigerator rolling freely needs to be properly installed.

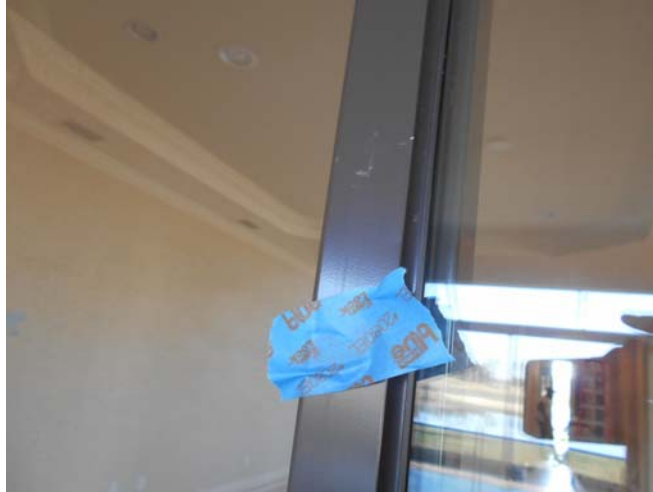
2205.	Exterior Doors	<b>Review; Aluminum sliding glass. Widespread damage noted at these doors. Doors need properly repaired or replaced. Tracks need cleaned.</b>
-------	----------------	---

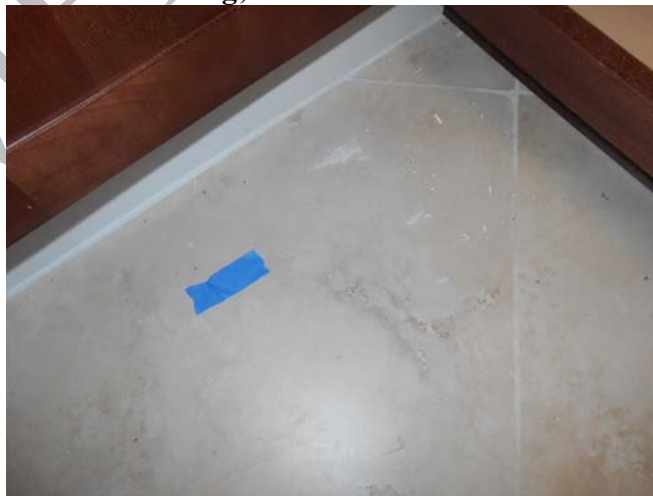
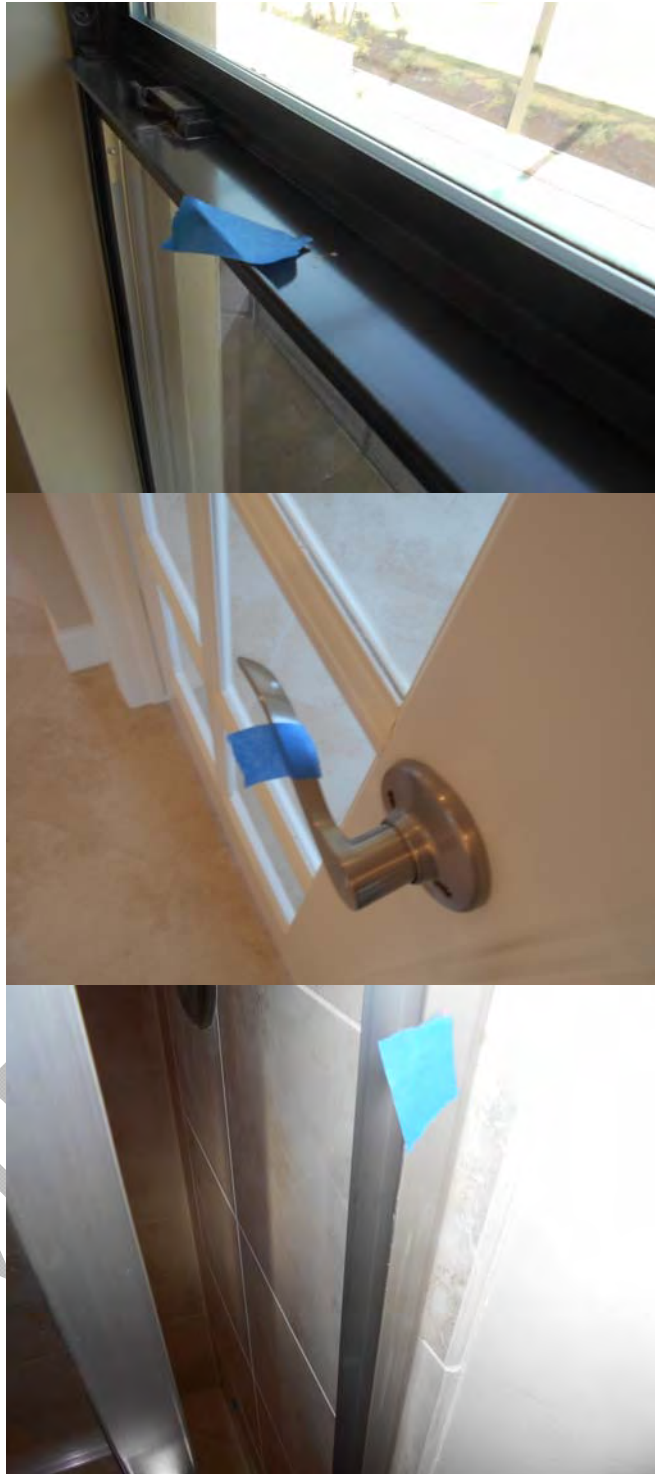
2206.	Windows / Screens	None.
2207.	Electrical	Functional.
2208.	Heat/Cooling Source	Forced air register.
2209.	Ceiling Fan	None.
2210.	Wet Bar	None.
2211.	Closet	None.
2212.	Comments	<p><b>Review; Finish quality of the home is very poor. Items requiring repair are too numerous to list individually. Blue tape was placed at many areas requiring repair. Not all areas marked due to vast numbers or repairs required but marked areas should provide guidance as to quality expected. Repairs include but are not limited to the following:</b></p> <p><b>Paint on flooring; cabinets and other fixtures and devices;</b></p>

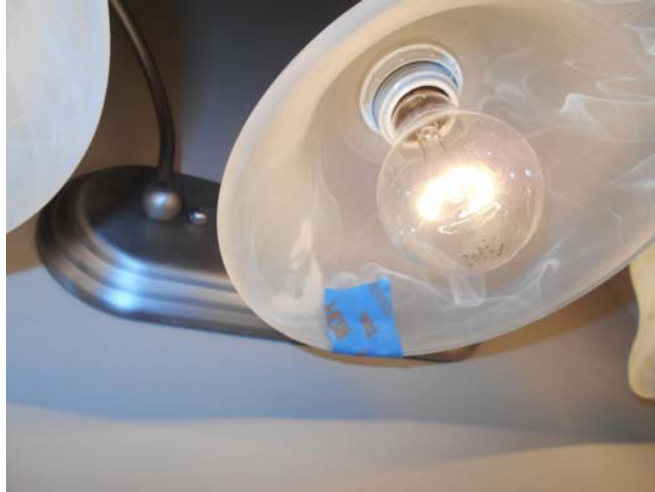
**Damaged doors present and improperly completed wood work present;**

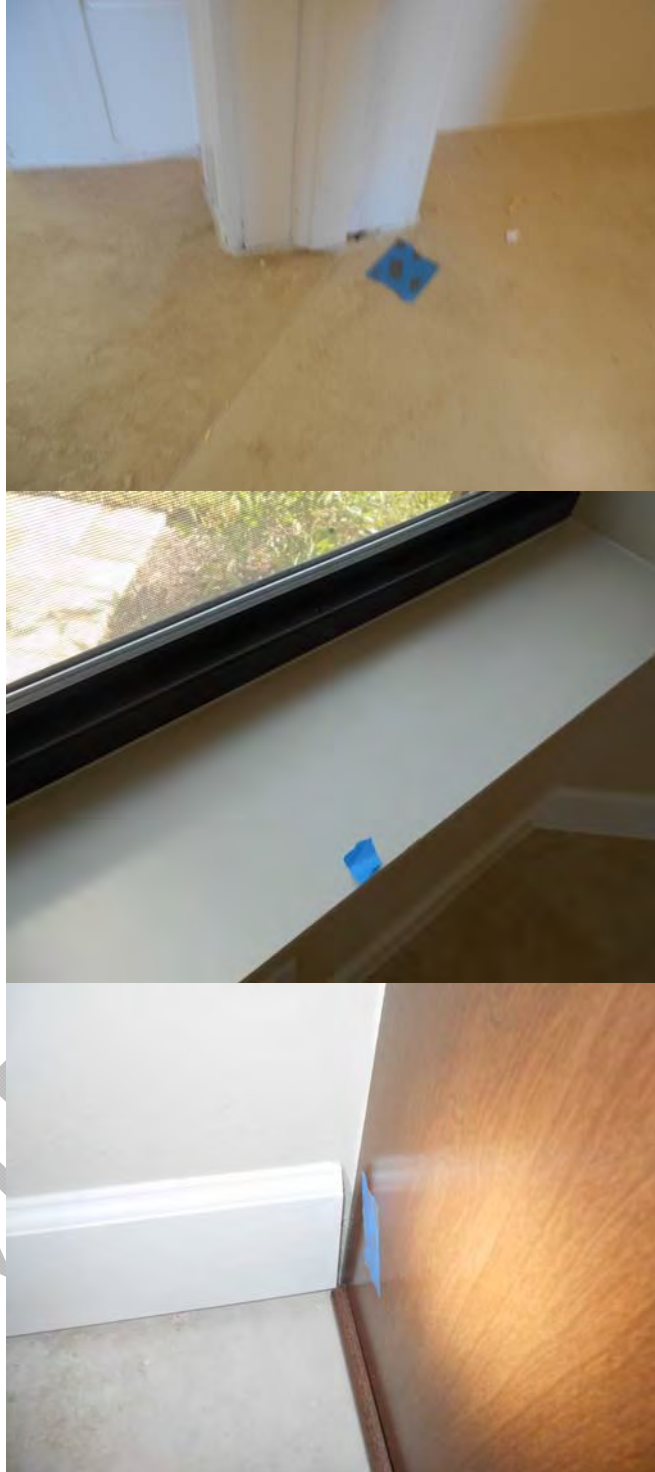
**Ceilings in most rooms have repairs requiring the entire ceiling to be repainted in each location;**

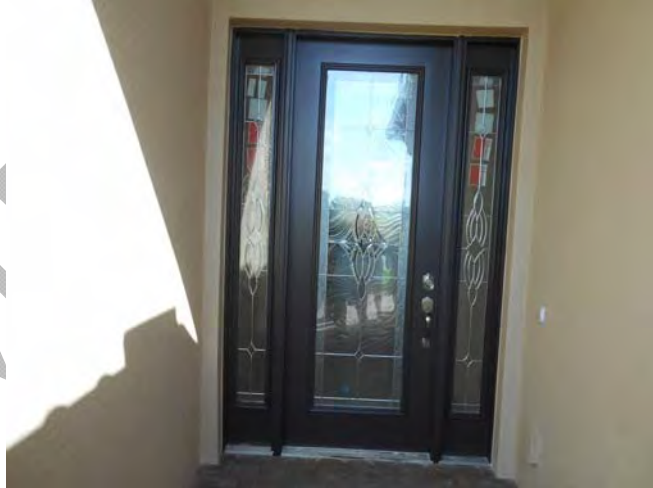
2504.	Exterior Doors	<b>Review. Wood/Metal/Glass, with side lite. Door missing weather stripping. Cleaning and final painting still in progress.</b>
-------	----------------	---

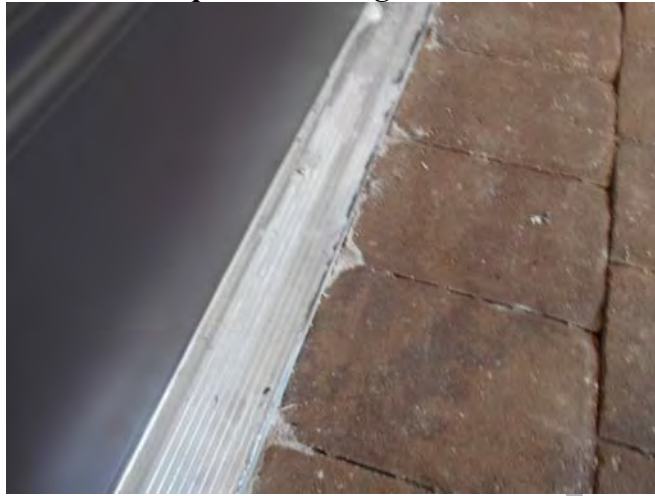
**Threshold requires cleaning.**

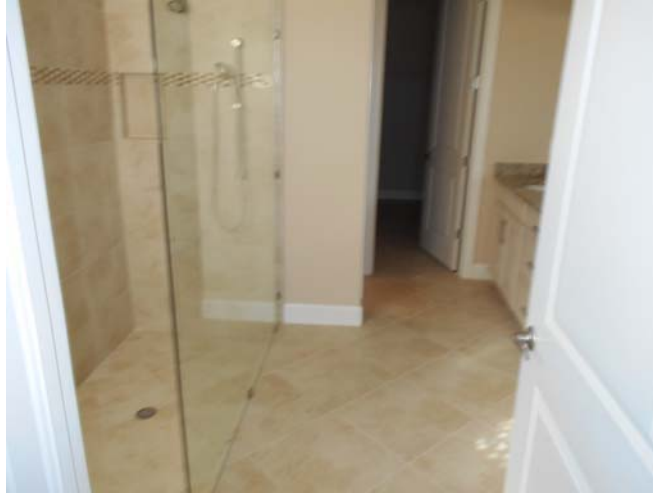
**Review; Damaged tile noted at toilet.**

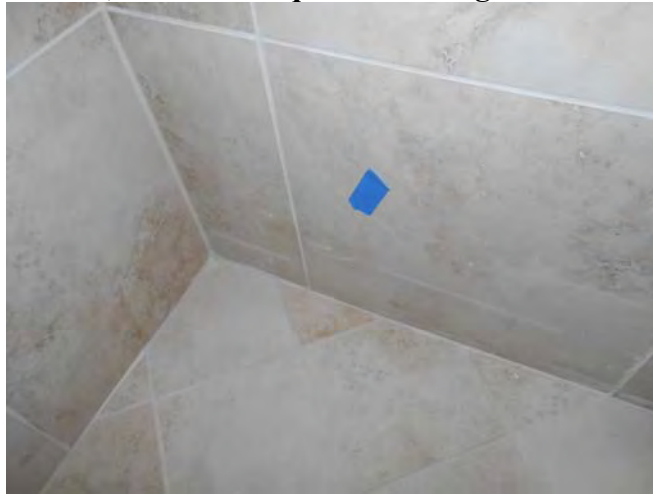
**Review; Tile. Tile requires cleaning.**

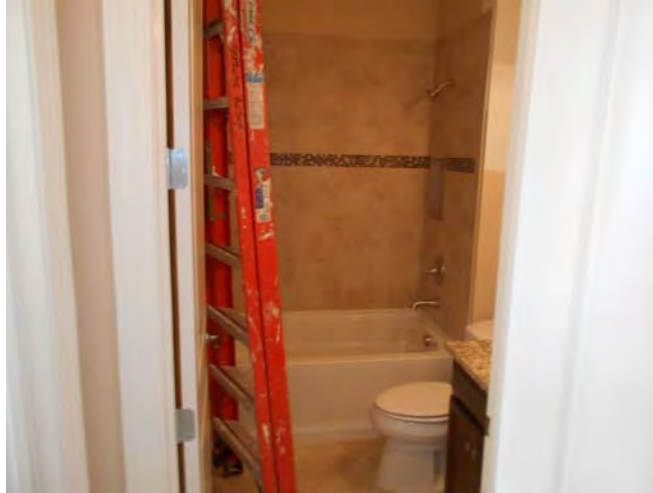
**Review; Poor finish quality and improper installation of baseboard noted.**

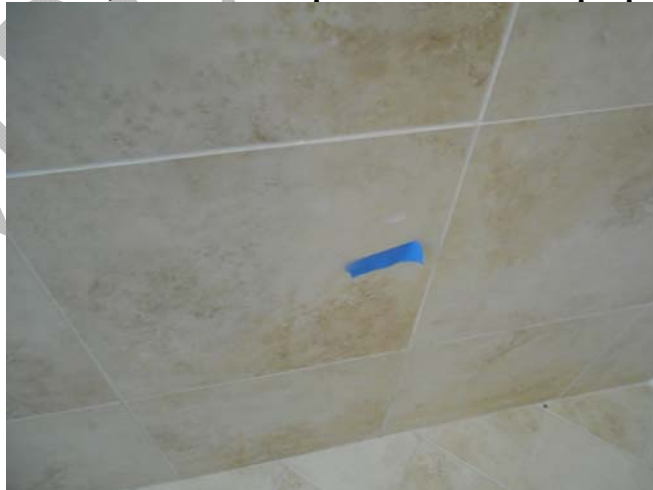
2803. 2.	Ceiling	Functional.
2804. 2.	Interior Doors	Functional; Wood.
2805. 2.	Exterior Doors	None.
2806. 2.	Windows / Screens	None.
2807. 2.	Electrical	Functional; GFI present and functional.
2808. 2.	Exhaust Fan	Functional.
2809. 2.	Ceiling Fan	None.
2810. 2.	Heat/Cooling Source	Forced air register.
2811. 2.	Tub & Surround	<b>Review; Tile. Remove paint from tile and properly clean.</b>

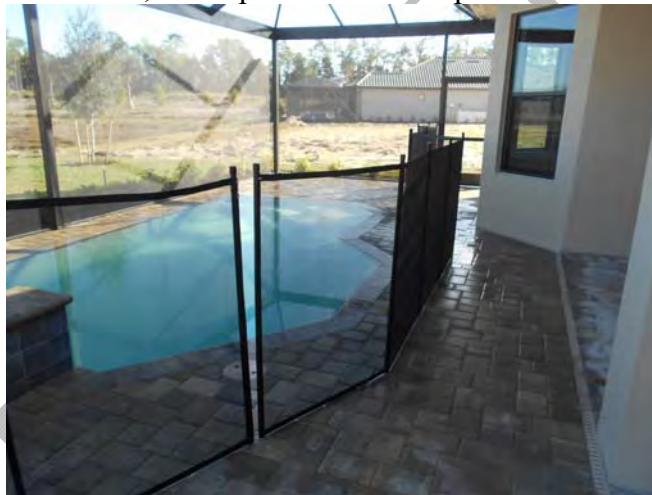
Step #	Component	Comment
3001.	Enclosure	Aluminum and screen. See lanai notes.
3002.	Decking	<b>Review; Brick. Cleaning required.</b>
3003.	Tile	Functional.
3004.	Dive Board	None.
3005.	Handrails	None.
3006.	Fences/Gates	Functional; Child protection fence present.

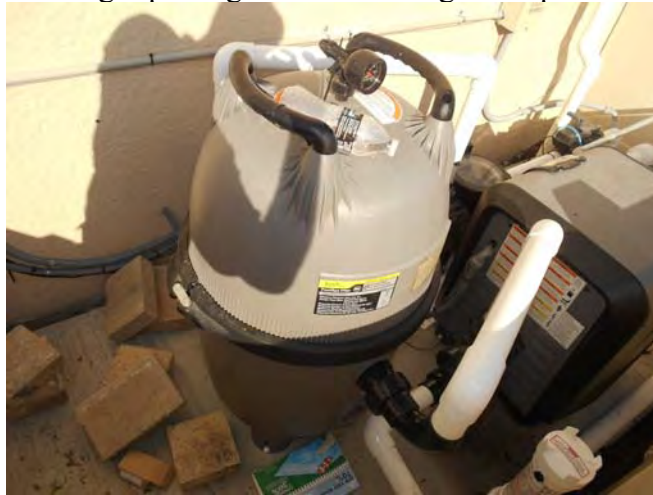
3011. Filter System Filter is the cartridge type. Filter was not accessed for inspection. Periodic cleaning/replacing of filter cartridge is required. Suggest replacing filter.

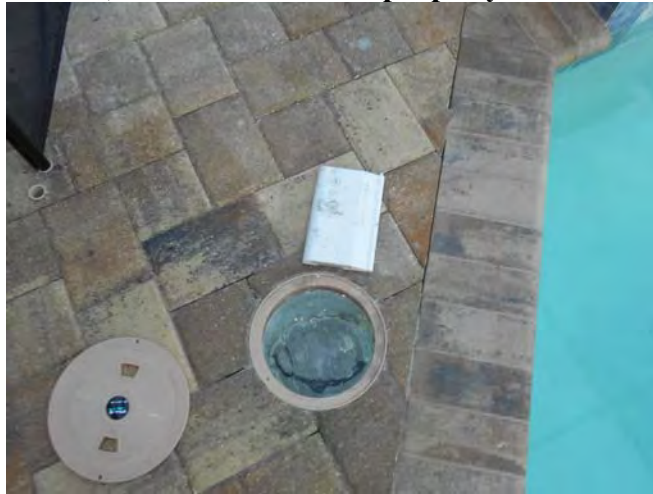
**Review; Skimmer door not properly installed.**

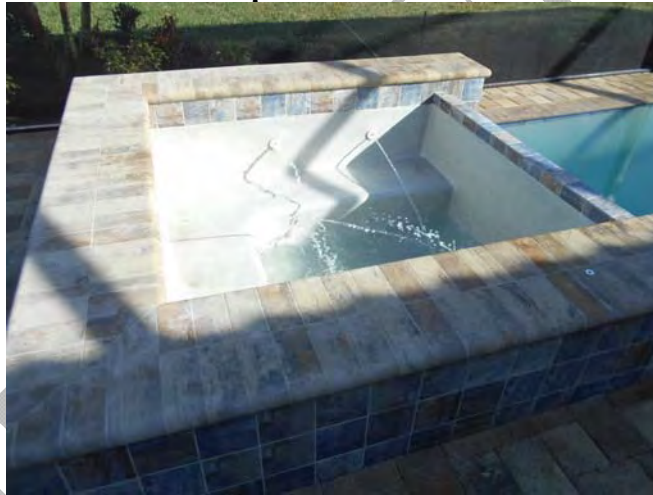
**Spa emptied when put in spa function and pool overflowed; pool not properly set up and not all equipment installed properly. Pool installation incomplete.**

**Builder to instruct owner on proper operation of pool equipment (pool school).**
