HAZELBAKER CONSTRUCTION SERVICES
8965 QUARRY DRIVE
NAPLES, FLORIDA
(239)213-8046

Doc #: 1412-000
Dwelling Address: 123 Sunshine Way # 204, Estero, Florida 33928
Client Name: John Doe
Inspector: Joel Hazelbaker, **Licensed Florida State Home Inspector: License No. HI874**

The Summary Report does not constitute our entire report and may not include all the items a client may consider important to home ownership, therefore, the client is advised to read the Inspection Report in its entirety.

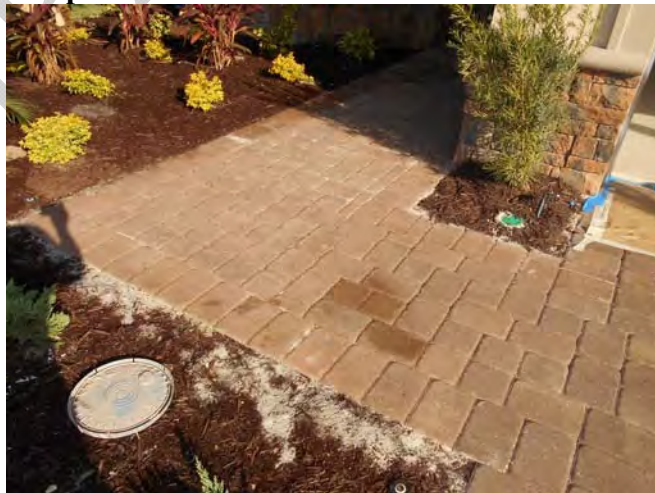
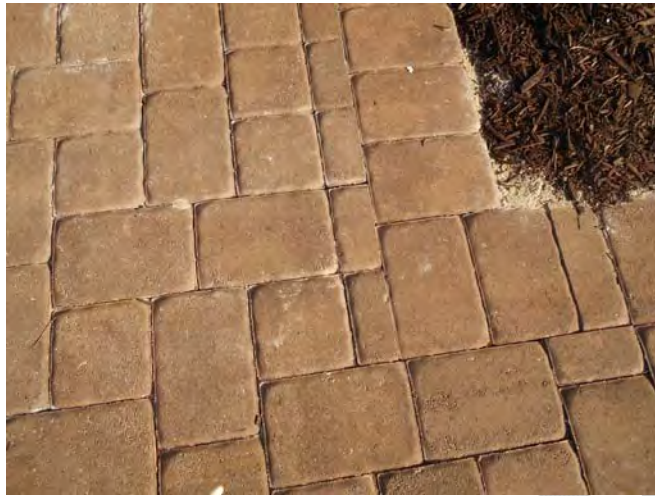
1102. Walkways

Review; Brick. Brick requires cleaning of construction debris and paint at all locations.

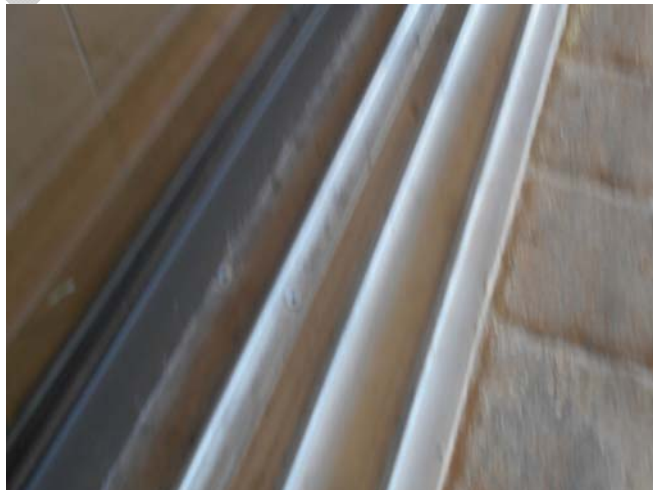
Frames/Tracks and thresholds should be thoroughly cleaned of construction debris.

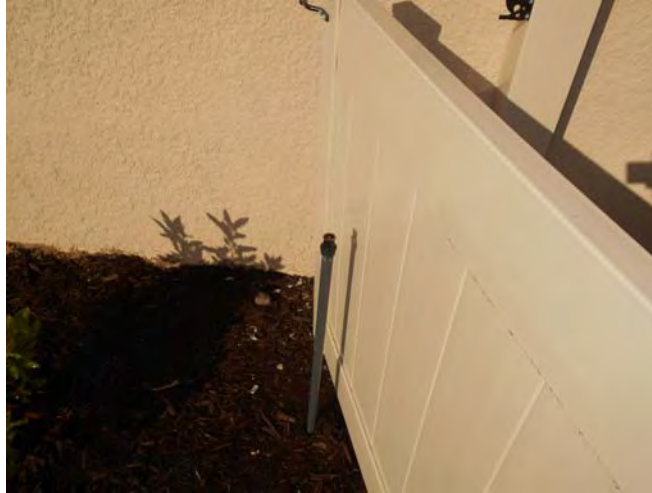
1110. Sprinkler
System

Review; Sprinkler head conflicts with gate at right side; suggest relocating head.

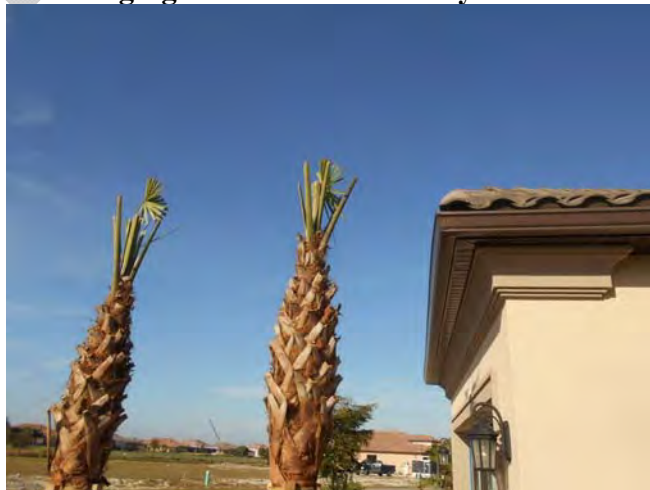
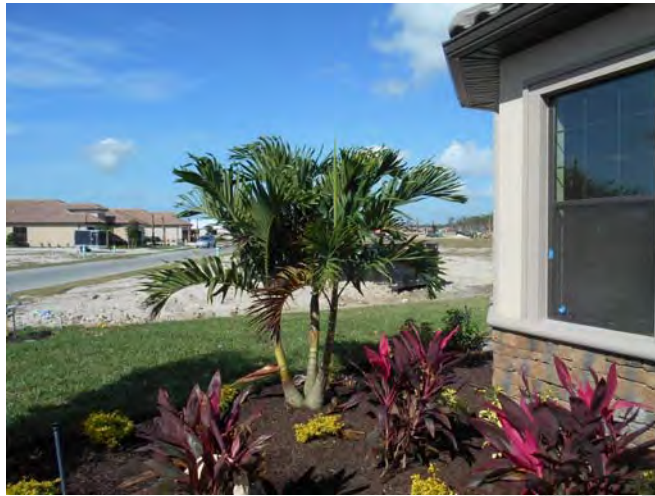
Review; Suggest relocating vegetation that will contact or overhanging the home at maturity.

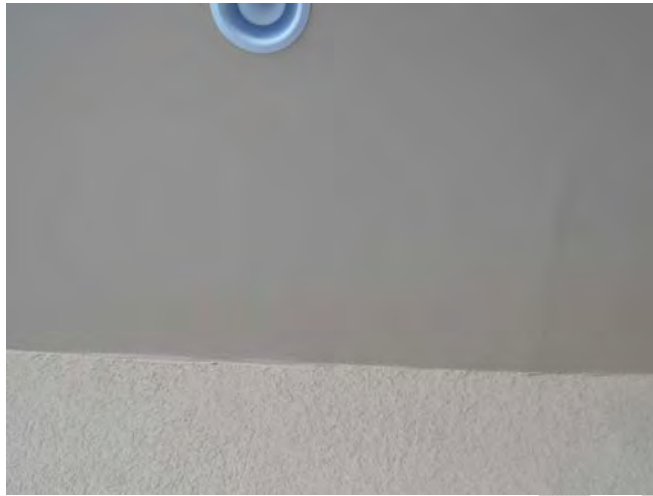
1202. Cover

Review; Ceiling needs to be repaired and repainted.

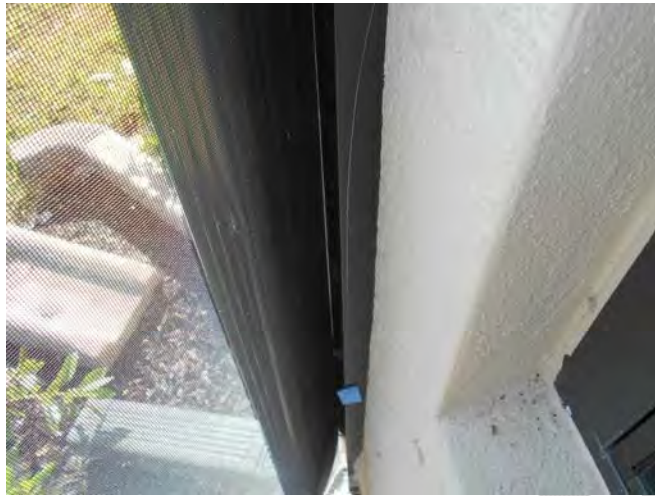
1203. Enclosure

Review; Aluminum and screen. Damage noted at frames in several locations.

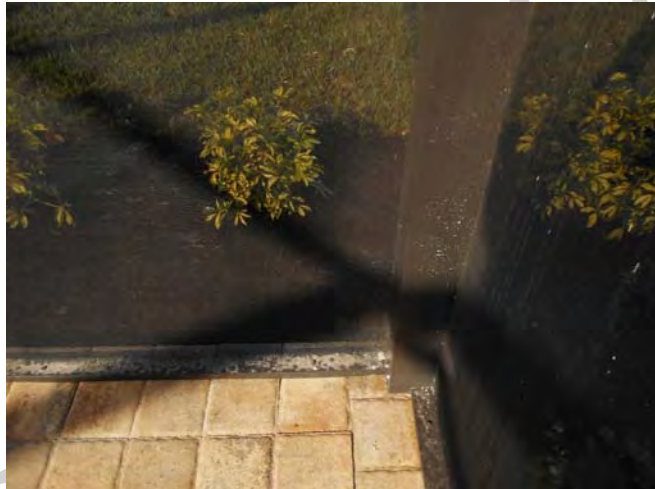
Paint should be cleaned from frames/screens.

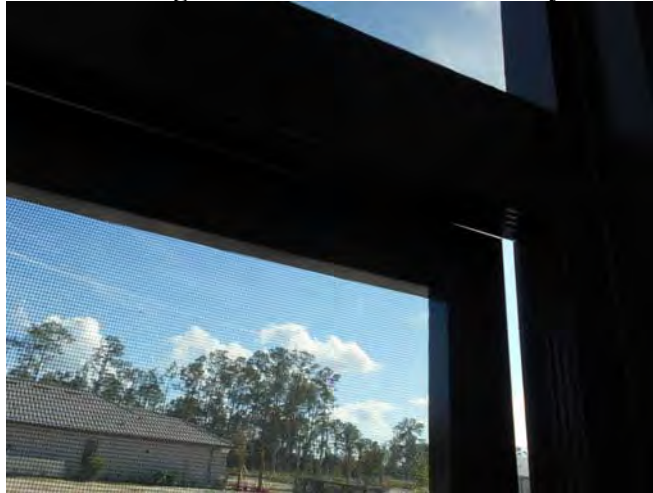
Door binding and will not close normally.

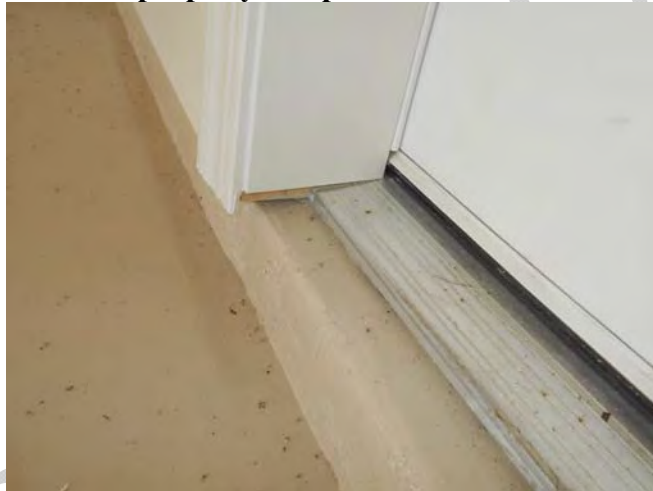
Trim not properly completed.

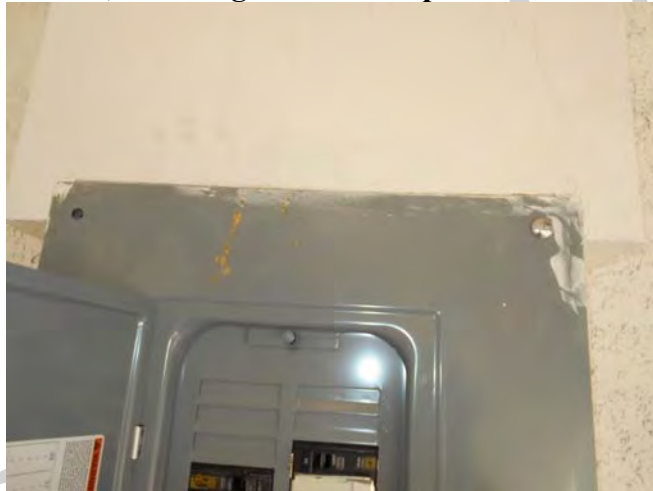
1516. Garage
Comments

Review; Cleaning of electrical panel and devices required.

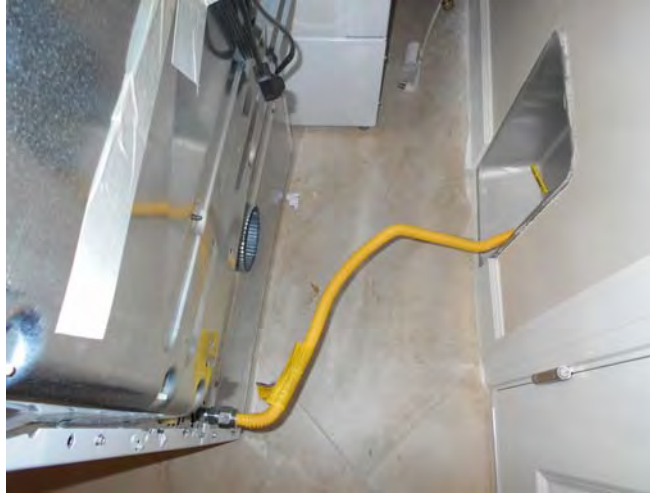
1612. Dryer & Hook-
 ups

Review; Gas; 110 volt. Dryer was not connected at the time of inspection and could not be tested.

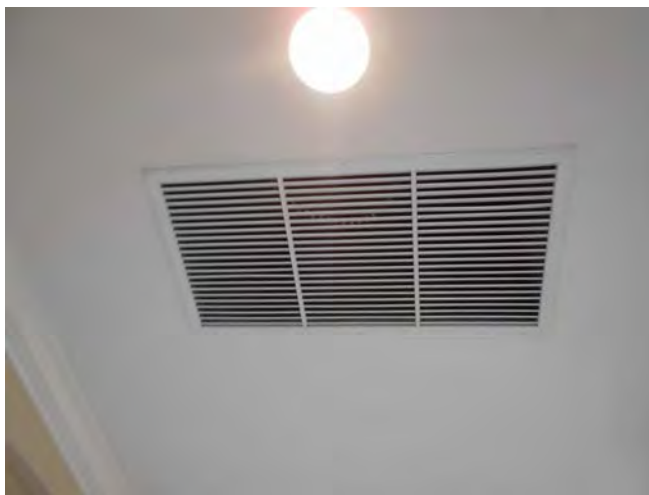
1806. Filter

Review; Located at the unit. Home was not even broom clean at the time of inspection and construction dust/debris not protected from return air locations. Ductwork should be cleaned and filter replaced after final cleaning completed.

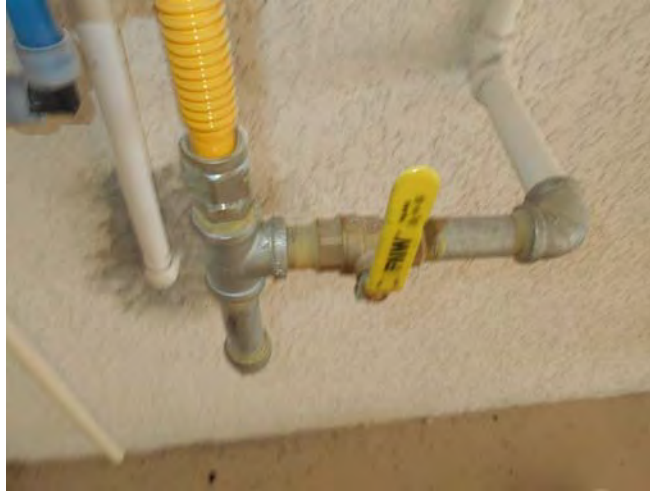
1907. Water Heater
Thermostat
Settings

Review; Gas was off to this unit. Hot water unit and fixtures could not be tested.

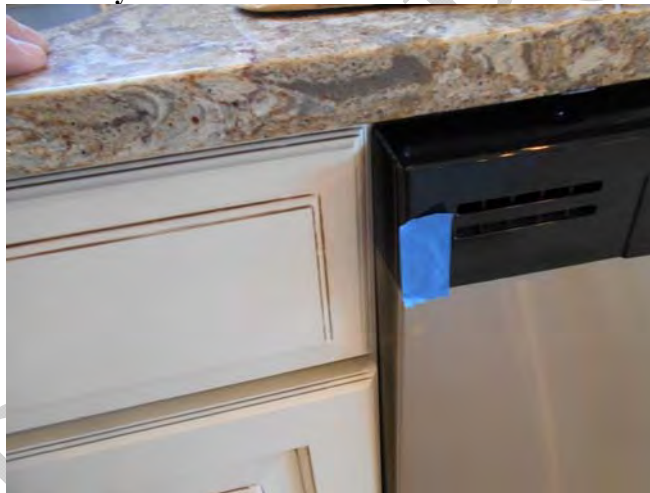
2114. Dishwasher

Review; Washer door conflicts with cabinets and does not close normally.

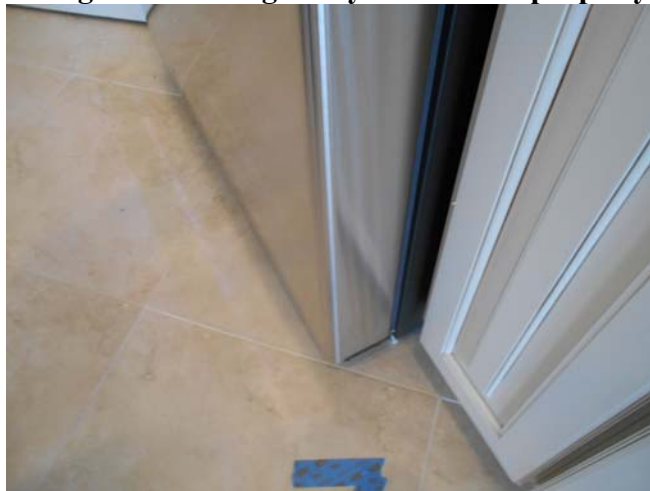
2119. Refrigerator

Review; Water dispenser inoperable at the time of inspection.

Refrigerator rolling freely needs to be properly installed.

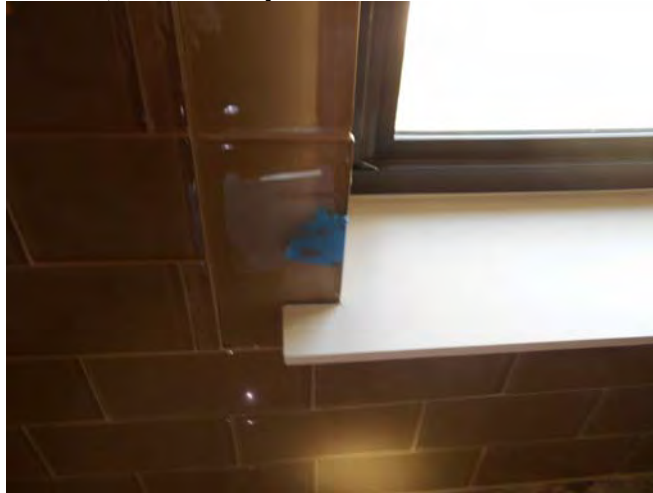
2125. Kitchen
Comments

Review; Tile backsplash uneven.

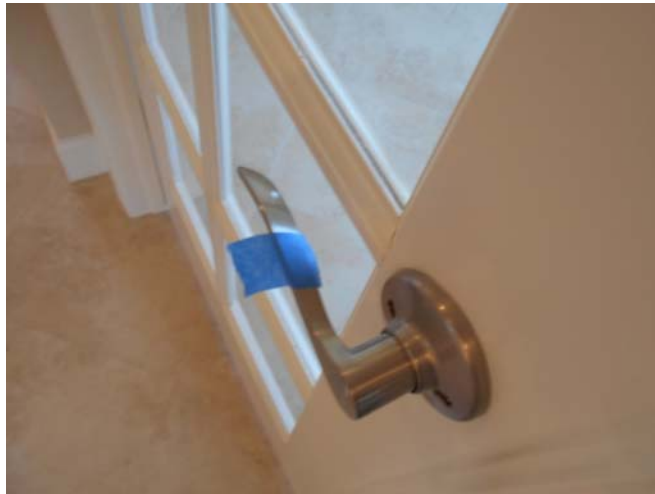
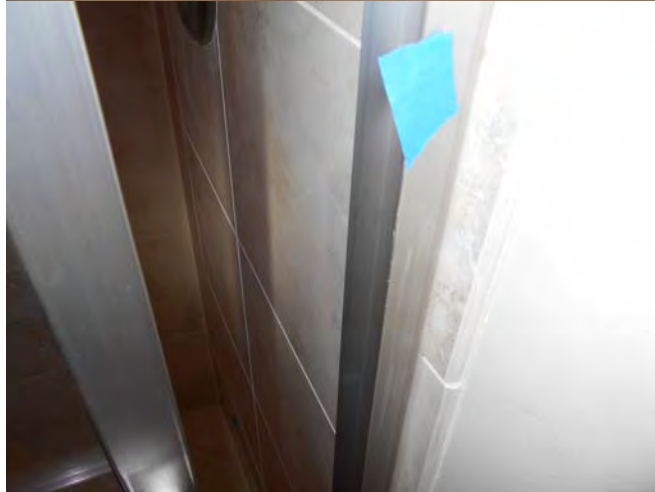
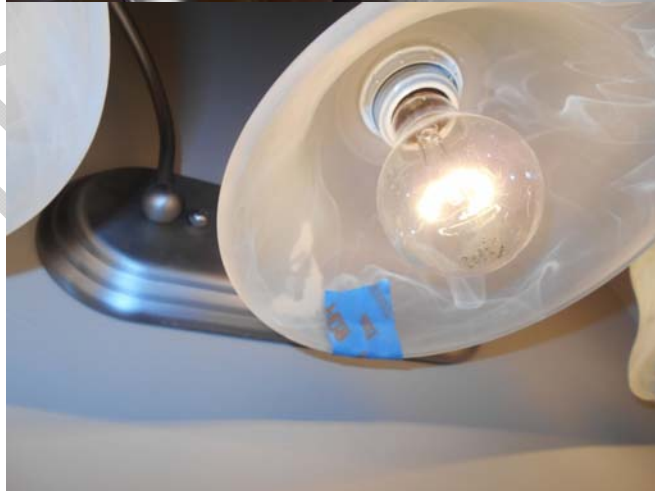
2212. Comments **Review; Finish quality of the home is very poor. Items requiring repair are too numerous to list individually. Blue tape was placed at many areas requiring repair. Not all areas marked due to vast numbers or repairs required but marked areas should provide guidance as to quality expected. Repairs include but are not limited to the following:**

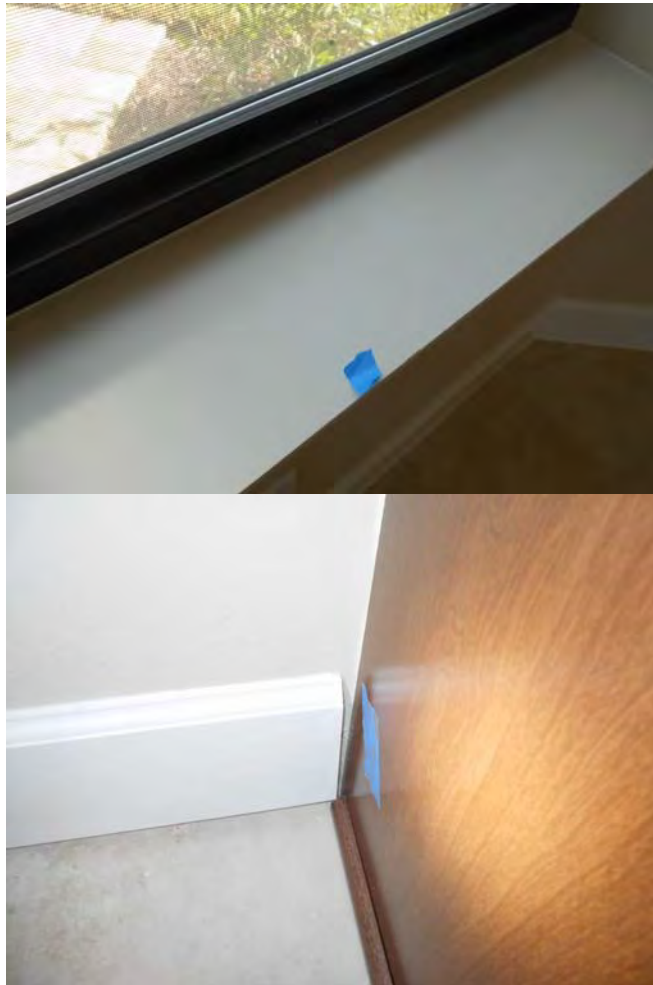
Damaged doors present and improperly completed wood work present;

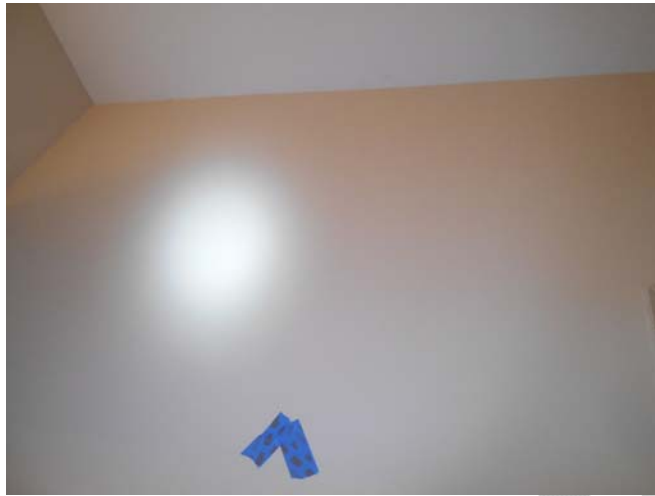
Ceilings in most rooms have repairs requiring the entire ceiling to be repainted in each location;

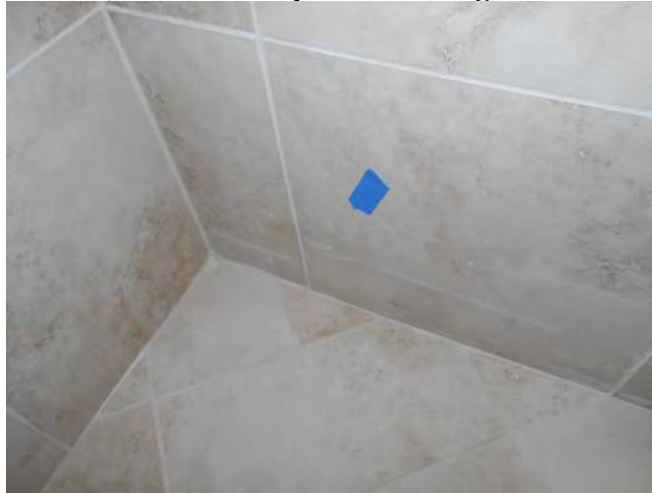
2814. Shower / **Review; Tile. Tile requires cleaning.**
Surround

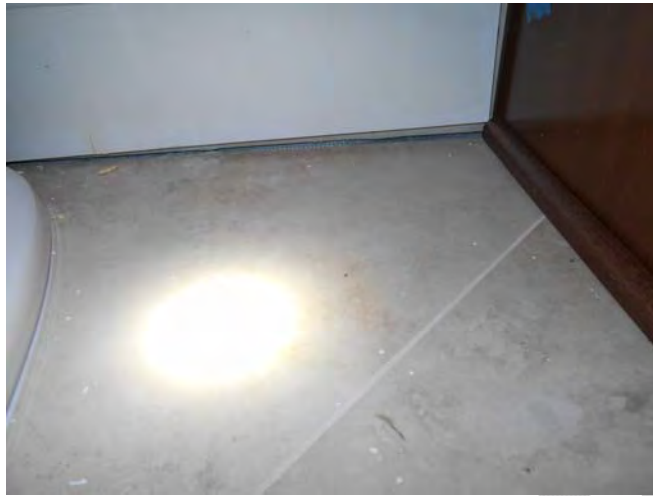
2802. 2. Walls **Review; Poor finish quality and improper installation of**
baseboard noted.

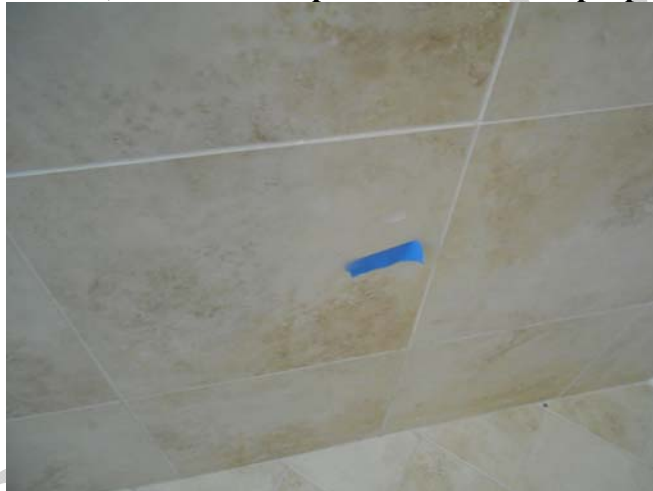
2811. 2. Tub &
Surround

Review; Tile. Remove paint from tile and properly clean.

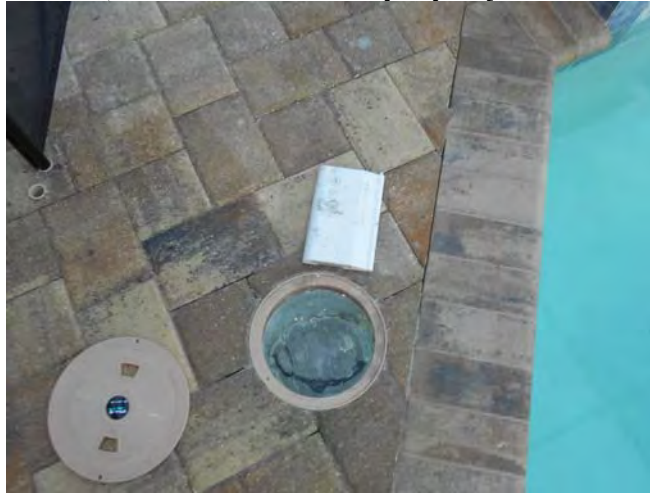
3016. Pool/Spa
Comments

Review; Skimmer door not properly installed.

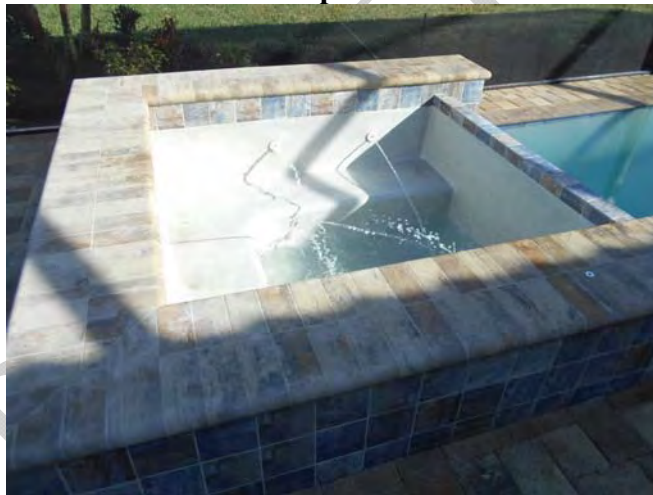
Spa emptied when put in spa function and pool overflowed; pool not properly set up and not all equipment installed properly. Pool installation incomplete.

Builder to instruct owner on proper operation of pool equipment (pool school).
