## FULL PROPERTY INSPECTION REPORT

Doc #: 2508-003 Inspection Date: 8/8/2025

Dwelling Address: XXXXX Vanderbilt Drive, Naples, FL 34108

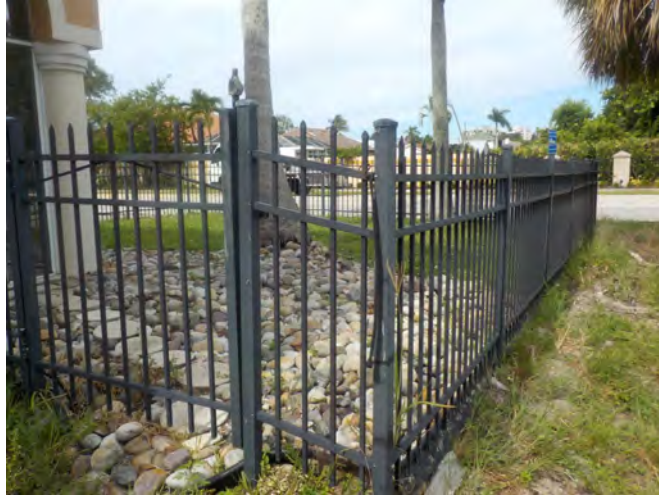
**Review; Gate at left side of home does not latch.**

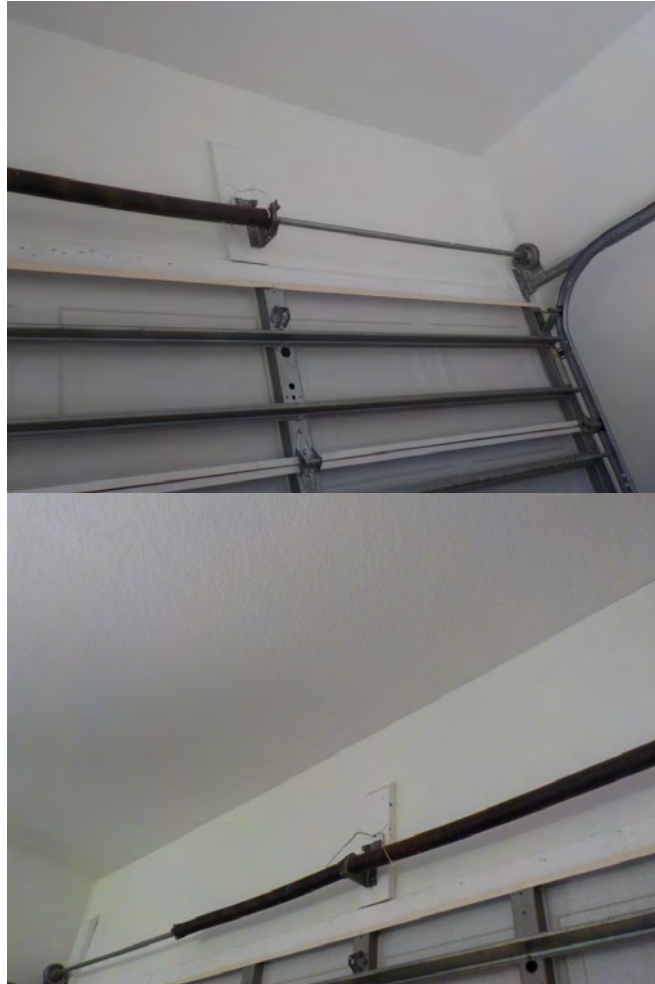
1505. Garage Door Opener

**Review; Garage doors inoperable. Garage door openers and tracks have been removed.**

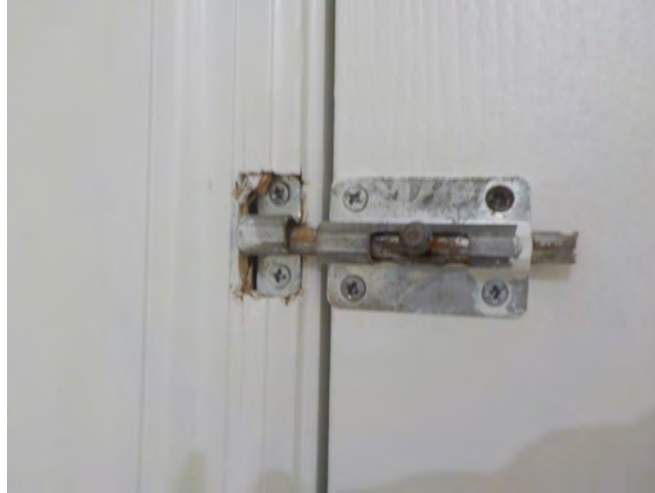
**Review; Lock is misaligned.**

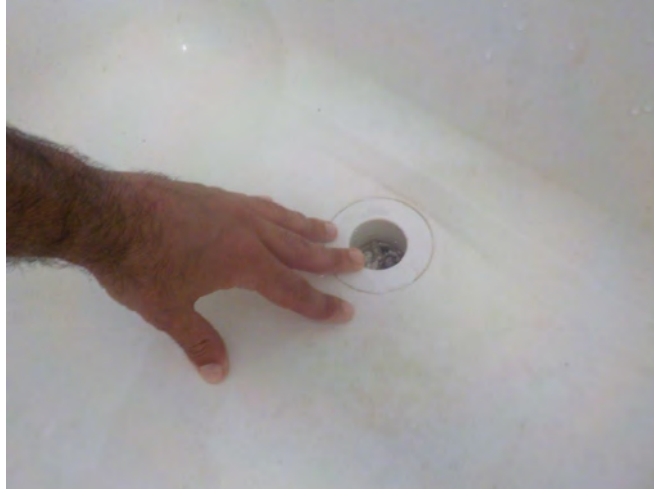
**Review; Slow drain noted at laundry room sink.**

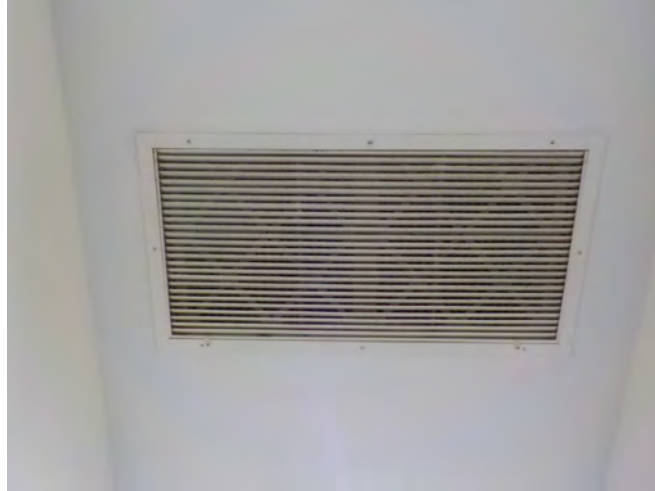
1806. Filter Located at the return air register. Suggest replacing filter. Filter should be changed every thirty days for most efficient operation.

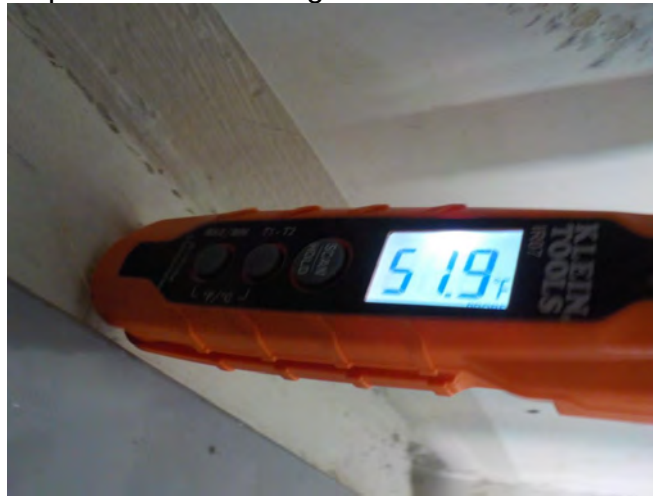
1810. A/C Temperature Differences Return air temperature at register was 74 degrees. Supply air temperature was 52 degrees. Difference in air temperature at time of inspection was 22 degrees.

Temperature difference was within the 16 to 22 degrees normal operating range at time of inspection. Unit functioned properly when tested. Appeared to be serviceable at time of inspection. As with all mechanical equipment, this unit may fail at any time without warning. Inspectors cannot determine future failures.

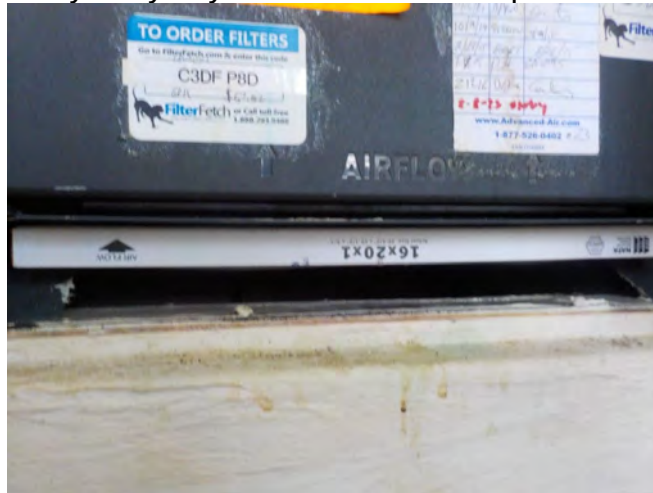
1806. Filter Located at the unit. Suggest replacing filter. Filter should be changed every thirty days for most efficient operation.

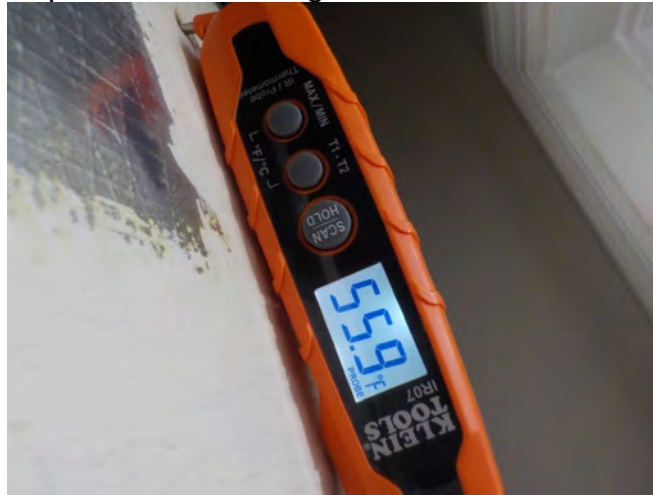
1810. A/C Temperature Differences Return air temperature at register was 75 degrees. Supply air temperature was 56 degrees. Difference in air temperature at time of inspection was 19 degrees.

Temperature difference was within the 16 to 22 degrees normal operating range at time of inspection. Unit functioned properly when tested. Appeared to be serviceable at time of inspection. As with all mechanical equipment, this unit may fail at any time without warning. Inspectors cannot determine future failures.

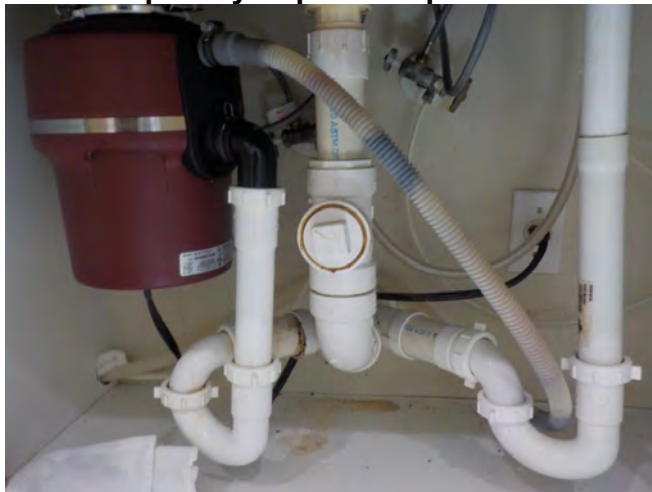
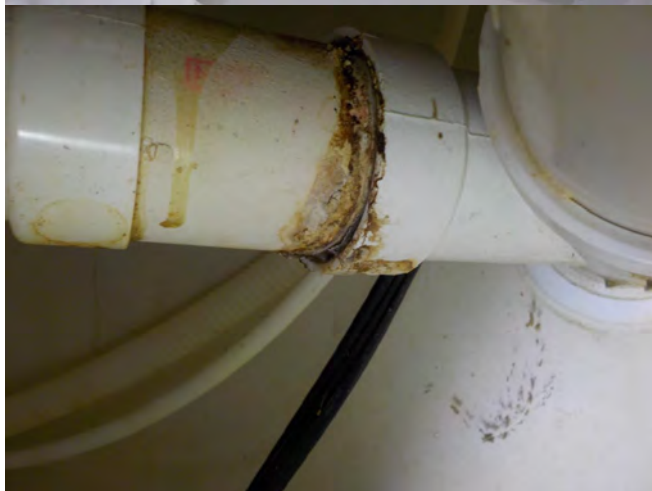
2112. Traps/Drain /Supply **Review; Leak noted at drainpipe underneath sink. Suggest review/repair by a qualified plumber.**

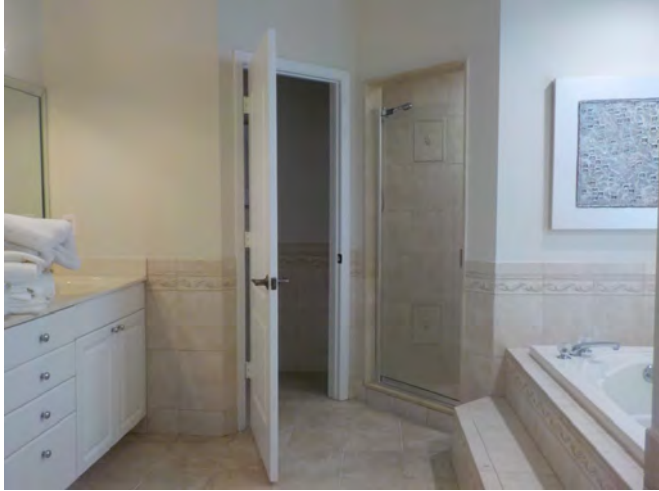
**Review; Tile. Cracked tiles and open grout joints noted. Suggest replacing grout or caulking to prevent future/further moisture penetration and damage/deterioration to interior walls. This damage is not always visible or accessible to the inspector at the time of inspection.**

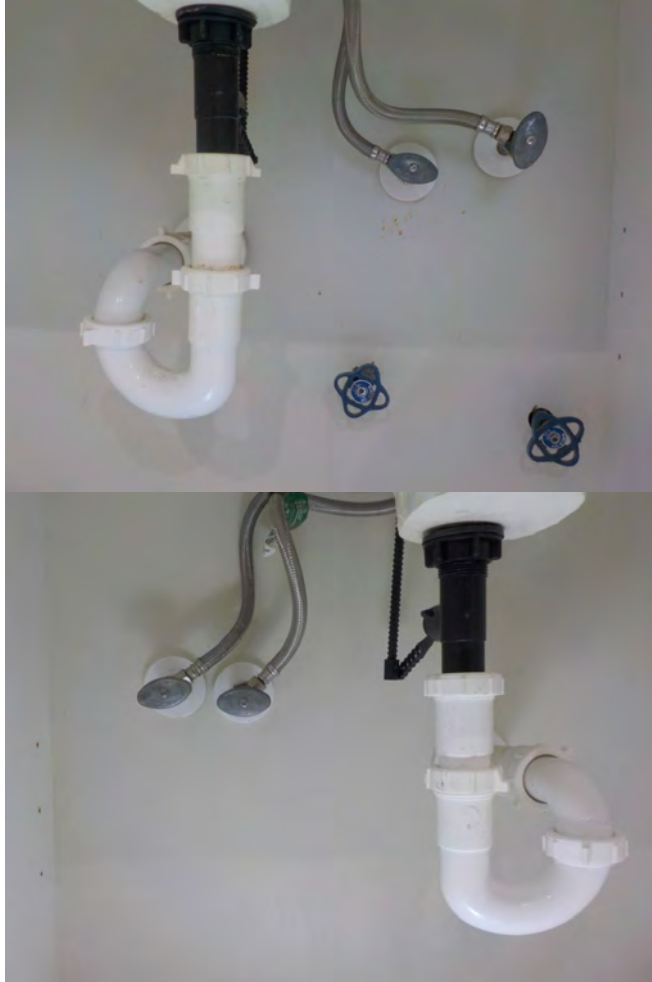
**Review; Leak noted at drainpipe underneath left side sink.**

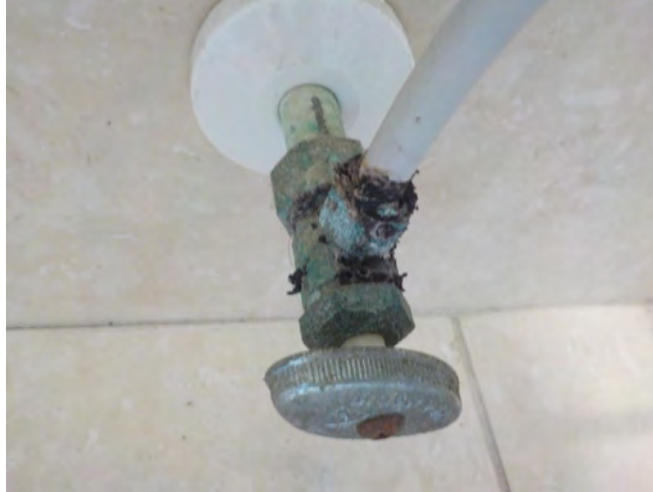
**Review; Corrosion noted at toilet supply valve. No leak noted at time of inspection.**

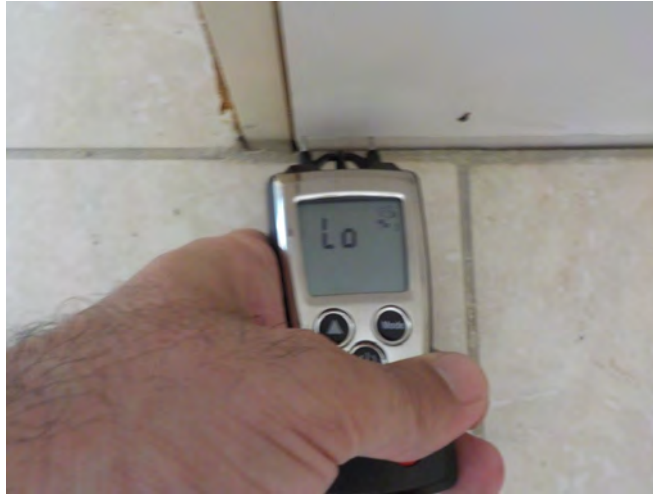
**Review; Signs of water damage noted at vanity cabinet base. Area was dry at time of inspection.**

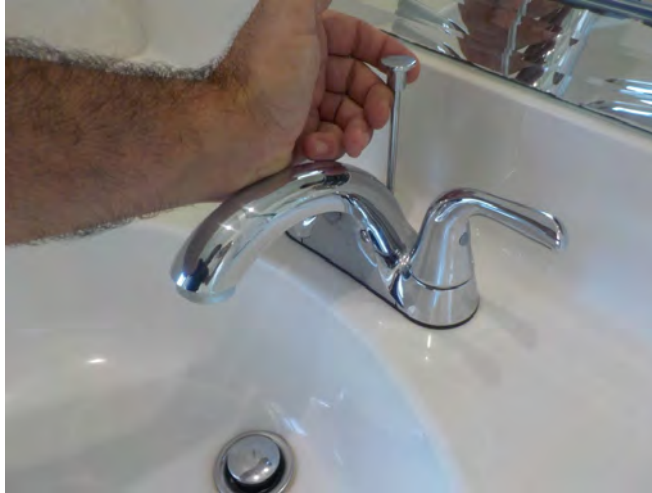
**Review; Sink stopper lever is detached.**

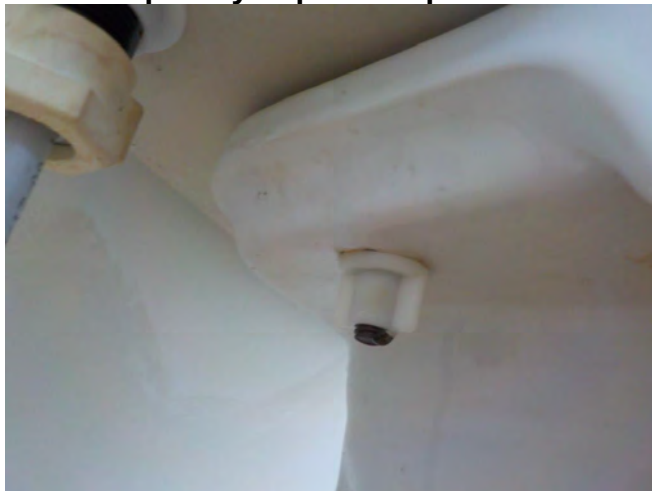
2820. 2. Toilet **Review; Leak noted at tank while toilet is filling. Suggest review/repair by a qualified plumber.**

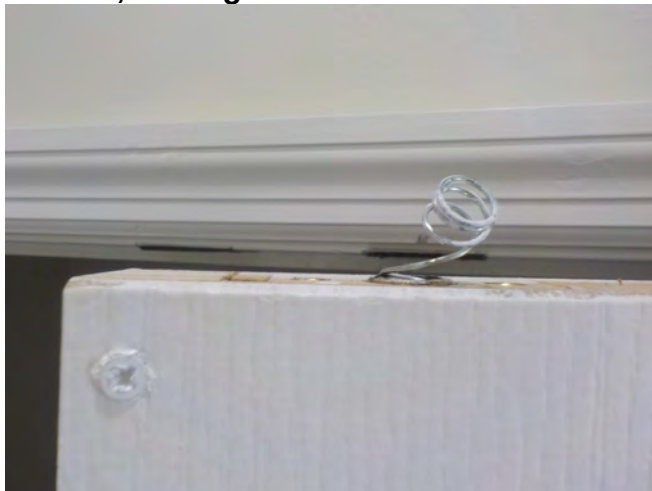
**Review; Damaged roller latch noted at one closet door.**

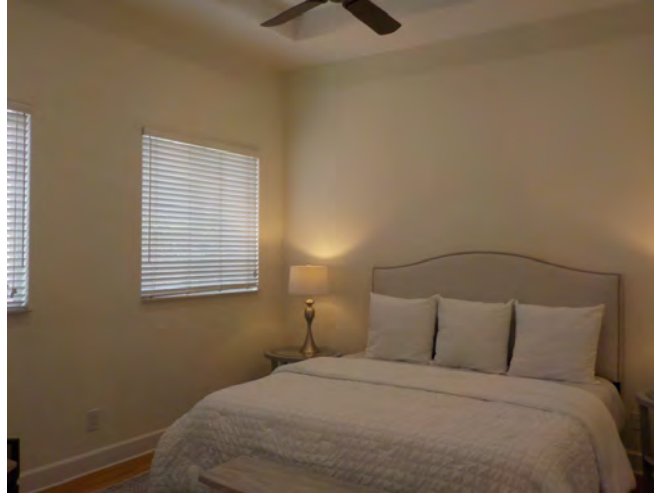
**Review; Laminate. Missing threshold noted at bedroom entry area.**

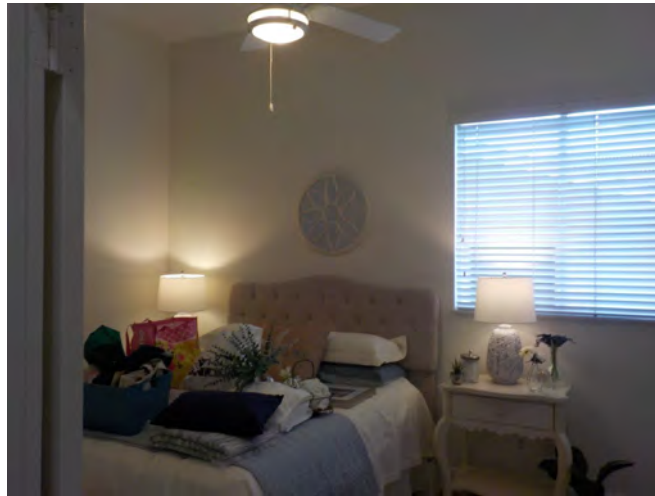
**Review; Laminate. Missing threshold noted at bedroom entry area.**

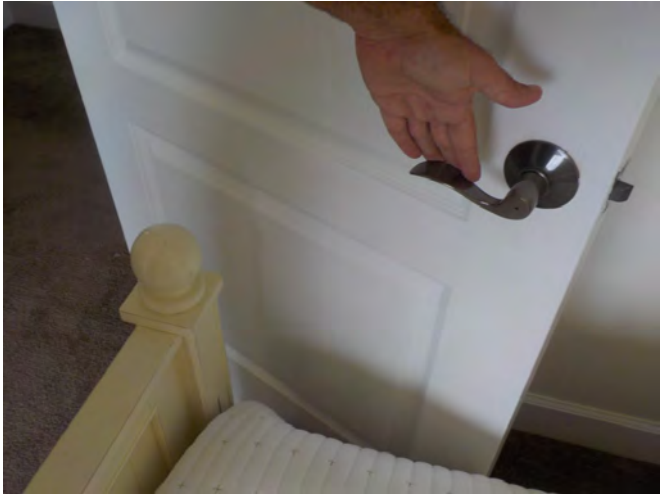
| Step # | Component | Comment |
|---|---|---|
| 2904.3. | Interior Doors | <b>Review; Wood. Door is obstructed by bed. Unable to test door latch.</b><br> |

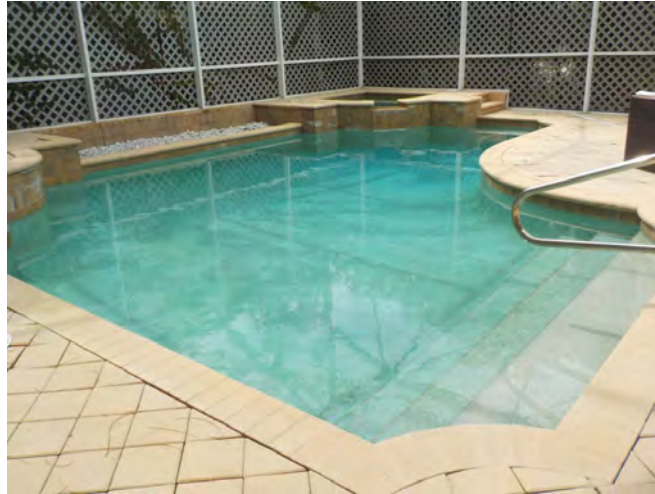
| 3002. | Decking | <b>Review; Pavers. Settlement noted at multiple areas of pavers causing trip hazard.</b> |

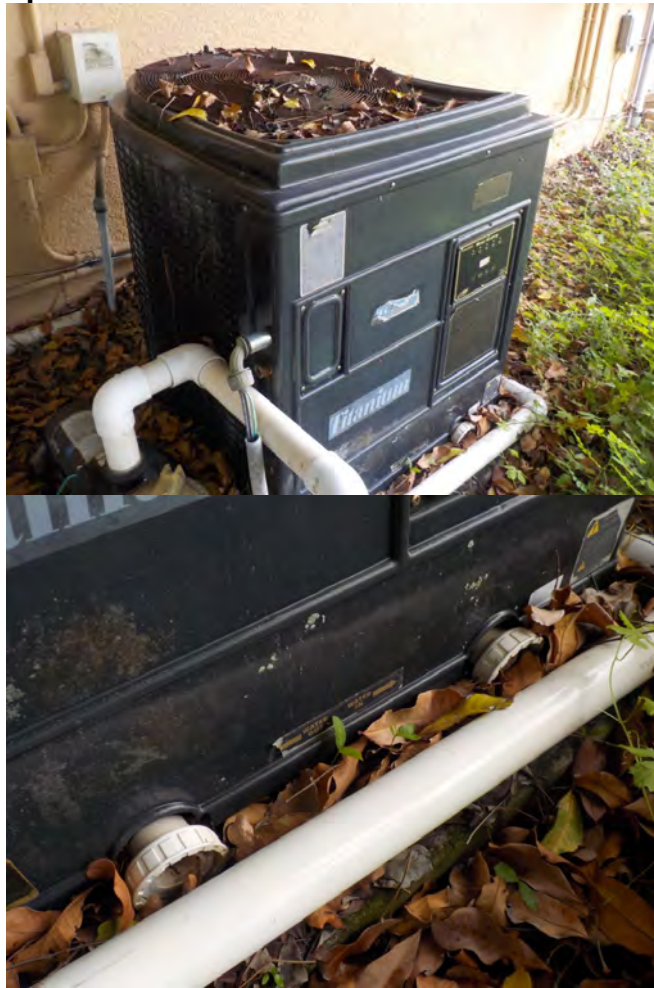
**Review; Electric Heater present but disconnected. Unit is not operable.**

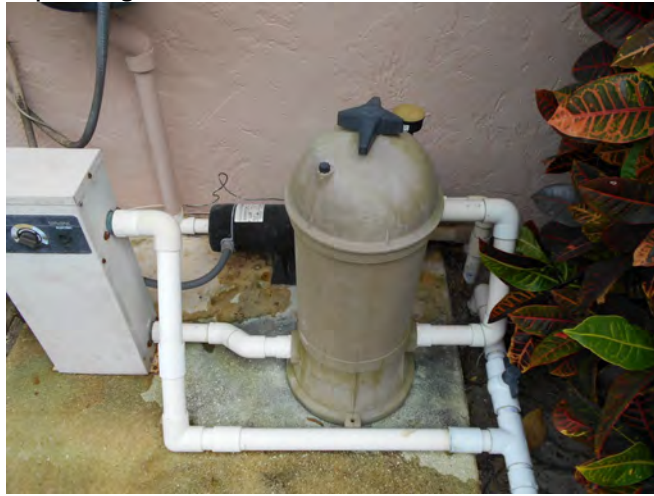
3011. Filter System Filter is the cartridge type. Filter was not accessed for inspection. Periodic cleaning/replacing of filter cartridge is required. Suggest replacing filter.
